2003 Pacific Conference on **Earthquake Engineering**

Preliminary results from the testing of a precast hollowcore floor slab building

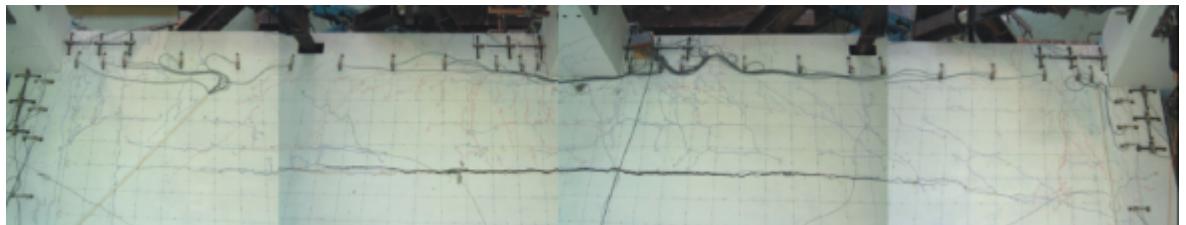
Overall the specimen behaved well up to interstorey drifts of $\pm 1.0\%$ ($\mu=2$). However significant cracking in the topping slab developed. As the drift increased this led to a tear forming within the floor slab at a drift of 1.9% . This tear was due to the elongation within the beam causing the central column to translate outwards and taking the first hollowcore unit with it. The reinforcing mesh in the topping slab between the first and second hollowcore units fractured. The tear can be seen in Figure 3(a).

(a) Longitudinal tear that formed at 1.9% drift.

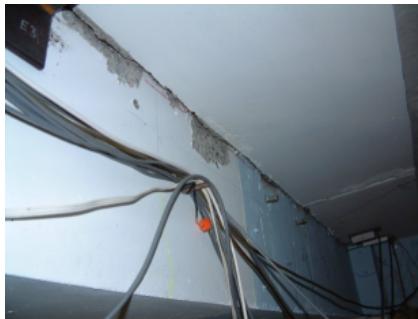
At the completion of the -2.0% cycle, the entire seating for the hollowcore units were damaged (Figure 3(b)), with some of the units dropping 10mm . There was also significant web splitting within the first hollowcore unit. It is considered that when compared to real dynamic earthquake loads, the test was possibly unconservative. This is because if any live load or vertical accelerations had been concurrently applied to the building it would be questionable as to whether the floor would remain standing. At the completion of the -2.0% drift cycle the central column displaced transverse to the direction of loading by 25mm . This also caused the first floor unit to rise 12mm relative to the rest of the floor. The extent of the crack propagation is shown in Figure 3(c) and (d). The translation was not only due to the elongation of the main beam. The newly formed inverted L shaped beam (beam plus the adjacent floor acting as a flange) contributed to some of this displacement as it tried to bend about its sloping principal axes. Since the central column is no longer tied to the floor slab it is possible for the column to fail under buckling. The reason for this is that the floor tear could occur over several floors of the building greatly increasing the columns effective length and hence reducing its load carrying capacity.

(b) Entire seat has been lost at the completion of the Phase I (-2.0% drift)

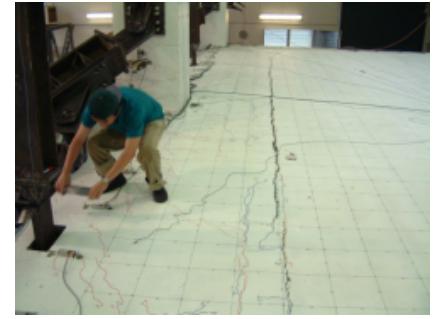
(d) Longitudinal view of floor slab tear at the end of Phase I (-2.0% drift)

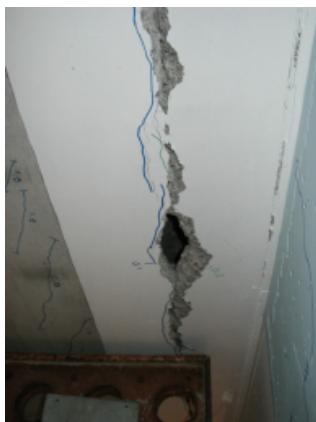
(a) Hollowcore damage

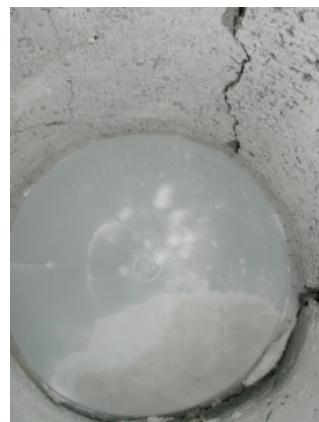
(b) Internal damage looking towards the seat

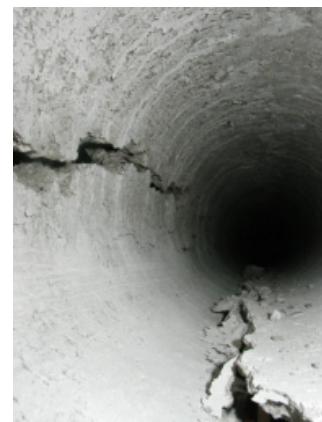
(c) Internal damage looking away from the seat

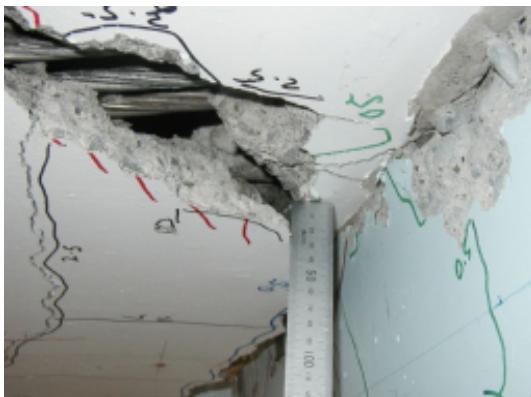
It should be noted that the hollowcore unit dropped some 30mm at this stage as shown in Figure 4(d). Figure 4(e) shows the first floor unit after a large piece of floor fell out. At this stage, the floor had dropped by some 60mm.

(d) Damage to the underside of the west hollowcore.

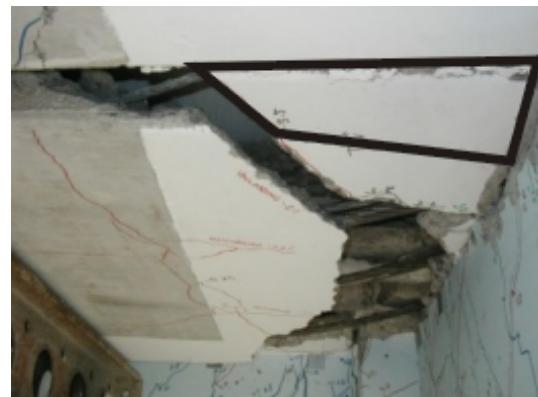
Since the side of the first hollowcore was adequately bonded to the beam, it caused the crack within the soffit of the first hollowcore unit to open some more. This meant that the condition of the hollowcore unit degraded as the transverse loading preceded. The first sizeable piece of concrete fell out around 2.0% drift. This is shown in Figure 4(a). Once the piece of concrete had fallen out of the hollowcore unit it was possible to look at the internal damage within the first hollowcore unit adjacent to the perimeter beam. Extensive damage could be seen to have occurred. Figure 4(b) and (c) shows the extent of the damage. The width of web crack within the hollowcore unit was approximately 25mm. At this stage, the webs of the first hollowcore unit had split halfway along the unit (approximately 6m). For some time now one small triangular shaped piece of concrete was holding the first floor unit up. This small section of concrete could not be relied upon to hold every time. This can be seen in Figure 4(e) at the top of the picture.

(e) Damage at 3.0% drift.

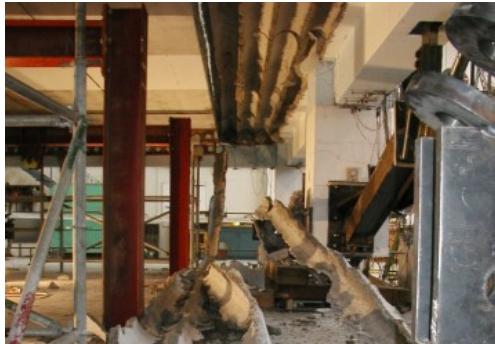
Eventually there was sufficient damage within the first hollowcore unit to allow the entire bottom section to drop as shown in Figure 6 (a) and (b). This failure occurred at a interstorey drift of 2.0%. These photos look very similar to those taken following the 1994 Northridge earthquake (Norton et al 1994).

(a) Failure of the first hollowcore unit

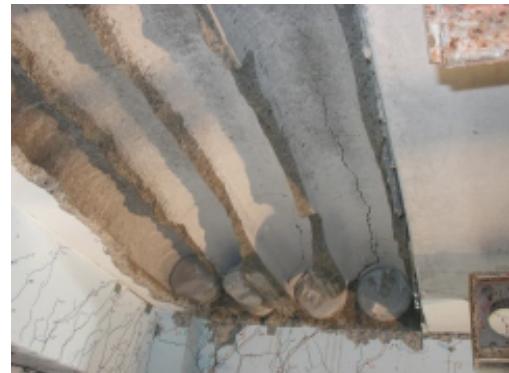
(b) Close up looking at the seat damage

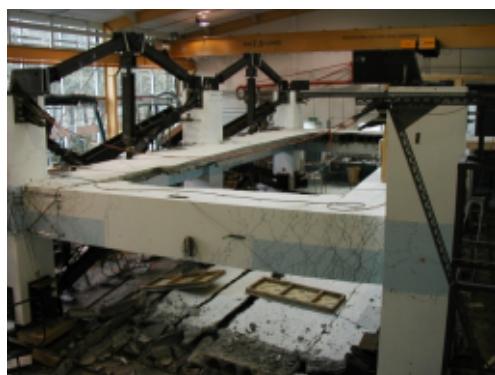
One major point to note is that even though the floor failed, the perimeter frames beams, columns, and beam column joints remained relatively undamaged. Clearly, significantly extra attention is required to be paid to the hollowcore seating details to ensure that class of precast floor system performs at a level that is not inferior to than that of the structural frame.

(c) The frame after the floor collapsed

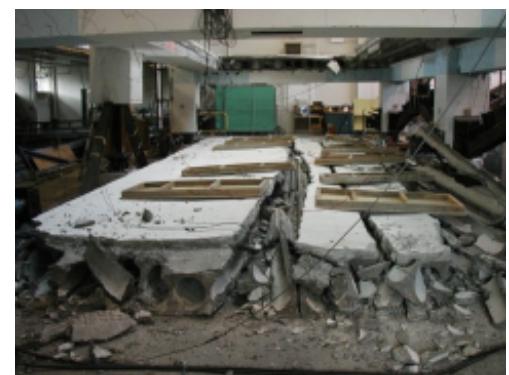
Upon further loading, to the -2.5% drift amplitude, the remainder of the floor failed when the design live load was applied. Again, the photos of this failure (Figure 6(c)-(f)) were very similar to that seen in Northridge.

(d) Collapsed floor units

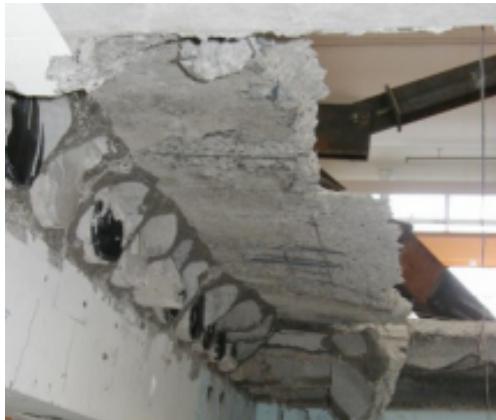
(e) The remaining topping and ends of the hollowcore units after collapse.

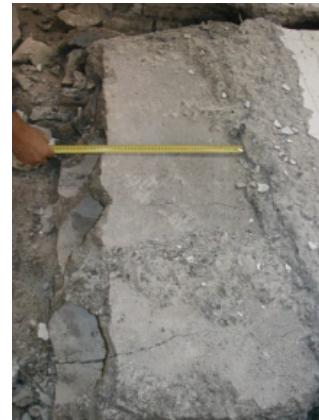
(f) The delaminated topping on the failed unit.

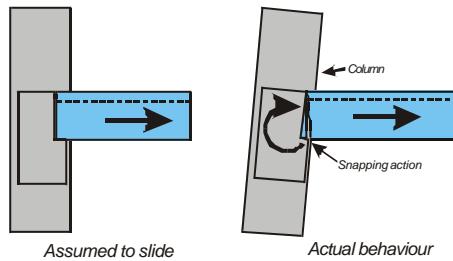
Figure 7. Assumed versus actual hollowcore to beam performance.

One major difference between the expected seating performance and the observed performance was the way in which the floor unit moved relative to the beam it was seated. In design it is customary to assume that hollowcore units would slide relative to the beam; this was not the case in the experiment. There was enough bond/friction to cause the end of the unit to fracture rather than slide, as shown in Figure 7.

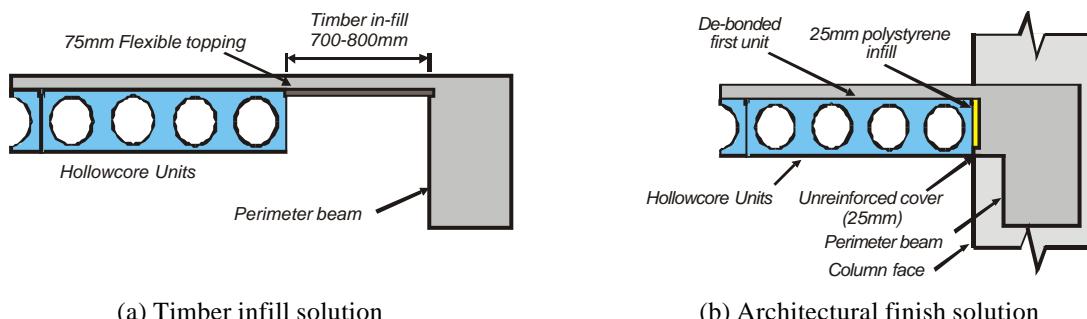
Figure 10 Two fixes that should allow the first hollowcore unit to be separated from the perimeter beam.

A hollowcore floor unit is designed to act as a simply supported one-way floor system. The first unit placed adjacent to the perimeter frame does not act in this manner as it is adequately tied not only at its ends but also along its entire length. This leads to the unit being displaced in a quasi-two way manner as the hollowcore unit is forced to undergo the displaced shape of the perimeter beam. This displacement incompatibility between the double curvature of the perimeter beam and the simply supported hollowcore unit causes the hollowcore unit to fail (Figure 8). Since the hollowcore unit has no redundancy in its design the unit fails through web splitting and the bottom half of the hollowcore unit drops.

Changing the way in which the first hollowcore unit is connected to the adjacent perimeter beam should allow the unit to perform in the manner in which it was intended by design—that is, a one-way slab. Two different connection details are proposed. The first involves a timber infill that allows a more flexible interface (Figure 10(a)). Damage is expected within this infilled section leaving the first hollowcore unit undamaged. The second is a detail that would need to be used if the bottom of the hollowcore unit is left exposed for an architectural finish (Figure 10(b)). This requires the unit to be butted against the perimeter beam. Placing some polystyrene against the edge of the first hollowcore unit and applying a bond release agent to the top of the first hollowcore unit, so that the topping does not bond to the unit, should allow the hollowcore unit to be de-bonded from the perimeter beam and permit the differential movement between the beam and slab as depicted in Figure 9.

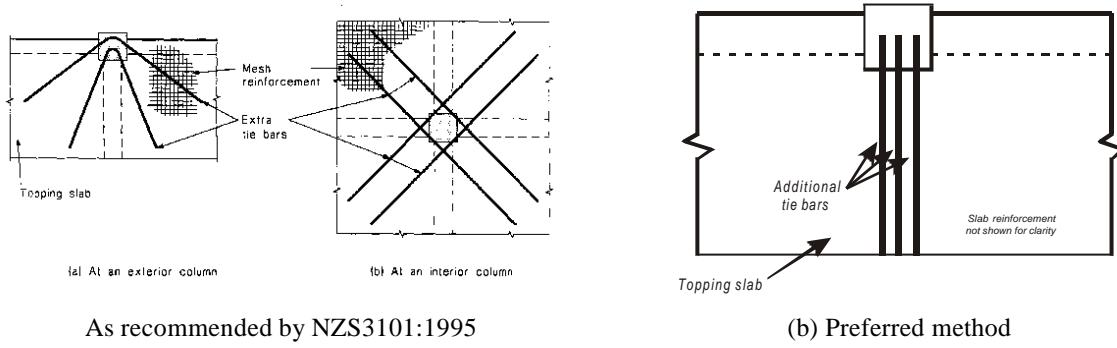
Figure 11. Recommended tie details.

During the experiment a longitudinal tear formed within the floor diaphragm due to the overloading of the diaphragm reinforcement as floor-frame set up displaced. This tear within the floor now affects the column effective length. If such a tear occurred over several floors in a real multi-storey frame then the column may become unstable.

As specified by the NZS3101 the bars should be placed at angles close to 45° . This does help tie the column in but also contributes to the perimeter beams overstrength actions. The bars would be better placed transverse to the perimeter beam. These two comparisons are shown in Figure 10.
