# Performance of highway bridges under Chuetsu Earthquake, Japan

2005 NZSEE  
Conference

**ABSTRACT:** This paper reports on the 3-day reconnaissance visit to the damaged sites of Magnitude 6.9 Chuetsu Earthquake in Niigata, Japan. The damage characteristics of about thirty highway bridges visited is described in detail. The damages to bridges were not extensive and less severe than witnessed in the Hyogo-ken Nanbu Earthquake of 1995. The main reason is that there are not many bridges in the areas that experienced high intensity earthquake ground motions. It was observed that bridges, which have been seismically retrofitted, performed satisfactorily without sustaining severe damage. It is vital that bridges designed to older design specifications should be retrofitted as soon as practicable. There was not enough evidence to confirm that bridges designed and constructed to the current specifications have performed well under the near field strong earthquake.

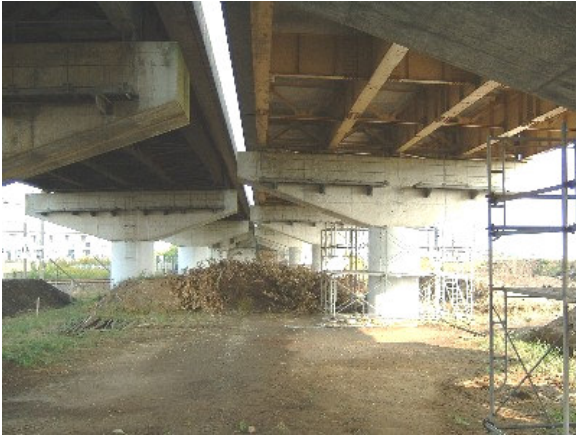
The other reason is that many of the bridges designed prior to 1980 have already been retrofitted after 1996, based on the experience from many catastrophic failures of civil structures in the Hyogo-ken Nanbu Earthquake. This was especially evident in one of the bridge sites on National Highway No. 8 in Ojiya, where there are twin bridges over a railway line (Figure 3). The older of the twin bridges already had its pier columns retrofitted with steel jackets and had no damages due to the earthquake. However, the other bridge designed to pre-1980 specifications did not receive any retrofit and had damage to the pier columns. The damage was in the form of cover spalling and buckling of longitudinal reinforcement (Figure 4), which has been temporarily repaired with carbon FRP wraps as an emergency measure to allow traffic.

Figure 3. Twin bridges on National Highway No. 8 over the railway in Ojiya

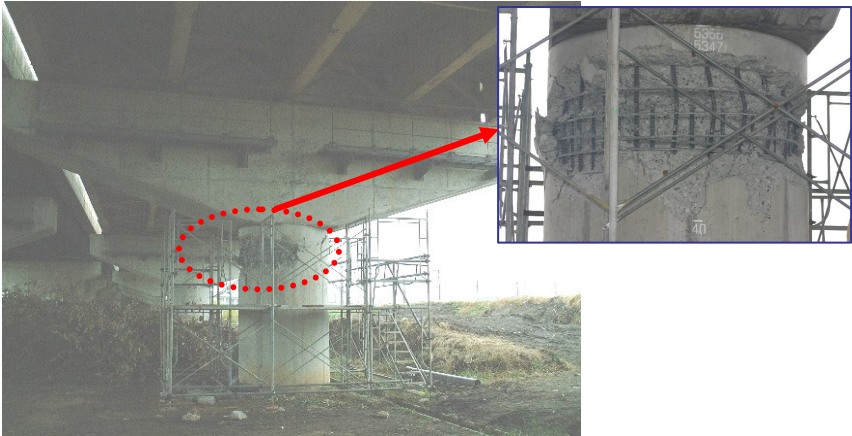
Figure 4. One of the damaged pier columns of the railway overbridge in Ojiya

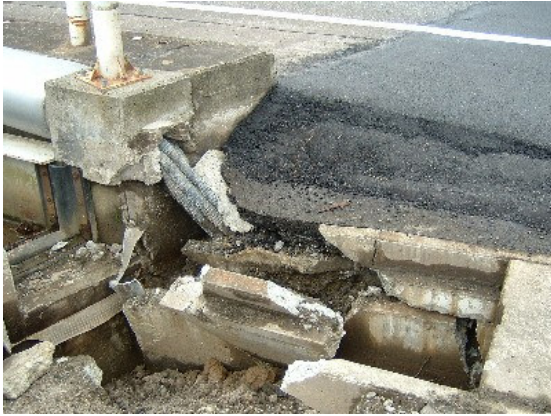
Most of the damage in many of these bridge sites was triggered by settlement of soil. This is mainly caused by the loosening of soil due to the typhoon that struck these areas a few days prior to the earthquake. Soil settlement is a disruptive damage as a number of approach roads of bridges have settled and required immediate resurfacing/repair for emergency and relief traffic to pass. Figures 5 and 6 show some of the approach road settlement.

Figure 5. Approach road settlement at Hurumiya Bridge

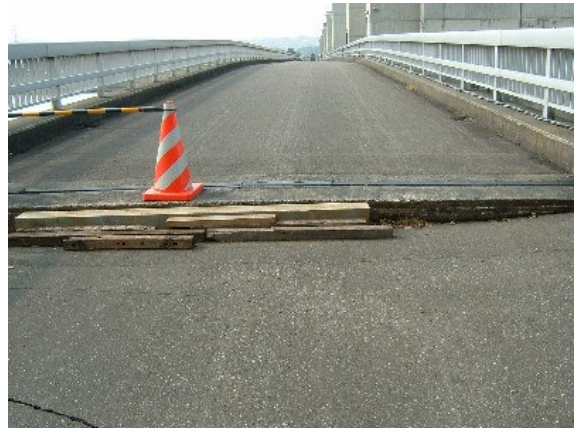
Figure 6. Approach road settlement at Koshino Bridge

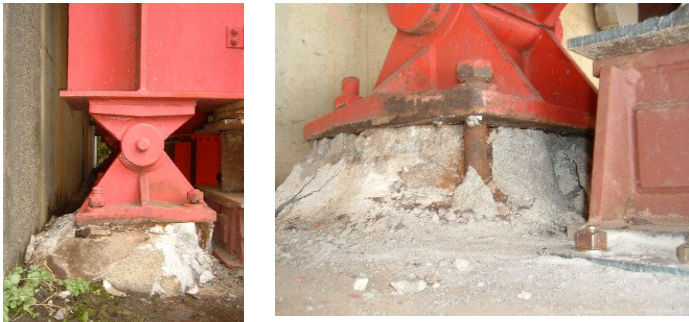
The bearings were damaged at the abutments of Miyanaka Bridge over the river Shinano, the longest river in Japan (367km long). The holding down bolts yielded and mortar pads cracked and spalled as shown in Figure 7. The damage was extensive that temporary supports had to be installed for emergency and relief traffic (Figure 8).

Figure 7. Damage to bearings of Miyanaka Bridge

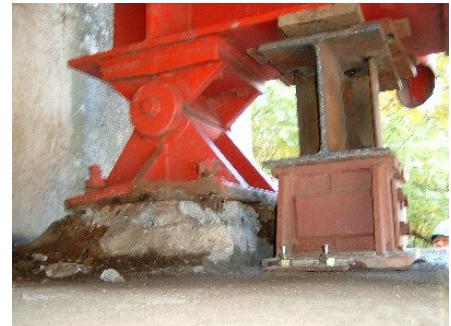
Figure 8. Temporary support at one of the damaged bearings, Miyanaka Bridge

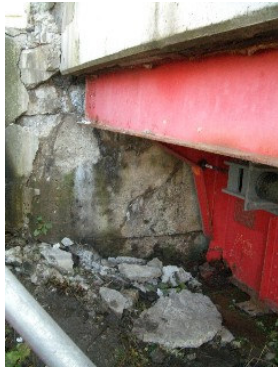
(a) Wanazu Bridge

Damage to the abutment back walls from the impact of superstructure (the form of cracking and spalling of concrete. Wanazu, Imok Bridge 9(a), (b) and (c) respectively) are a few examples where damage to back walls has occurred under longitudinal response.

Figure 9. Damages to abutment backwalls

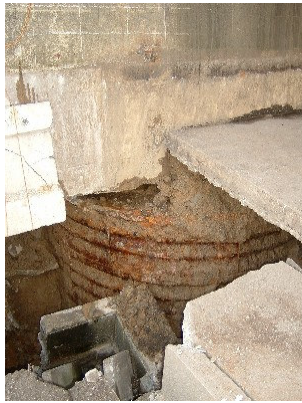
The abutments of Yamabe Bridge, located at the foot of a sloping terrain, have rotated considerably and pulled off the piles as shown in Figure 10. Soil has slumped more than a metre at this bridge site as shown in Figure 11.

Figure 10. Pile pull-off, Yamabe Bridge

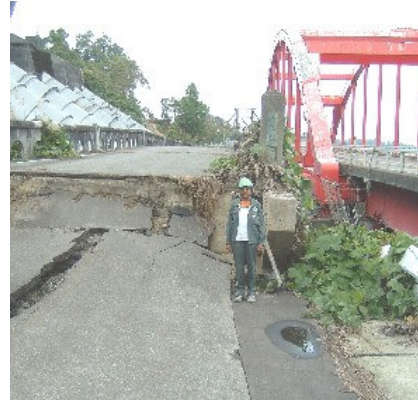
Figure 11. Soil slumping at Yamabe bridge site

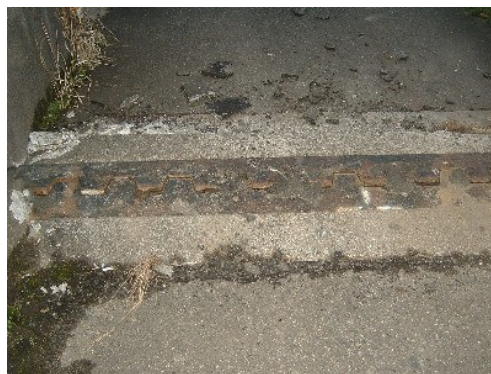
Another feature that has caused damage in bridges was excessive longitudinal displacement. In addition to the damage to bearings and back walls, bridge joints have been damaged due to excessive longitudinal movement. Figure 12 shows a damaged joint on Uonuma Bridge.

Figure 12. One of the damaged joints on Uonuma Bridge

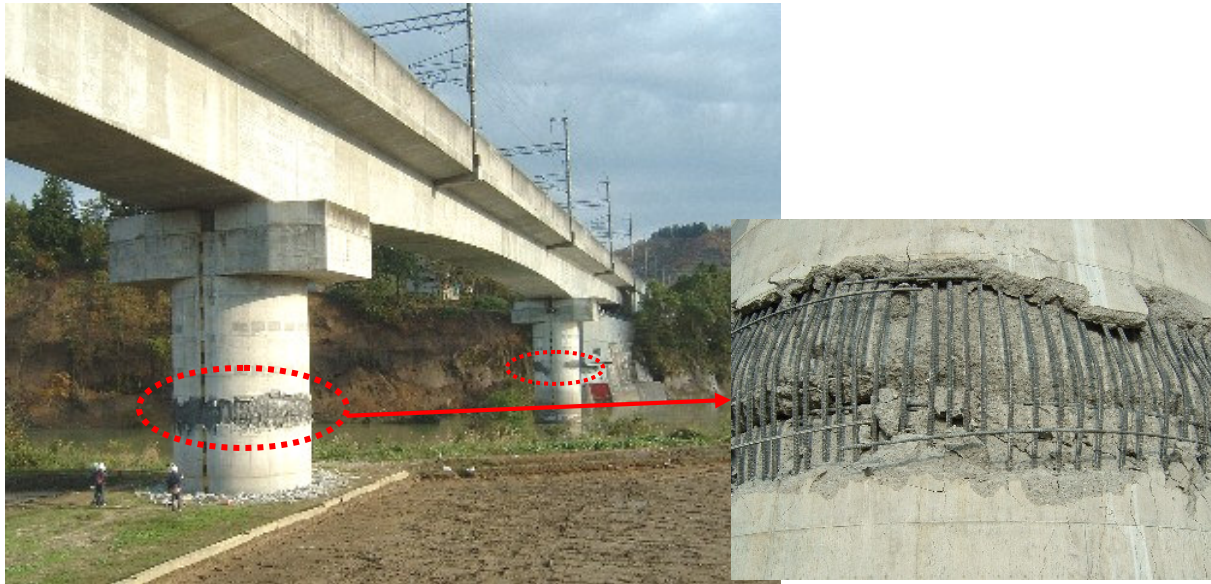
Both pier columns of Uonogawa Bullet Train Bridge sustained flexural plastic hinges at their mid-height as seen in Figure 13. Part of the longitudinal reinforcement was cut-off at mid-height resulting in inadequate flexural strength in these columns.

Figure 13. Flexural hinges developed at mid height of pier columns, Uonogawa Bullet Train Bridge

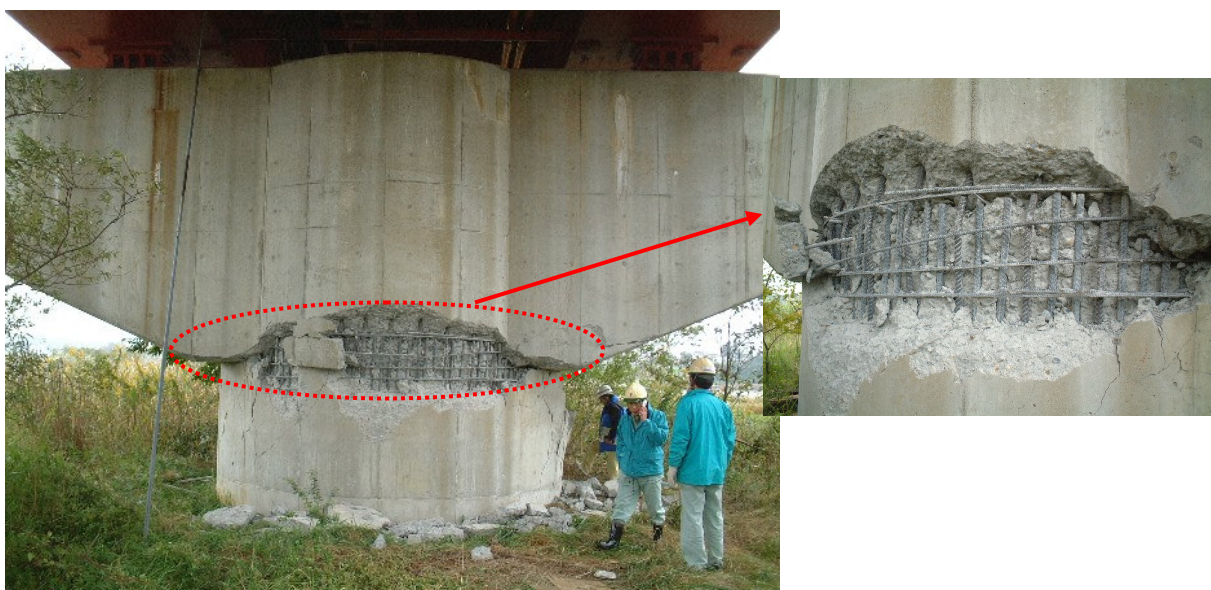
Ojiya Bridge over the river Shinano received damage to its shortest pier column. The cover concrete has spalled and longitudinal reinforcement buckled at the top of the column as shown in Figure 14. The column was later wrapped with carbon FRP sheets as a temporary repair for emergency and relief traffic (Figure 15).

Figure 14. Damaged pier column, Ojiya Bridge (Photo courtesy of H. Nishida, PWRI)

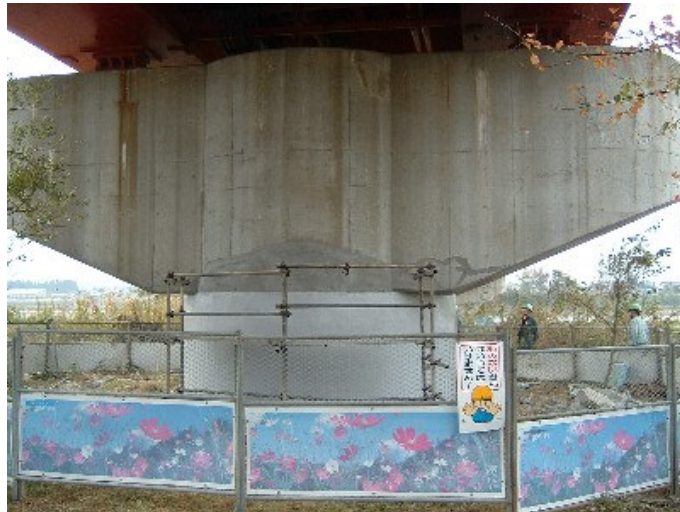
Figure 15. Column repaired with carbon FRP sheets, Ojiya Bridge  
(Photo courtesy of H. Nishida, PWRI)

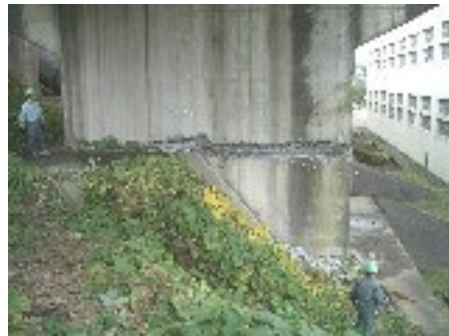
One of the wall piers of Yamabe Bridge developed flexural plastic hinges at the section of abrupt change in stiffness (Figure 16) under transverse response. This was further exacerbated by the sloping terrain and condition of the site soil.

Figure 16. Damaged wall pier, Yamabe Bridge

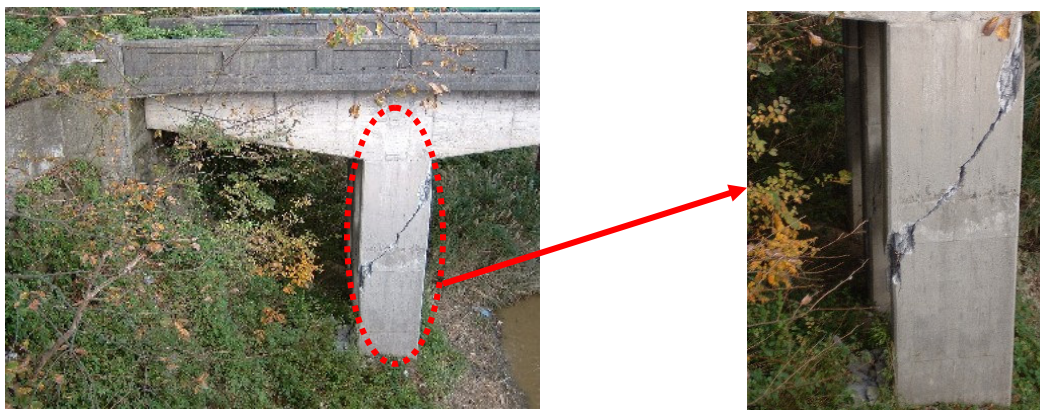
The old Uragara Bridge, a 3-span continuous reinforced concrete bridge, received damage to its pier columns. Shear cracks developed in the top part of the pier columns as shown in Figure 17.

Figure 17. Shear cracks in one of the pier columns, old Uragara Bridge

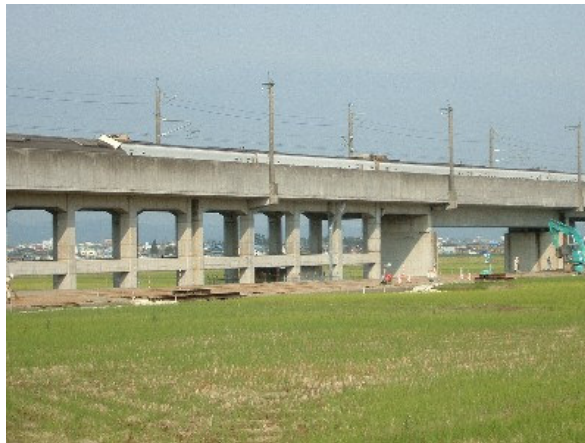
Liquefaction of soil was observed at the site of Katada Viaduct, where the bullet train derailed. Figure 18 shows the site where liquefaction has taken place and a part of the Katada Viaduct with derailed bullet train. No visible damage was observed at the footings of the viaduct. Development of Plastic hinges were observed at the top of the columns in some of the piers.

Figure 18. Katada Viaduct with derailed bullet train
