# Field Measurements of Lateral Spreading following the 2010 Darfield Earthquake

K. Robinson, M. Cubrinovski & P. Kailey

**ABSTRACT:** A field investigation was launched following the 2010 Darfield Earthquake in order to measure permanent lateral ground displacements in areas significantly affected by liquefaction-induced lateral spreading. Ground surveying techniques were used to estimate total displacement along specific transects. Approximately 75 transects have been completed to date in the areas of Kaiapoi, Spencerville, and various suburbs within Christchurch City. Maximum lateral displacements measured in these areas ranged from about 0.5 m to up to 3.5 m, causing significant damage to nearby structures and lifelines. This paper presents the methods involved in our investigation, a summary of our results, and characteristics of the lateral spreading which occurred in South Kaiapoi.

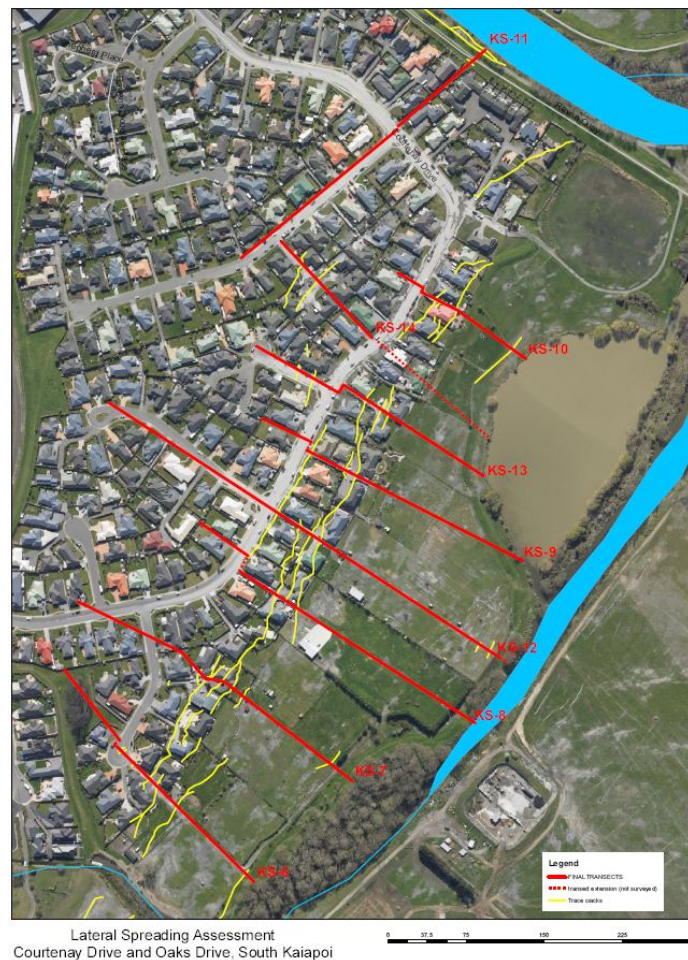
**Figure 3. Aerial view of South Kaiapoi indicating lateral spreading transects and locations of major ground cracks/fissures**

Figure 3 shows eight transects performed along Courtenay Stream/Lake as part of our reconnaissance work. Measured permanent lateral displacements at the banks in this area ranged from 1.3 to 2.7 m. A graph showing permanent ground displacement,  $U_g$ , versus distance from the waterway,  $L$ , for the transects shown in Figure 3 is presented in Figure 6 (a). In the graph, the “waterway” refers to Courtenay Stream or Courtenay Lake.

Cross-section KS-10 was combined with KS-14 given their proximity to one another as shown in Figure 3. The combined displacement fits well within the trend observed along other transects in the area. A block type of movement is apparent where large ground cracks/fissures are concentrated about 120 to 200 m from the banks with few/small cracks adjacent to the waterway. This is different from a typical distribution of ground displacement due to lateral spreading where the majority of displacements (largest cracks) occur near the banks and decrease with distance from the waterway. A similar plot of distribution of permanent lateral ground displacement with distance from the waterway for North Kaiapoi is shown in Figure 6 (b).

In South Kaiapoi, block-type movement was observed with atypical distribution of ground displacements where no cracks occurred close to the river bank, but very large ground fissures/cracks split the ground at distances of 120 to 200 m from the waterway. This feature significantly contributed to the severe damage of residential properties/houses in this area.

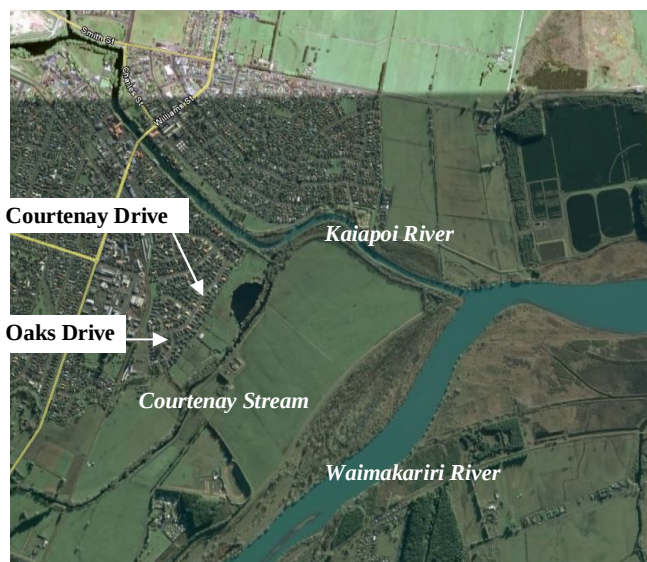
**Figure 5. Aerial view of South Kaiapoi that was severely affected by lateral spreading**

As seen in Figure 5, the Waimakariri River is the dominant channel feature in the area. The historical meandering loops of this river are likely the cause of the extensive liquefaction observed after the earthquake. Prior to 1868, the river consisted of a northern branch which flowed into present-day Kaiapoi River and a southern branch which flowed into a now abandoned channel in the area of present-day Courtenay Drive area (Ward and Reeves, 1985). As a result of the two branches, the present town centre area was referred to as “Kaiapoi Island.” The old Waimakariri channel likely deposited loose silts and sand in its path (Berrill et al. 1994).

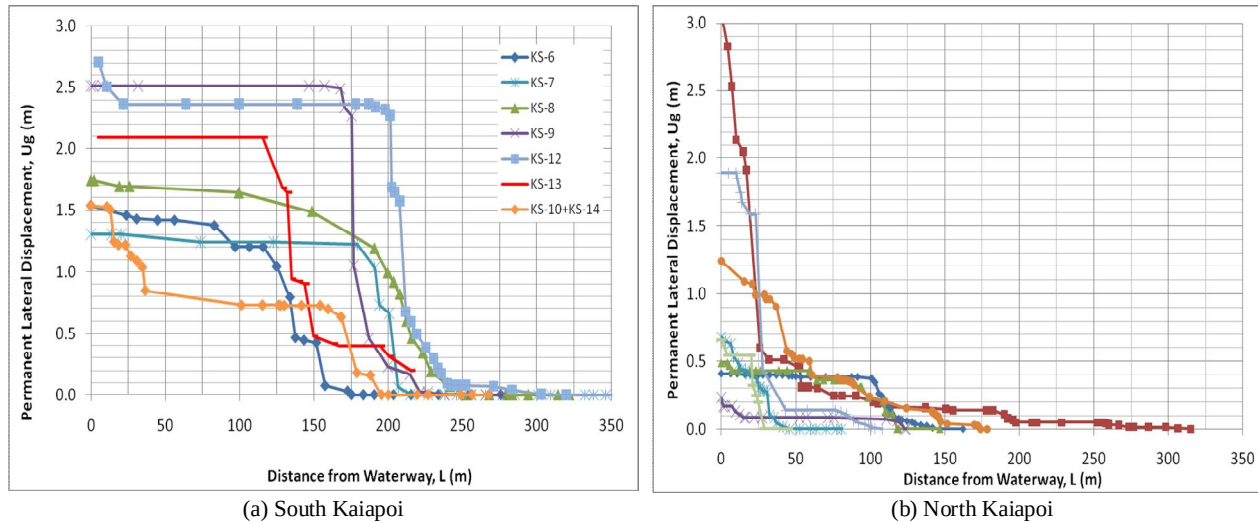
**Figure 6. Distribution of permanent lateral ground displacement with distance from the waterway at: (a) South Kaiapoi and (b) North Kaiapoi**

In North Kaiapoi much of the displacement occurred within 50 m of the bank. Similar findings were observed following the 1995 Hyogoken-Nambu (Kobe) earthquake, where permanent lateral displacements were reported to increase sharply within 50 m of the quay walls (Cubrinovski and Ishihara 2003). The block-type movement of South Kaiapoi is probably related to the fact that this area coincides with the location of an old Waimakariri River channel dating back to 1868 (Wotherspoon et al. 2010; Cubrinovski et al. 2010).
