# The Performance of Residential Houses in the Darfield Earthquake of 4 September 2010

G. J. Beattie, R. H. Shelton, S. J. Thurston & A. Z. Liu

*BRANZ Ltd, Porirua, New Zealand.*

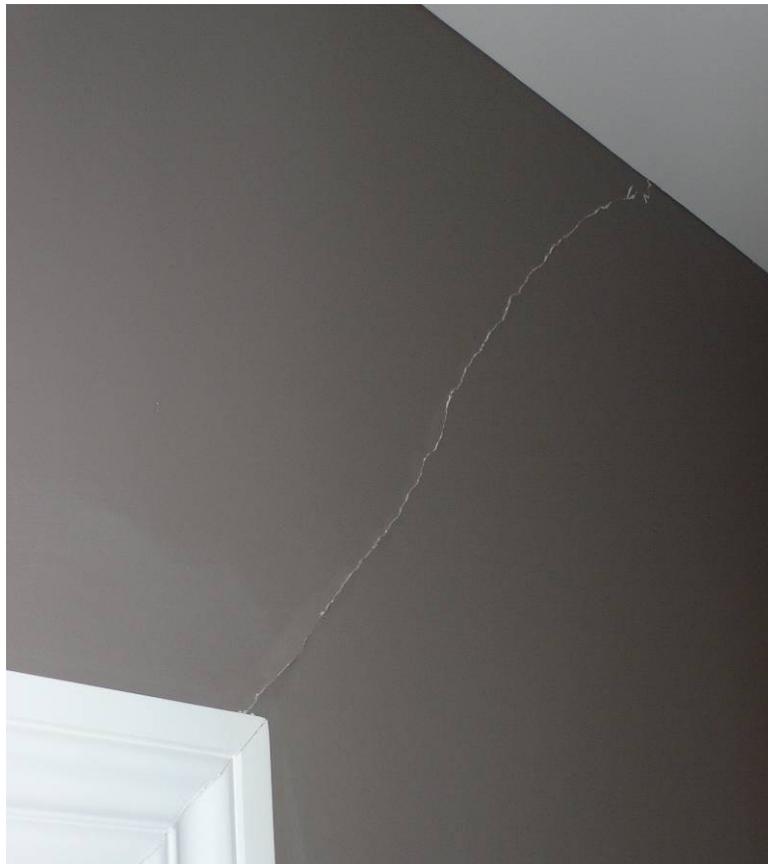
Because gypsum plasterboard provides most of the bracing in modern houses, the study team was keen to understand how well it worked in the earthquake. Damage observations ranged from “no damage” to diagonal cracking in the sheets. The incidence of diagonal cracking in the sheet was rare and was restricted to cracks that emanated from the top corners of large door openings in lower storey walls (Figure 3). While it will be necessary to replace the cracked sheets, such damage is expected in an ultimate limit state earthquake event. Plasterboard manufacturers recommend that sheet linings are cut around openings because this ensures that in normal circumstances seasonal variations in the framing are not expressed as cracks in the joints between sheets. However, this recommended practice is not always followed, and fine vertical cracks can be seen on the joints at the corners of windows and door openings (Figure 4). The racking that has occurred in the earthquake has sometimes exacerbated the damage at these joints, but it was found that rarely had the fixings “popped” and, the repair will be a simple racking out of the joint and re-stopping with the inclusion of paper tape reinforcement for added strength against seasonal movement.

**Figure 3 Diagonal cracking of gypsum plasterboard sheet from top corner of door**

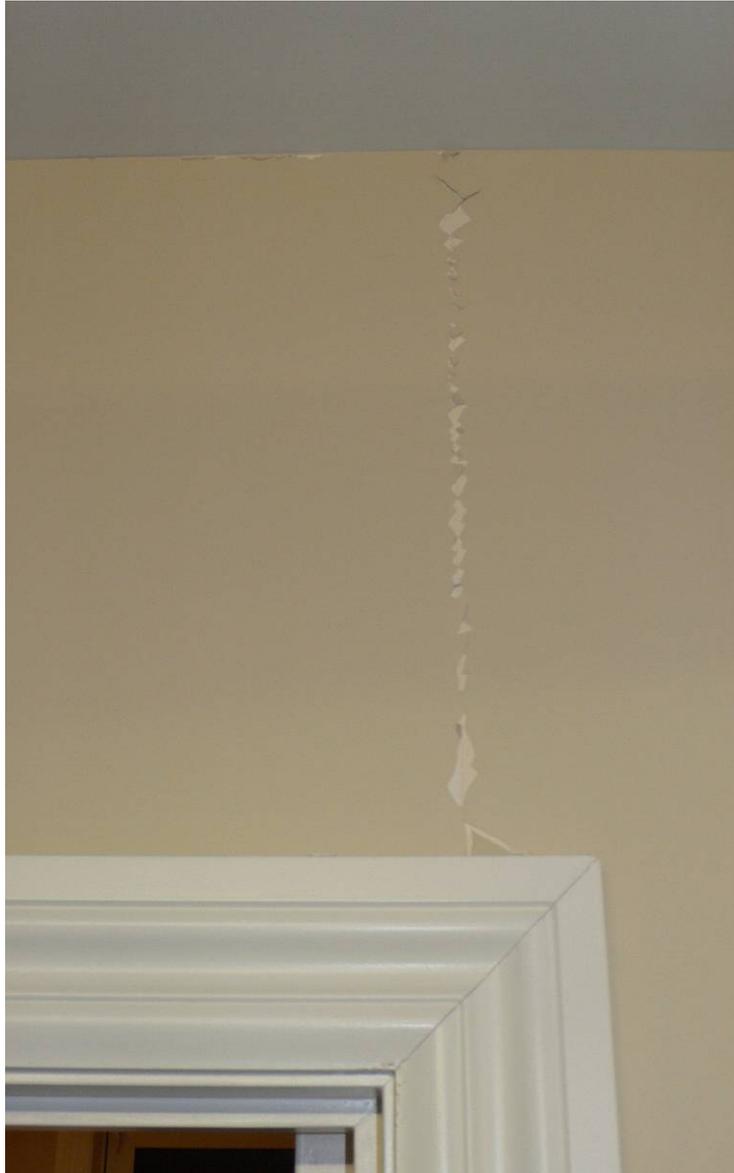
There has been some discussion in the engineering community about the possible reduced stiffness of these houses after the earthquake. There is some anecdotal evidence that houses are responding more to high winds and minor tremors now than they were prior to the earthquake. This is quite possibly the case as it is known that at service loads in laboratory tests no “popping” of fixings shows up, yet small slots have been created in the plasterboard around the fixings through which the fixings must slide before taking up load. If this is proven to be a common behaviour, it may be necessary to re-fix some of the sheets during the post-earthquake repair work.

**Figure 4 Earthquake induced cracking at joints between plasterboard sheets**

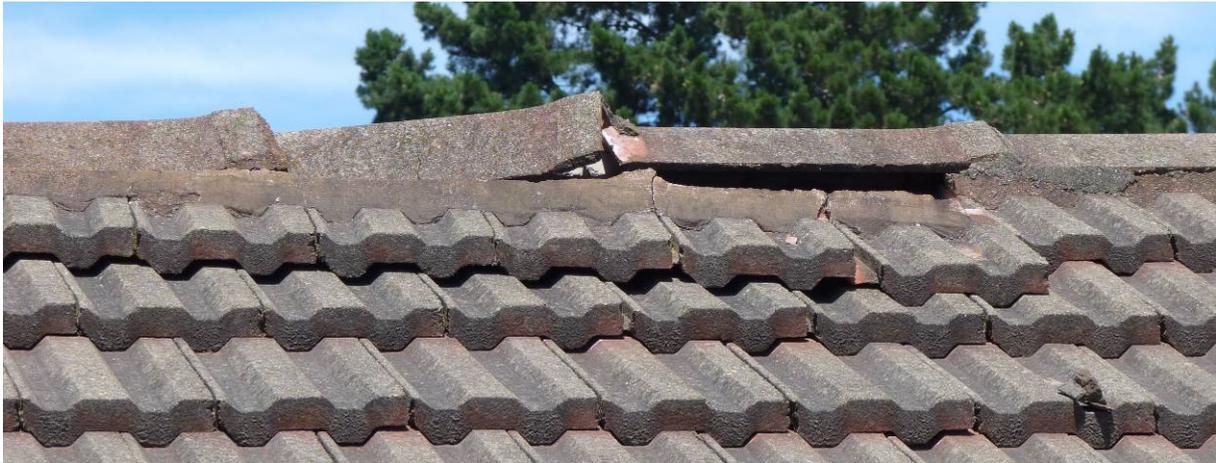
Metal roof cladding behaved well, and no evidence was seen of damage to either corrugated steel sheets and fixings or to metal roof tiles. Minor shaking damage occurred with heavy concrete tiles. A long, narrow garage structure located near the epicentre which had a brick veneer cladding experienced some roof tile damage, most likely caused by transverse flexibility of the structure (Figure 5). At the same property, some minor damage to the mortar pointing on the roof hips was also observed.

**Figure 5 Dislodged roof tiles and ridge capping tiles**

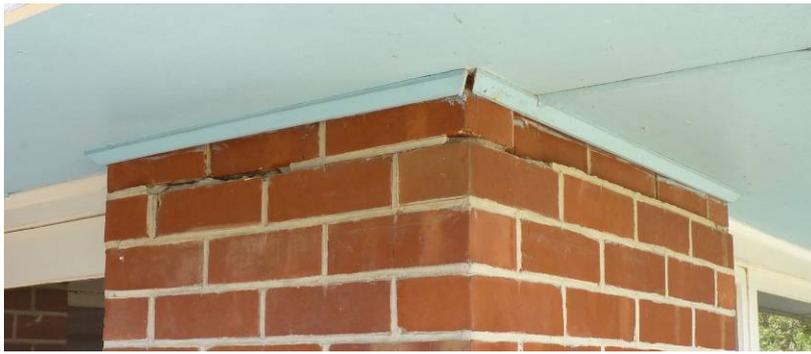
Often bricks had moved in the brick veneer top course, particularly the end bricks in isolated piers (Figure 6), or adjacent to air vent slots where a vertical joint between bricks (perpends) had deliberately not been filled with mortar. The likely reasons for the cracked mortar joints in this area are that the differential movement between the soffit lining and the veneer has caught hold of the bricks, or the veneer ties in the top mortar course (if present) have lifted the top brick as they have twisted with the differential movement. These can be easily and relatively cheaply repaired. Few actually fell as they tended to become wedged against the soffit or retained by the wooden trim.

If these bricks did fall they would pose some risk of injury in single storey veneers and significant risk to life in two storey construction. The top one or two courses of brick, above the top level of brick ties, are not well restrained, and can easily be dislodged. In an earthquake they tend to act as a cantilever above the top row of brick ties, and have a lower natural frequency than that of the brick wall below. A possible solution to this weakness may be to require that the uppermost mortar course has ties included and further restraint could be provided by the inclusion of a timber trim, as is often the case by default, fixed to the soffit.

**Figure 6 Dislodging of brick veneer beneath soffits**

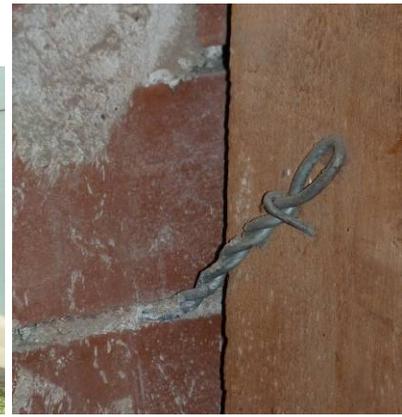
Prior to the introduction of screw fixed veneer ties in the late 1990's, the veneer was generally tied to the framing with twisted number eight wire (Figure 4) and staples. There was some evidence of the staples being pulled from the framing, but this was limited to properties where substantial lateral spreading had occurred and the foundation supporting the veneer had separated from the timber floor structure.

**Figure 7 Old style wire veneer tie**

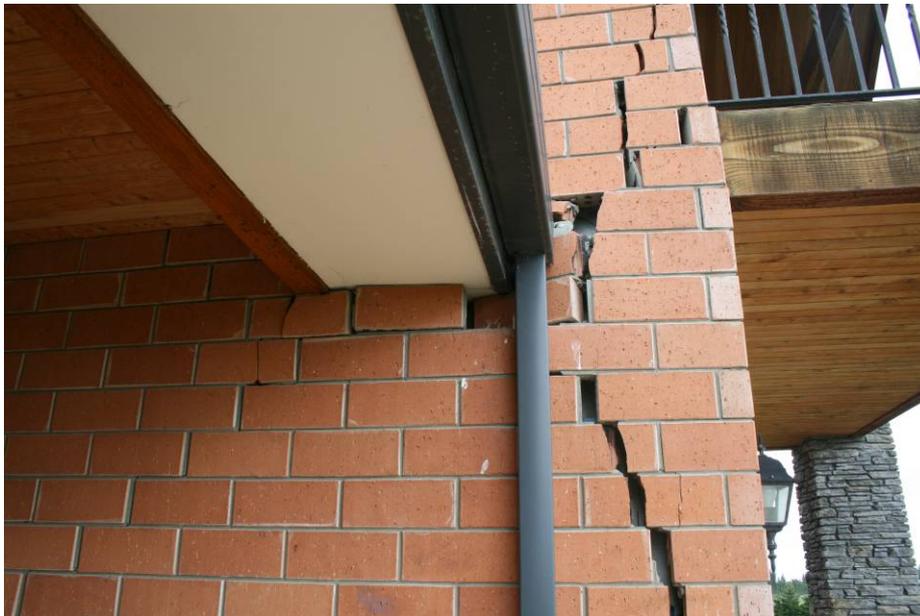
Two storey veneer clad structures did not appear to behave significantly worse than single storey houses, except near the epicentral area where the cracking was more severe but with little loss of bricks (Figure 8). One modern two storey property inspected in the central city was clad with Oamaru Stone veneer. Damage was limited to minor cracking of mortar joints and occasional fine cracks through the individual bricks.

**Figure 8 Cracking in veneer at the junction of two storey and single storey sections**
