Retrofit to improve earthquake performance of bridge abutment slopes

P. Brabhakaran, J. Duxfield, S. Arumugam

Opus International Consultants, New Zealand.

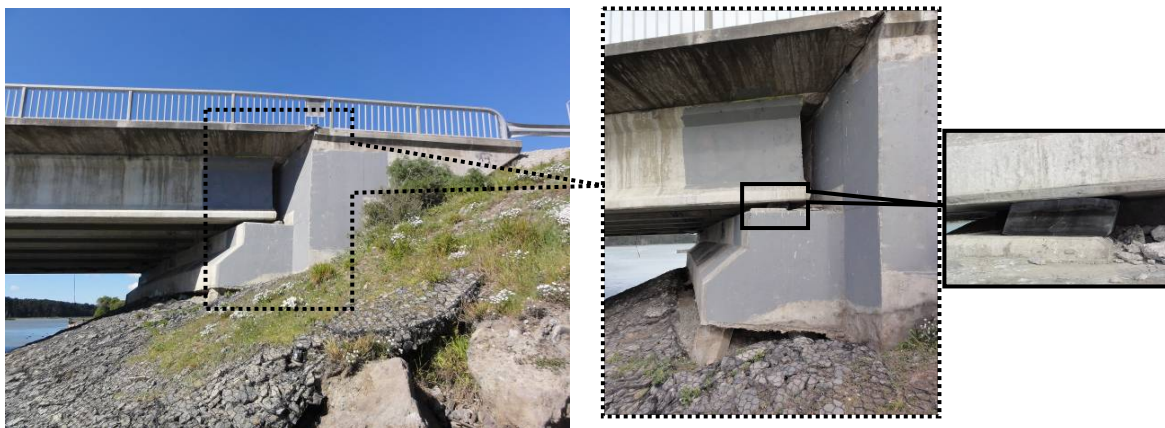
Notably the abutments of the South Brighton Bridge over the estuary and its approaches on Bridge Street were damaged. The bridge was quickly reopened to provide limited access to traffic after reinstatement of the approaches. Liquefaction and lateral spreading of the abutment slopes led to rotation of abutment, with some damage to the raked piles supporting the abutment, see Figure 1.

Figure 1. Damage to bridge abutment at South Brighton Bridge in 2010 Darfield Earthquake

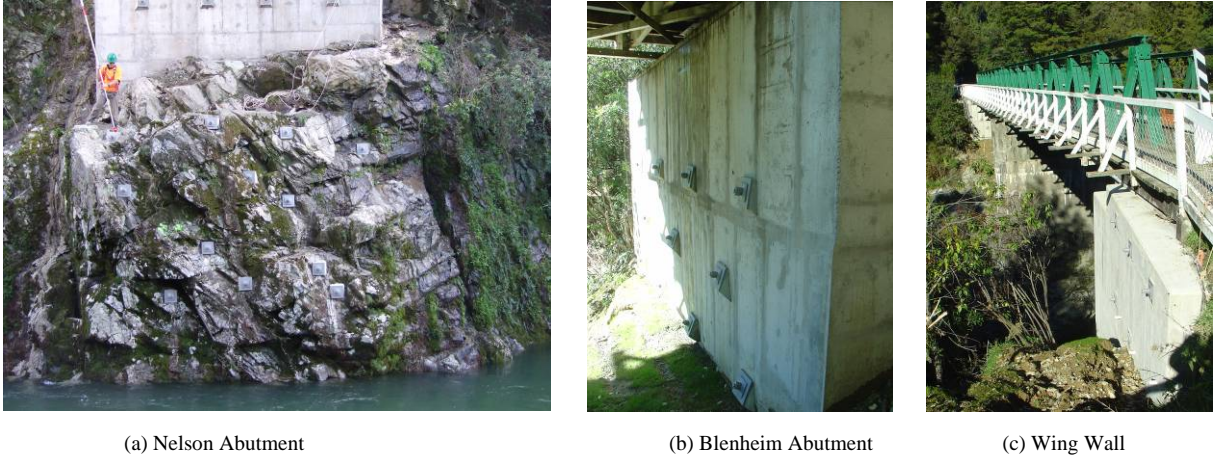
The Nelson abutment and central pier of the bridge are founded on indurated sandstone bedrock, while the Blenheim abutment is founded on outwash gravels underlain by bedrock at shallow depth. It was assessed that the unfavourably oriented defects in the jointed rock mass at the Nelson abutment are likely to lead to planar rock slope failure under strong earthquake shaking, with a return period as low as 50 years. The cast in situ concrete abutment walls were also vulnerable to large displacements in 250 to 300 year return period earthquake shaking.

Figure 3. Rock anchor strengthening of abutments at Pelorus Bridge

Rock anchors were chosen as the most economic method to retrofit both abutment walls as well as the rock bluff below the Nelson abutment, given the presence of good bedrock at shallow depth. Both concrete abutments were strengthened using a concrete overlay, and anchored back using rock anchors comprising double corrosion protected 32 mm diameter 1030 MPa Macalloy bars grouted into 150 mm diameter holes, see Figure 3. The wing walls were also tied back using anchors between opposite wing walls on each abutment. The rock blocks in the bluff below the Nelson abutment were rock bolted using double corrosion protected 25 mm 500 MPa Reid bars grouted into 130 mm diameter holes. The Macalloy and Reid bars were chosen because of their ductile post-yield behaviour.

With the anchors in place, the abutments and underlying rock are secured against movement or failure in 0.36g peak ground accelerations with a 1000 year return period. The anchors were designed using capacity design principles to ensure ductile failure by yielding of the anchor bars under seismic overload, rather than failure in a brittle manner by either rock-grout bond or grout-bar bond failure. This was achieved by providing greater strength reduction factors for these more brittle failure mechanisms, and the ductile elongation of the bars accommodating some displacement, and allowing associated reduction in earth pressures on the walls.

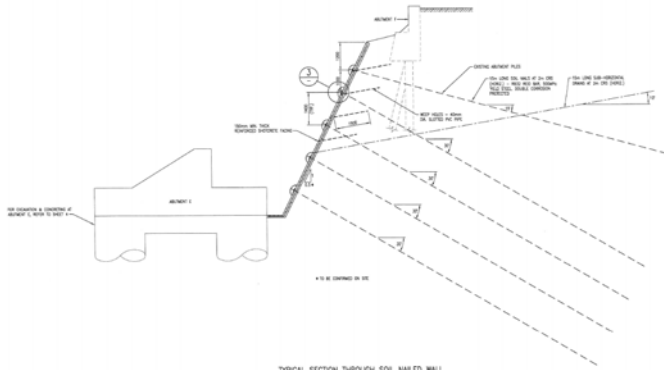
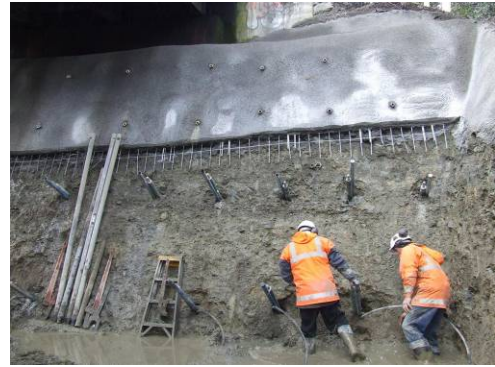
The southern abutment slope was underlain by fill and weak alluvium deposits, with potential for large displacements of up to 450 mm in a 500 year return period event (0.41g peak ground acceleration). Such displacements had the potential to cause significant damage to the four slender reinforced concrete 400 mm octagonal driven piles supporting the southern land span Abutment F and the bearings, and possibly lead to collapse in larger events.

Figure 5. Mohaka Bridge south abutment strengthened using post-grouted soil nails

The soil nails were installed to stabilise the ground between Abutment E and Abutment F, and comprised 32 mm Reid Bars (500 MPa yield strength) at 2 m horizontal and 1.4 m vertical spacing. The soil nail heads and the ground face were supported using a 150 mm thick reinforced shotcrete facing, see Figure 5. Drainage holes were also installed.

However, given the variable poor alluvial ground conditions, ordinary soil nails would not give adequate capacity and would give large displacements. The soil nails were *post-grouted* at 300 to 500 psi grout pressures through nodes in a post-grout tube grouted in during the initial grouting of the double corrosion protected bar assembly into the holes. This *post-grouting* technique for soil nails was originally developed for the Wellington Inner City Bypass project (Brabhaharan, 2007), and was adapted to suit this site. Soil nail pull-out tests were carried out to confirm design parameters and their suitability to give an adequate level of earthquake performance. The post-grouted soil nails reduced earthquake induced displacements of the abutment slope in a 1000 year earthquake, to less than 50 mm, which can be tolerated by the existing sub-structure.

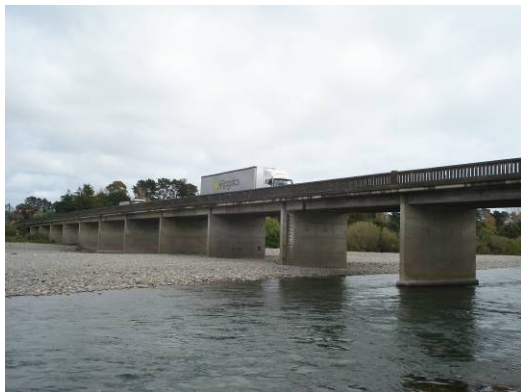
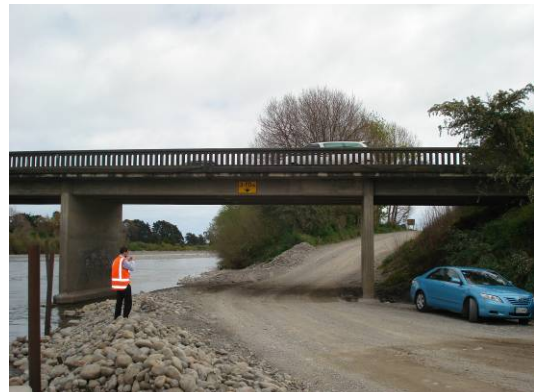
Figure 6. SH1 Otaki River Bridge and its north abutment

A seismic and scour assessment of the bridge indicated that the bridge abutments were prone to scour damage, and significant displacement of the abutment embankment slopes in large earthquake events. The displacements were assessed to be 200 mm to 400 mm at the north abutment, and 50 mm to 150 mm at the south abutment, in a 1000 year return period earthquake shaking (peak ground accelerations of 0.69g). The bridge sub-structure at the abutments comprised four reinforced concrete square columns supported by reinforced concrete octagonal piles, and was assessed capable of tolerating the displacement at the southern abutment slope, but not the larger displacements at the steeper northern abutment. Additional piles at the abutments are being considered to resist the loads from the bridge superstructure.

Discussions with Greater Wellington Regional Council indicated that river protection works for that section of the river and construction of a walkway along the northern bank of the river was under consideration. An integrated solution was developed that provided scour protection for the bridge abutment, river protection works, and a walkway under the bridge for recreational use. Riprap protection of the river bank at the north and south banks and a concrete block walkway at the north bank were constructed in 2010, see Figure 7. The buttressing works will reduce the earthquake displacements at the abutments to less than 100 mm in a 1000 year return period earthquake shaking.

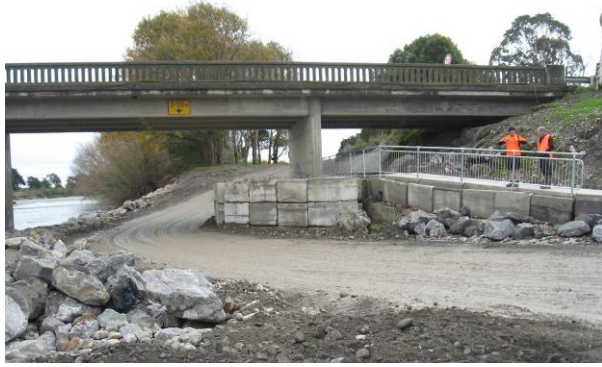
Figure 7. Rip rap and concrete blocks provide scour and earthquake protection at Otaki River Bridge

To avoid the imposition of additional lateral loads on the piers, space was provided between the concrete blocks and pier walls, to allow for limited displacement of the buttress.

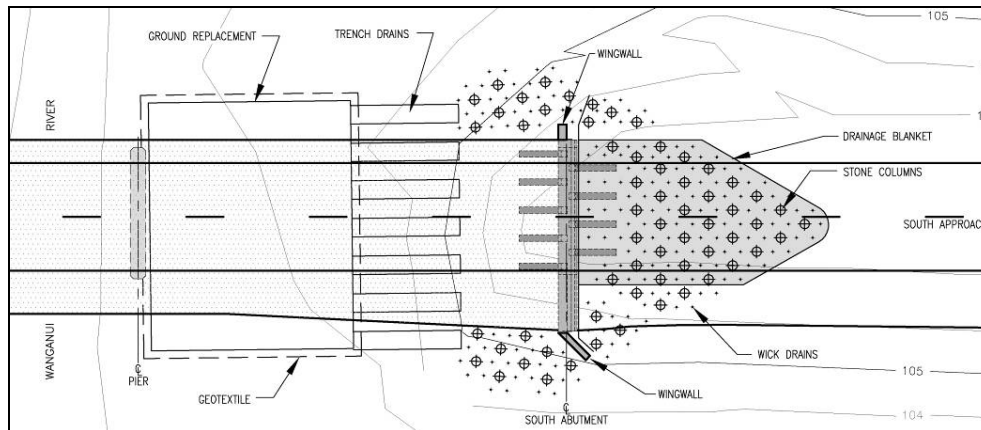
A detailed description of the bridge, seismic assessment and retrofit is presented by Brabhaharan et al (2009). Geology of the area is alluvium comprising sand and silt of Holocene Age, deposited in an estuarine environment. The Cobham Bridge site has the potential for liquefaction, and consequent lateral spreading. Liquefaction will almost certainly lead to slope failure, and lateral spreading of the embankments, either during earthquake shaking or in the hours afterwards while the pore water pressures in the liquefied soils remain high. The abutment structure is expected to fail under large forces from the embankment fill.

Figure 9. Layout of stone column ground improvement at south abutment of Cobham Bridge

A novel triangular shaped area of ground improvement behind each abutment, using stone columns and wick drains (see Figure 9) was adopted to protect the abutment while allowing lateral spreading or failure of the approach embankment slope away from the abutment. This design philosophy recognises that provided that the structure is protected from failure, the approach embankment could be relatively quickly reinstated by earth moving machinery after a major earthquake. This approach optimised the area of ground improvement, leading to a cost effective solution.

Wick drains were also installed to the full depth in between the stone column locations prior to the construction of stone columns in each area. The purpose of the wick drains was to facilitate dissipation of the pore pressures generated in the ground during vibration of the stone columns, enabling densification of the ground, and providing additional drainage of the ground in between the stone columns, in the event of a rise in pore pressures during an earthquake.

A new construction approach was adopted, comprising drilled and compacted stone columns. Holes were drilled to 600 mm diameter with casing providing temporary support. A central steel probe was lowered into the hole, clean 5 mm to 50 mm size aggregate was poured into the hole in stages, as the casing and probe were withdrawn, with compaction by concurrent vibration. This enabled implementation on an active highway without causing failure of the embankment during construction. Areas in front of abutments were improved by trench drains to facilitate porewater pressure dissipation and avoid liquefaction, and replacement of liquefiable sands with dense gravels, see Figure 9.
