# Damage assessment, analysis and modelling of bridges in non-liquefiable soil during Canterbury earthquakes

2012 NZSEE  
Conference

A. Palermo & M. Brando

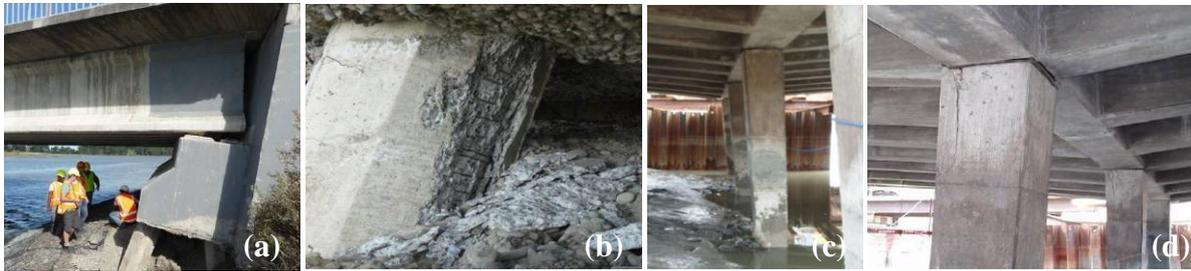
During the Darfield earthquake the Western abutment of Bridge Street Bridge (latitude: -43.5252, longitude 172.7241) rotated by approximately 5 degrees due to lateral spreading, and light cracking was observed on the tension face of the abutment piles after the event. The pile damage was exacerbated during the Christchurch earthquake, with further abutment rotation to more than 12 degrees at the West end (Figure 2a), and plastic hinging was clearly visible on the abutment piles of the Western abutment (Figure 2b).

Pier damage was caused either by ground shaking, with a combination of vertical and horizontal components, or by lateral spreading. Some bridges experienced pier cracking as a result of extensive lateral spreading, which caused a lateral force applied to the pier base inducing a large moment at the stiff pier-deck interface. The liquefied soil layer also reduced the lateral stiffness of the pier foundation system, allowing rotation of the bottom of the pier towards the centre of the river. Ferrymead Bridge (-43.5584, 172.7086) sustained damage due to lateral spreading, with permanent rotation and cracking of some of the piers situated in the estuary (Figure 2c-d).

Figure 2. Bridge Street Bridge. (a) Back rotated abutments [Photo by M. Bruneau]; (b) Plastic hinging of the abutment piles of Bridge Street Bridge [Photo by M. Bruneau]. Ferrymead Bridge. (c) Tilted piers [Courtesy of OPUS]; (d) Close-up view of cracks caused by superstructure bearing on the edge of the pier top [Courtesy of OPUS].

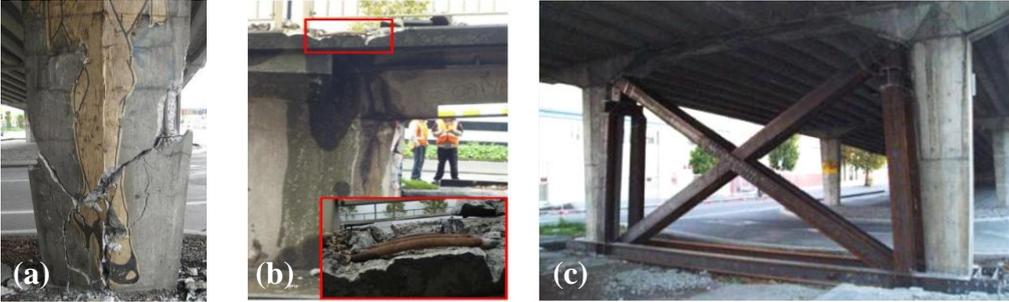
During the February earthquake, piers were significantly damaged with shear cracking and buckling of longitudinal rebars. The bridge sustained damage to one column near the North-East approach where a deck expansion joint was located. The insertion of steel rod linkages in the deck at the expansion joint at the only West side of the bridge caused irregularity in the bridge structure (Figure 4). In fact, because of the West and central part of the linked bridge, the pier at the East expansion joint suffered extensive displacement demand. The slenderness of the pier affected the vertical load carrying capacity of the structure along with the lateral capacity. The columns had also widely spaced transverse reinforcement, making the structure susceptible to a brittle failure mechanism (Figure 5a).

Figure 5. (a) Shear failure mechanism of the pier [Photo by A. Palermo]; (b) Concrete spalling and bar buckling at South-West side abutment [Photo by A. Kivell]; (c) Temporary repair solution [Photo by A. Palermo].

Observations after the Christchurch event indicated that the damaged columns had started to buckle putting the central span at risk of collapse. Due to the higher displacement demand in the West-Central part of the bridge, the deck pounded against South-West abutment of the bridge causing extensive spalling and bar buckling (Figure 5b). Strengthening works were erected around the failed pier. These consisted of two built up square block concrete columns with timber blocking to prop the bridge while further works were undertaken. A multi-span structural steel frame was designed and constructed spanning between the two failed columns, as a temporary solution to prevent the collapse of the damaged section. This solution did not provide any additional lateral stability and therefore the overbridge was not reopened to vehicle traffic until March 31, 2011, when the final repair solution consisting of dual cross-bracing units at each of the weakest piers was constructed (Figure 5c).

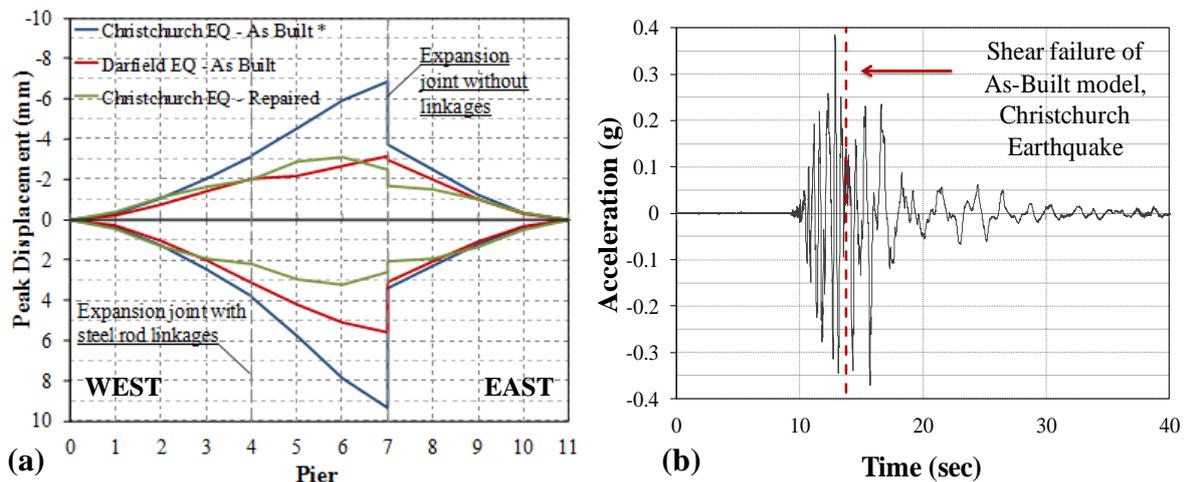
Figure 6a shows the peak displacement profiles for each model. The pier located at the expansion joint without the steel rod linkages undergoes the largest displacement demand in the As-Built model; it actually exhibited the most severe damage in assessment inspection. As expected, a shear failure occurs in the As-Built model when subjected to the Christchurch earthquake (Figure 6b). No failure occurs for the Repaired model, indicating that the repair and retrofit methods were effective in preventing the failure of the bridge. The insertion of tie-bolt links in the free expansion joint would also have limited the displacement demand in the piers and re-established the regularity of the bridge response under transverse seismic loads. The displacement profiles show a larger peak displacement in the South direction than the North direction which is consistent with the observed damage to the West abutment, where spalling occurred on the Southern side of the abutment, but not on the Northern side. Moreover, the peak displacement and shear force of the As-Built model during the Christchurch earthquake is approximately 1.6 times those that occurred during the Darfield earthquake.

Figure 6. (a) Displacement profile of each model; (b) Ground motion measured at Catholic Cathedral College (CCCC) with the indication of the instant in which the shear failure occurred according to the numerical analyses.

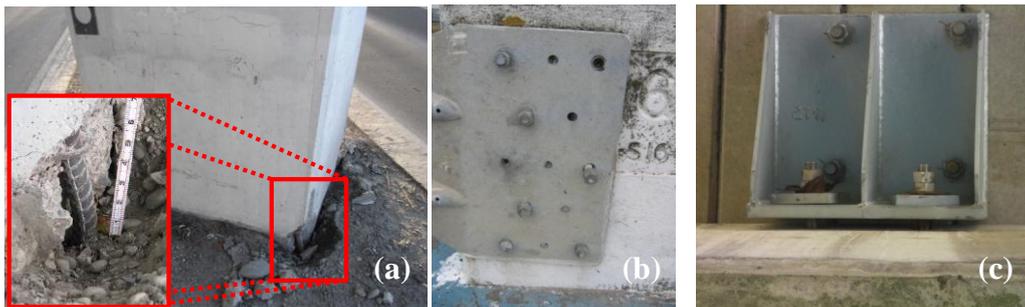
During the Christchurch earthquake, flexural cracking developed in the lower halves of the piers of both bridges except those adjacent to the abutments. In fact, despite the presence of the linkage rods increased the deck diaphragm action, this was not enough to control the higher displacement demand occurring in the central piers. Soil gapping at ground level occurred at the faces of most of the pier stems with separation cracks up to 15 mm wide. Spalling occurred at the base of the central pier, and the longitudinal bars started to buckle (Figure 8a). The damage increased during the June 13, 2011 aftershock. The nominal 10 mm gaps between the new shear keys and the abutment face at the South-East abutment closed up with no clearance on two of the four keys.

Slope failure at the abutment slopes under the bridge resulted in wide cracks in the soil and at the interface between the soil and abutment face under the South-East abutment. There was also minor settlement and displacement of the approach pavement and back-fill at the abutments.

Figure 8. Port Hills Overbridge. (a) Buckling of reinforcing steel at the base of the piers [Courtesy of OPUS]; (b) Pop out of the bolts of the guardrail [Courtesy of OPUS]; (c) Elongation of the links between the spans [Courtesy of OPUS].

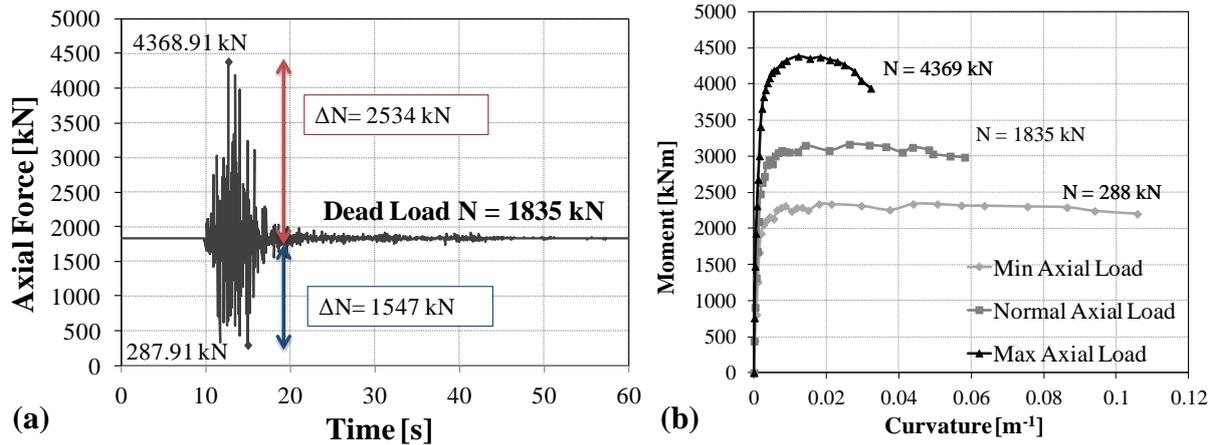
While the CCCC and CMHS records match the design spectrum (NZS 1170.5:2004) quite well in the range 0.17-0.27 s (natural period of the structure), the spectral accelerations from HVSC are much greater than the design ones, reaching a value of 1.2g (Figure 1a). In fact, this event caused exceptional vertical accelerations with values up to 2.2g at the HVSC station (Palermo *et al.* 2011). This led to a significant variation of the axial force in the columns (Figure 9a), which caused a reduction in the ductility of the piers when subjected to high axial compression as shown in Figure 9b for the central pier.

Figure 9. (a) Time-history of the axial force loading the central pier when subjected to HVSC record. (b) Evolution of the moment-curvature with varying axial force.

Time history analyses are carried out including the vertical component of the ground motion. Figure 9b shows how the moment capacity and curvature ductility in the central pier changes drastically. When the axial load variation caused by the vertical ground acceleration (HVSC record) is additive to the static load ( $N+\Delta N$ ), there is an increment of 39% in the moment capacity a reduction of 49% in the curvature ductility, relative to the case in which the acceleration-induced axial load variation is not considered. Vice versa if the axial load variation is subtracted from the static load, ( $N-\Delta N$ ) the moment capacity reduces of 28% while the curvature ductility increases of 94%.

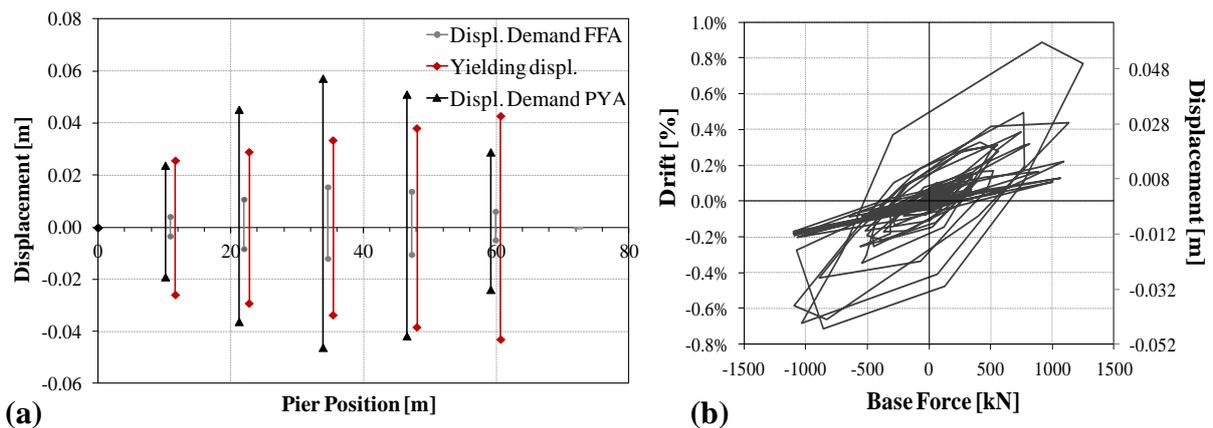
Figure 10. (a) Comparison between the displacements of the top of the columns subjected to HVSC records; (b) Base shear vs top displacement of the central pier when subjected to HVSC records in the PYA model.

Numerical results show that the bridge performed well when subjected to the CCC and CMHS records (with vertical acceleration of 0.8g), during which they remained in the elastic shape. Nevertheless, the observed actual damage showed that the central piers behaved unelastically, even if the overall performance was better than expected from the high spectral acceleration values. This inconsistency can be due to the location of the strong motion stations, which were far from the bridge and the epicentre. The accelerograms recorded by these stations were chosen to perform the dynamic analyses because the soil conditions at the station site are similar to the ones at the bridge site. However, the PGA recorded at these stations could have been smaller than the one experienced by the bridge.

A good correspondence between the numerical analyses and the actual response of the bridge is obtained with the HVSC record. Figure 10a shows that the displacement demand is lower than the displacement at the yield of the base section of the piers for the model with Fully Fixed Abutments (FFA). On the other hand, in the model with the superstructure Pinned around the Y-y Axis (PYA) plastic hinges (Figure 10b) develop at the bottom of the piers, with top displacements greater than the yielding ones (Figure 10a). The response of the bridge is hence likely to have been more similar to the
