# Lessons from the Performance of Houses in the Canterbury Earthquake Sequence of 2010-11

2013 NZSEE  
Conference

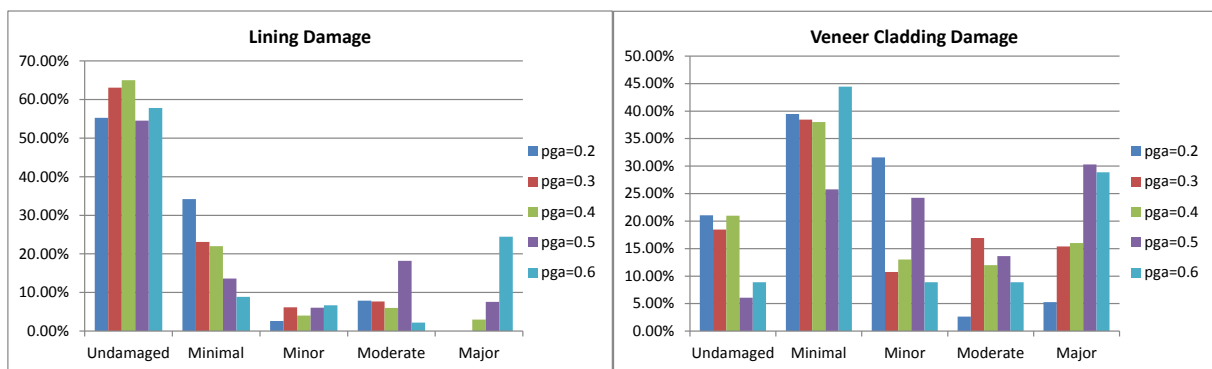
The peak ground accelerations (pga) for each group of houses has been input into the database in values of increments of 0.1g based on the maps produced for the main 22<sup>nd</sup> February and 13<sup>th</sup> June Earthquakes, based on the pga contour maps from the Canterbury Geotechnical Database (2013). It was intended that the damage be compared against the highest pga from either event, however none of the house groups surveyed underwent a higher pga in June than February, so only February values have been used for comparison. Figure 1a and 1b compares peak ground acceleration against damage to internal linings and external veneer claddings respectively. The expected result is that damage would generally increase with increased peak ground acceleration for both linings and claddings. This expectation is met, which gives confidence in the accuracy of the survey, but there are some anomalies. There are a slightly lower proportion of houses subjected to a pga of 0.2 and 0.3 in the undamaged category, than those subjected to a pga of 0.4, and more in this category from pga of 0.6 than a pga of 0.5. There is obviously some variation due to statistical variation, but an obvious reason for this discrepancy is the effect of liquefaction on damage to houses on sites that experienced lower pga's.

Figure 1a & 1b. Lining and Veneer Damage as a function of Peak Ground Acceleration

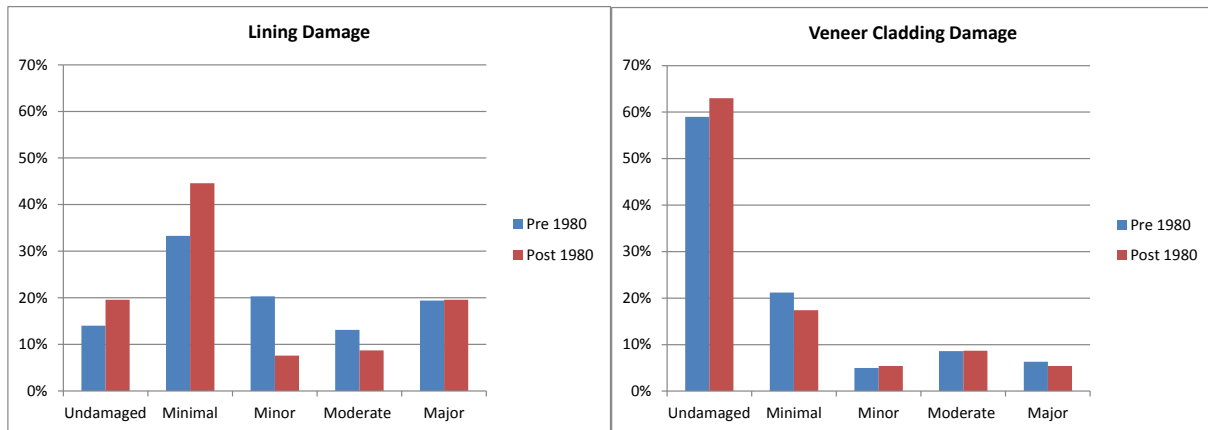
Although older and newer houses had a similar proportion in the “major” category for lining damage, overall the older houses performed slightly worse, with more in the minor and moderate category. There were about the same or higher proportion of houses surveyed in every category except “undamaged” for veneer damage. Pre-1980s houses had slightly less openings, but more importantly the location of openings around the houses, as measured by the relative proportions of windows on each side is more even. Hence it can be inferred that the improvement in bracing performance that occurred with the introduction of NZS3604 has been compensated for in a large part by a trend to having dominant openings on one or two adjacent sides of a house and to a lesser extent by an increase in the overall amount of openings. Furthermore without the improvement in lateral load resistance from designing to NZS3604 it is likely the design trend to more and less symmetrical layouts of external openings would have resulted in much poorer performance.

Figure 2a & 2b. Cladding and Veneer Damage as a function of House Age

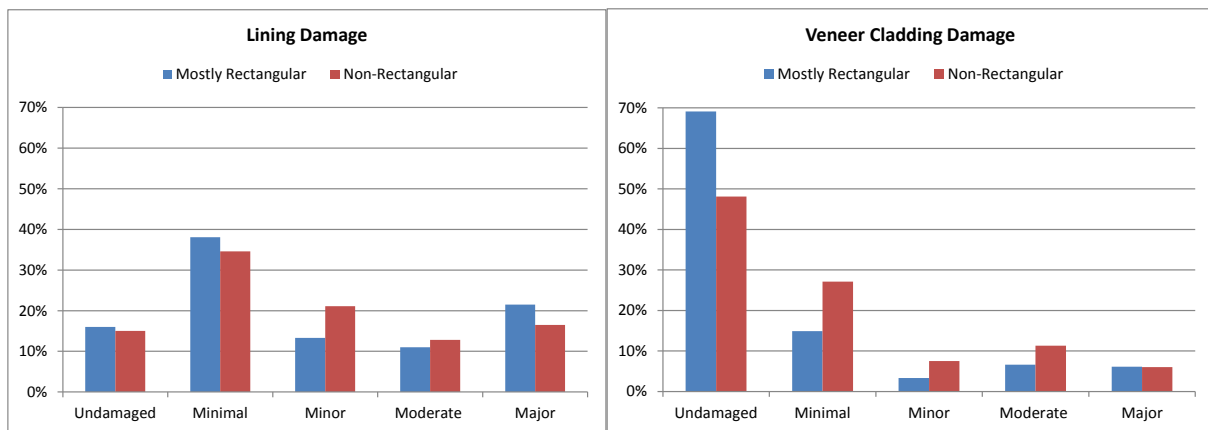
Most houses (58%) in the sample were mostly rectangular, and non-rectangular houses had more damage overall, to both claddings and linings (Figure 3a & 3b).

Figure 3a & 3b. Lining and Veneer Damage as a function of Plan Shape

Mostly rectangular is defined as houses that are rectangular or square or with a slight deviation from rectangular, for example a small extension of a room a few metres outside the otherwise rectangular plan. Mostly rectangular houses are more likely to be in the undamaged or minimal categories for lining damage. Close to 70% of rectangular houses had no veneer damage compared to less than 50% of non-rectangular houses. This discrepancy between veneers and linings may be because houses are planned so that re-entrant internal corners are not common as internal walls are located at the junctions of different wings, and any damage is likely to be confined to the re-entrant corner joint anyway. On the other hand with veneer claddings, there is likely to be significant differential movement between two planes of cladding meeting at an re-entrant corner with confinement by the other plane of cladding and the wall framing limiting differential movement and therefore the cladding can only crack, displace or fall off and this damage can propagate along the length of the wall.

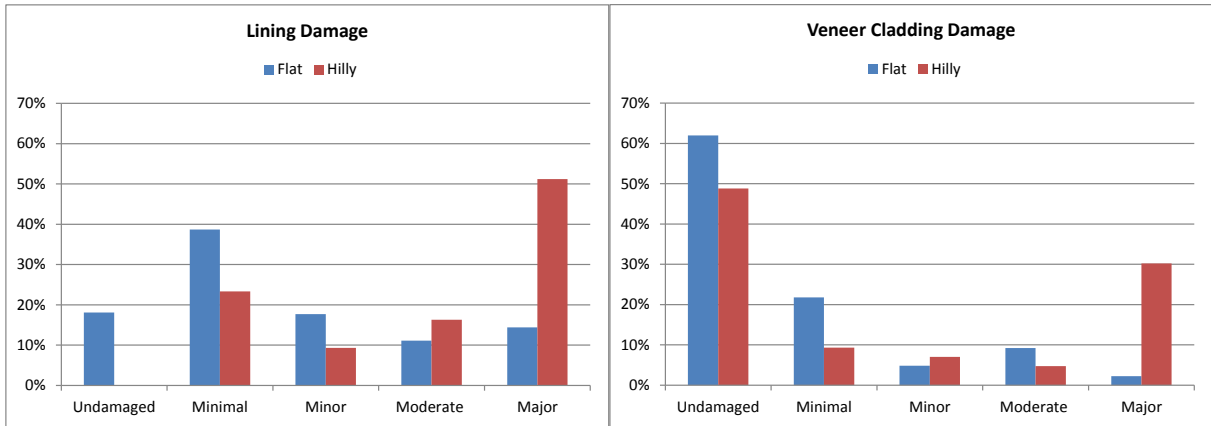
The effect of topography on damage is marked. Figure 4a and b show that all houses on hilly (sloping, or hill top) sites had some cladding damage. Although a higher proportion of houses on the flat (271 out of a total of 314 house surveyed), were in the minimal and minor categories, over 50% of houses on hilly sites had major damage to linings. The same trend although less marked is apparent for veneer damage, with over 30% of the houses on hilly sites having major damage to veneer claddings. This finding is complicated by the fact that the level of shaking was higher in hill suburbs, and the results have been separated for flat and hilly sites compared with pga's in figure 5a & b for lining damage and figure 6a & b for veneer claddings to ascertain whether this result is due to, level of shaking or a combination of both.

Figure 4a & b. Lining and Veneer Damage as a function of Topography

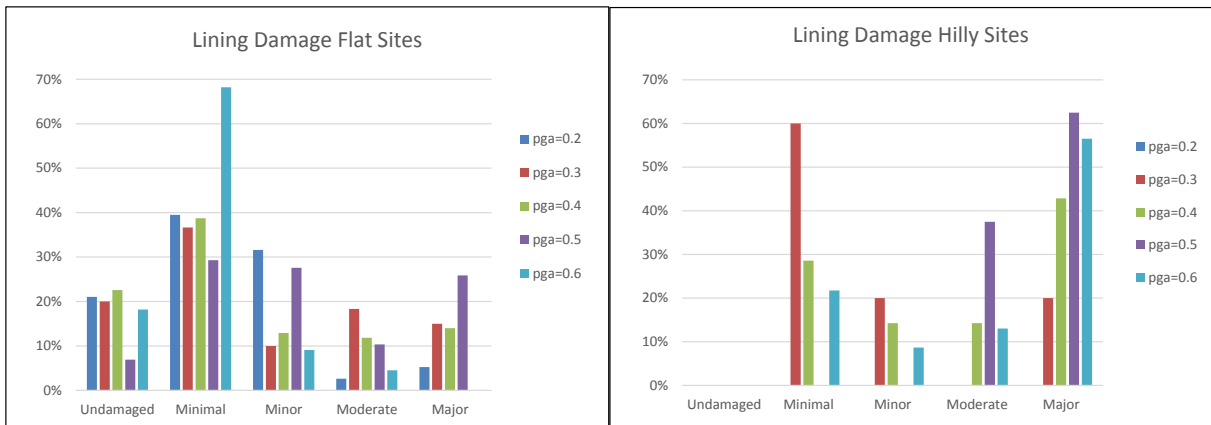
It is difficult to draw general conclusions from the middle of the range of lining damage, but at the extremes findings are more obvious. No houses on hilly sites had linings that were undamaged, regardless of the pga, but on flat sites about 17% were undamaged. In the major category there are a much higher proportion of houses in this category, regardless of pga on hilly sites. For cladding damage with a smaller sample size for both hilly and flat sites, there is more scatter in the data, but there appears to be some evidence of a trend of more damage in hilly sites regardless of pga. The increased level of damage on hilly sites regardless of pga is even more significant when the increase levels of damage on some flat sites, due to liquefaction and lateral spreading is considered.

Figure 5a & b. Lining damage as a function of PGA for flat and hilly sites.

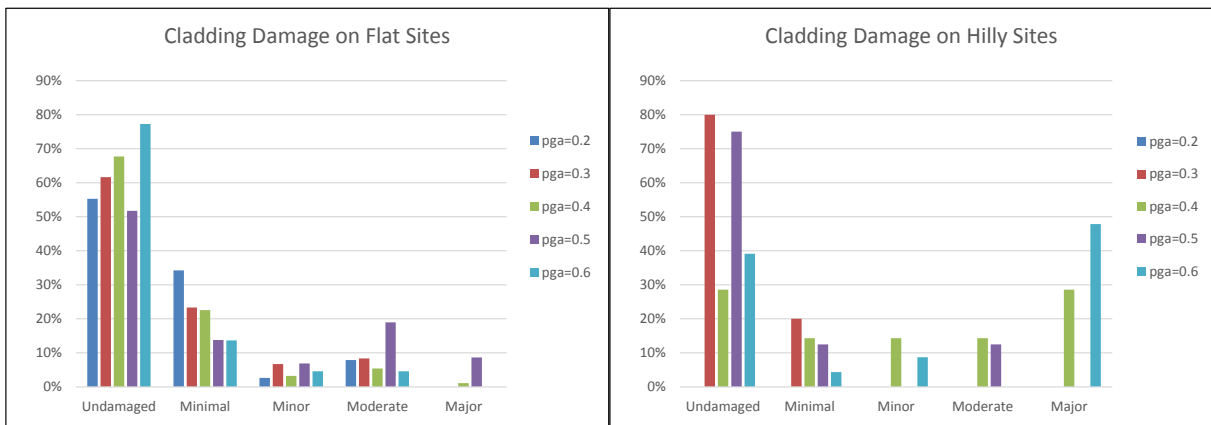
Figure 6a & b. Veneer cladding damage as a function of PGA for flat and hilly sites

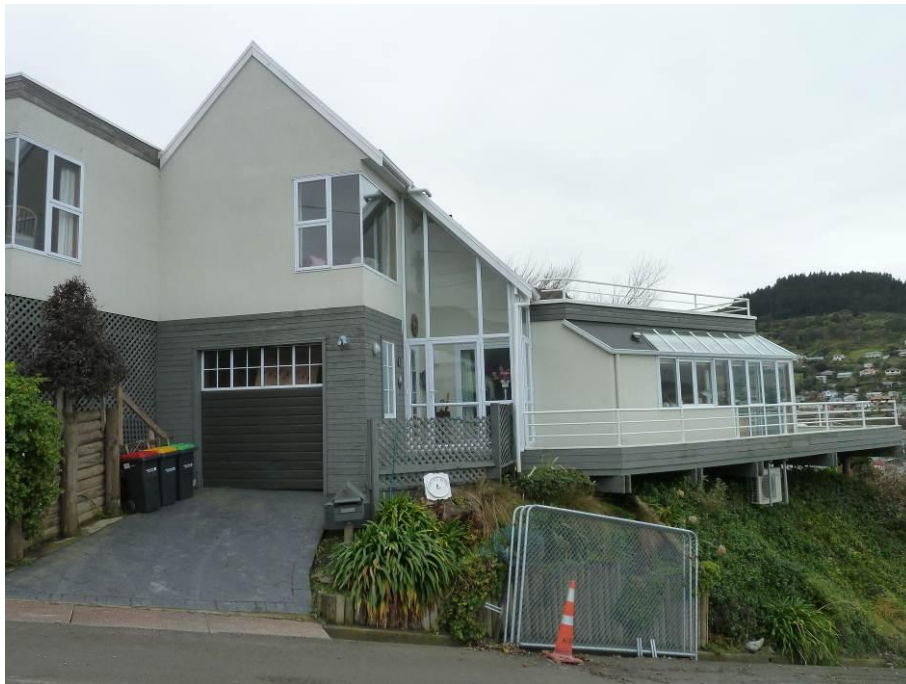
Another major area of work yet to be completed is the effect of openings on damage, both the percentage of wall openings in a house and their distribution around the walls. Of particular interest is house with dominant openings on one side, or two adjacent sides which could result in significant torsional problems. This analysis is complicated by houses with dominant openings on one side, facing a view, frequently being on sloping sites and also have higher foundations on the side with large openings or even different foundation types on the higher side. They may also have horizontal as well as vertical irregularities, a good example being the house in Lyttelton shown in figure 7, which is partly on cantilever timber beams at the front, but built into the slope on concrete slab at the back and has vertical and horizontal irregularities.

Figure 7. House on Sloping site with horizontal and vertical irregularities and differing foundation types.
