Network protection without compromise – Deconstruction of 91 Hereford Street for Telecom

D.M. McGuigan & C. Hill

Aurecon New Zealand Ltd, Wellington & Christchurch.

2014 NZSEE
Conference

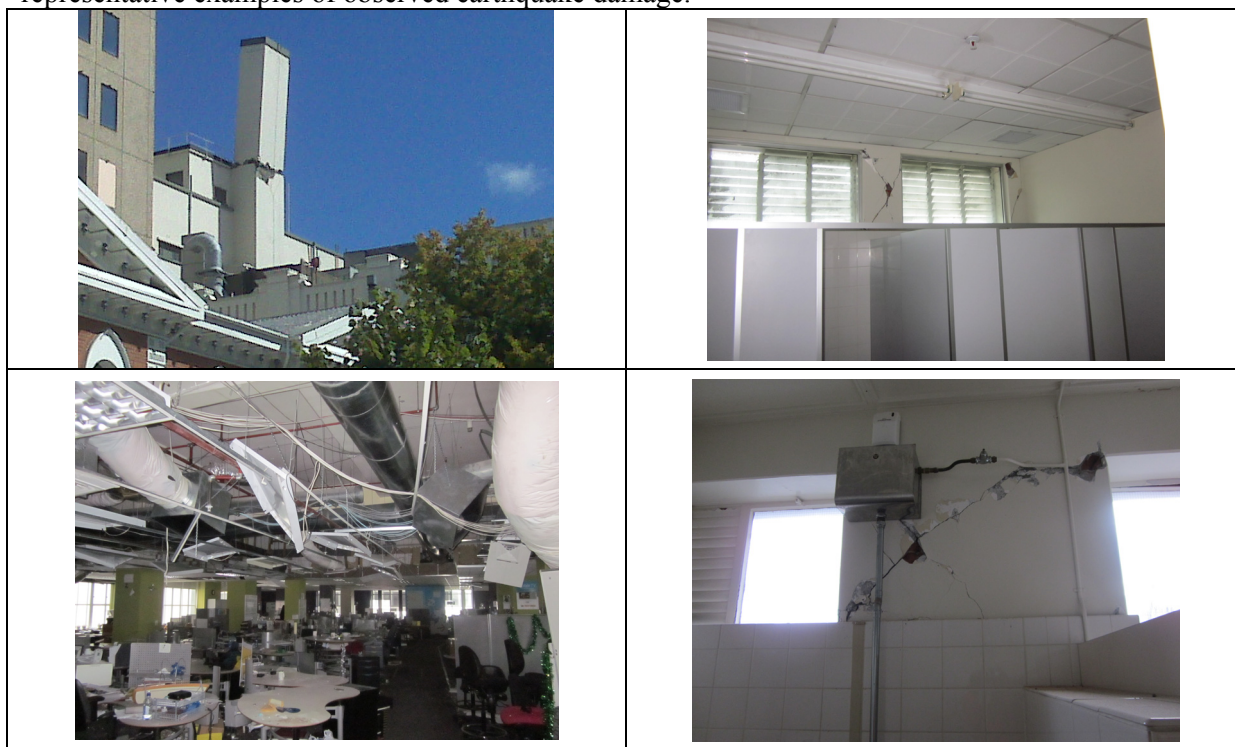
The building suffered a reasonable degree of damage to its façade, architectural fit-out and building services as a result of the 22 February 2011 earthquake. This included the following:

- Leaning masonry boiler chimney – this was removed from the building soon after the 22 February event
- Substantial collapse at two upper floors of suspended ceiling in the upper parts of the building which resulted in damage to the building services components on those floors
- Extensive cracking and damage to the masonry façade on the north and west elevations of building
- Extensive cracking to masonry in the stairwells
- Significant damage to the toilets and plumbing services

The visual examinations that took place immediately following the 22 February 2011 earthquake event indicated that there was no obvious damage to the primary structural frame. Figure 2 provides some representative examples of observed earthquake damage.

Figure 2. Examples of damage to the 91 Hereford St Building

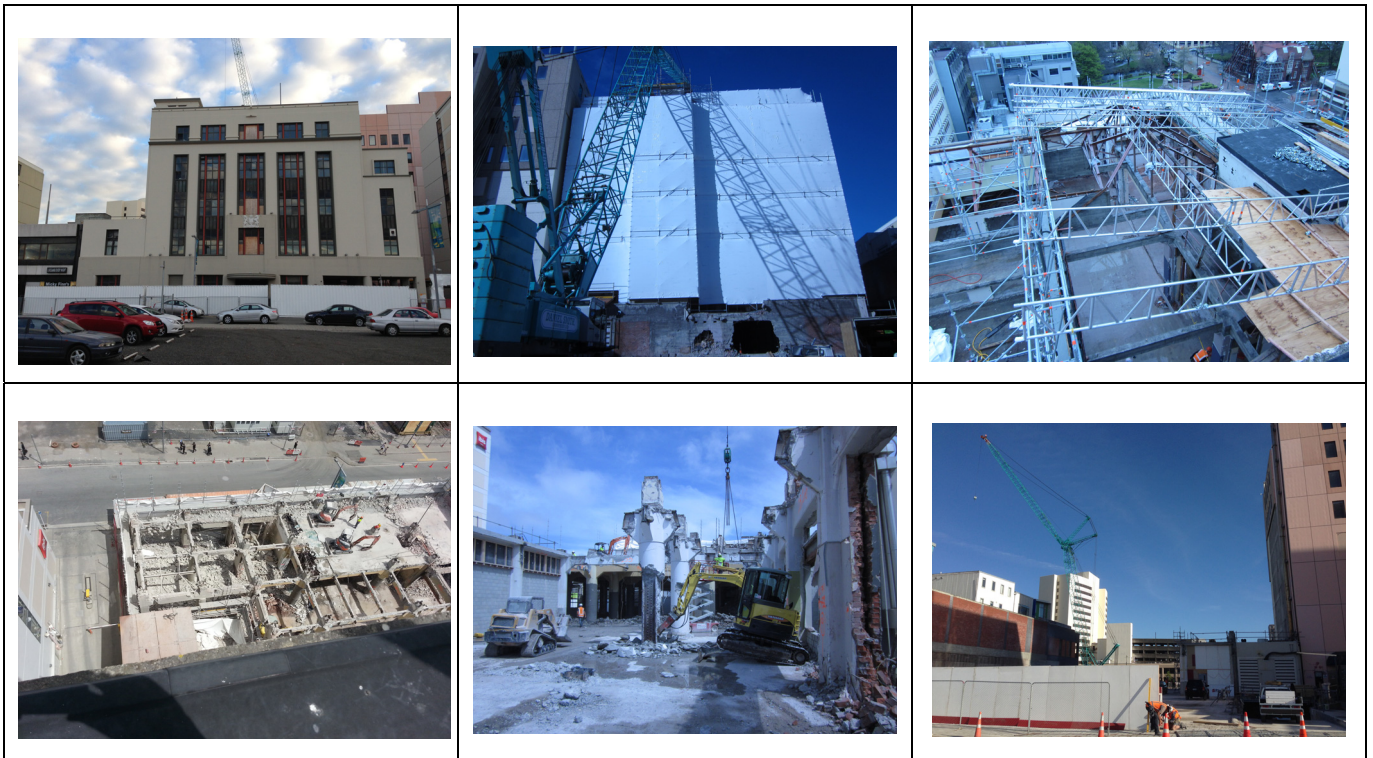
Figure 5 shows a selection of pictures taken during the deconstruction phase including the 91 Hereford Street building at the commencement of deconstruction and the site at the conclusion of deconstruction.

Figure 5. Representative images during deconstruction phase including images of the building at the commencement of deconstruction and the site at the completion
