A novel approach to rehabilitation of a church in Fendalton, Christchurch

S.J. Neill & A.S. Beer

Beca Ltd, New Zealand.

2014 NZSEE
Conference

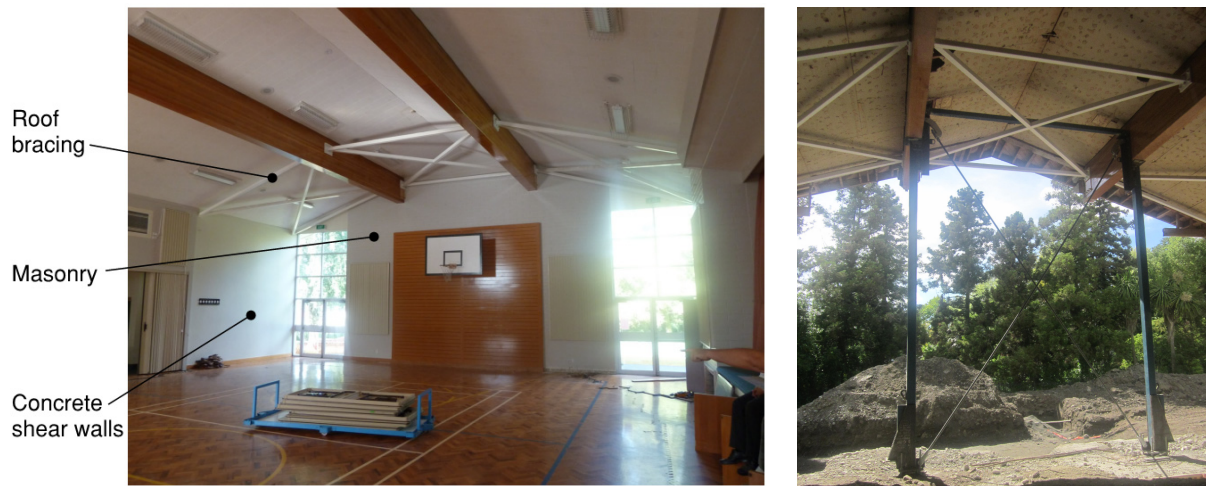
Figure 3. Hall strengthening. Eastern side during construction.

Two new reinforced concrete shear walls were constructed to replace the two short masonry walls towards the Eastern end of the hall (as shown in Figure 3). These walls were anchored to the adjacent structure and roof bracing was added between the new walls. Steel cross bracing was added to some of the masonry walls adjacent to the stage. Above the stage, plywood diaphragms were installed, which also served to restrain the high Southern gable wall. Independent supports were added beneath critical load bearing elements, which comprised mostly of steel posts beneath existing roof beams.

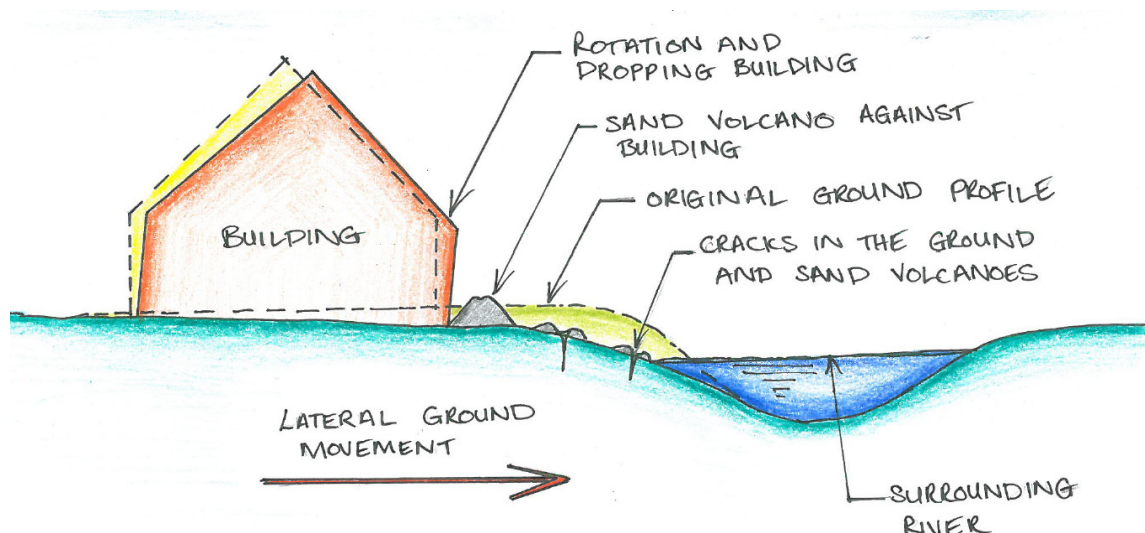
The ground beneath the Fendalton building settled due to two phenomena, direct vertical settlement due to sand ejection from liquefaction, and settlement due to liquefaction induced lateral spread. When the soil liquefied it flowed towards the surrounding river, which is the lowest point of the site. The river encroaches to within approximately 20m of the hall on the Eastern side of the building (see Figure 4). Due to the proximity of the river, vertical settlement was particularly prominent on the Eastern side of the building. Some lateral displacement of the building was also evident on the Eastern side (see Figure 5).

Figure 4. Lateral spread towards the river that occurred when the sub-surface soil liquefied.

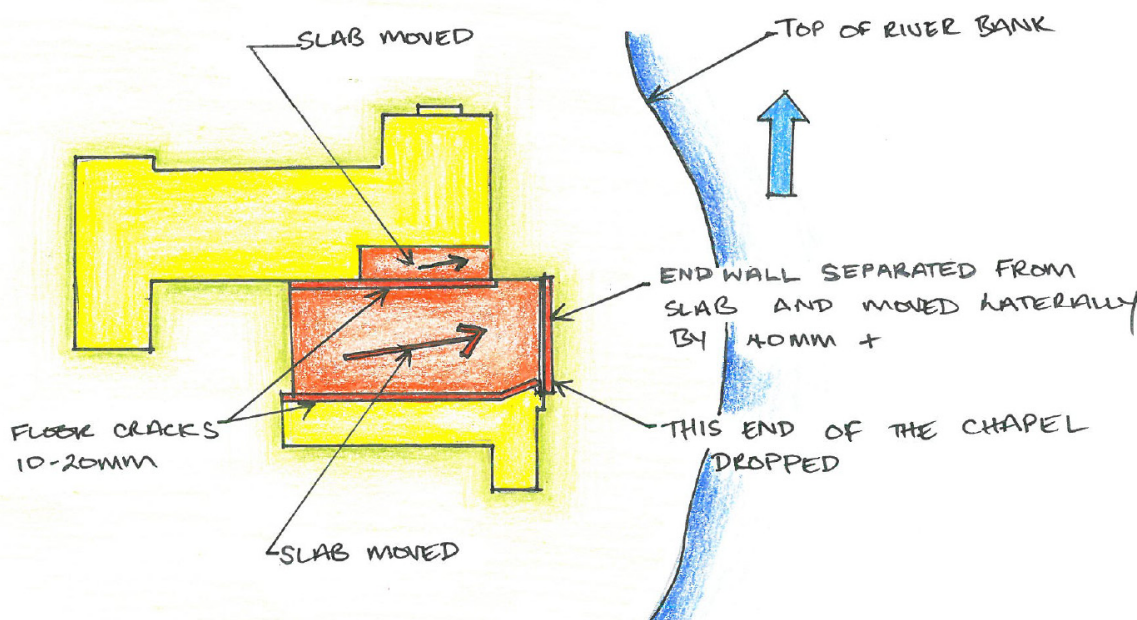
Figure 5. Plan view of lateral spread towards the river that occurred when the soil liquefied.

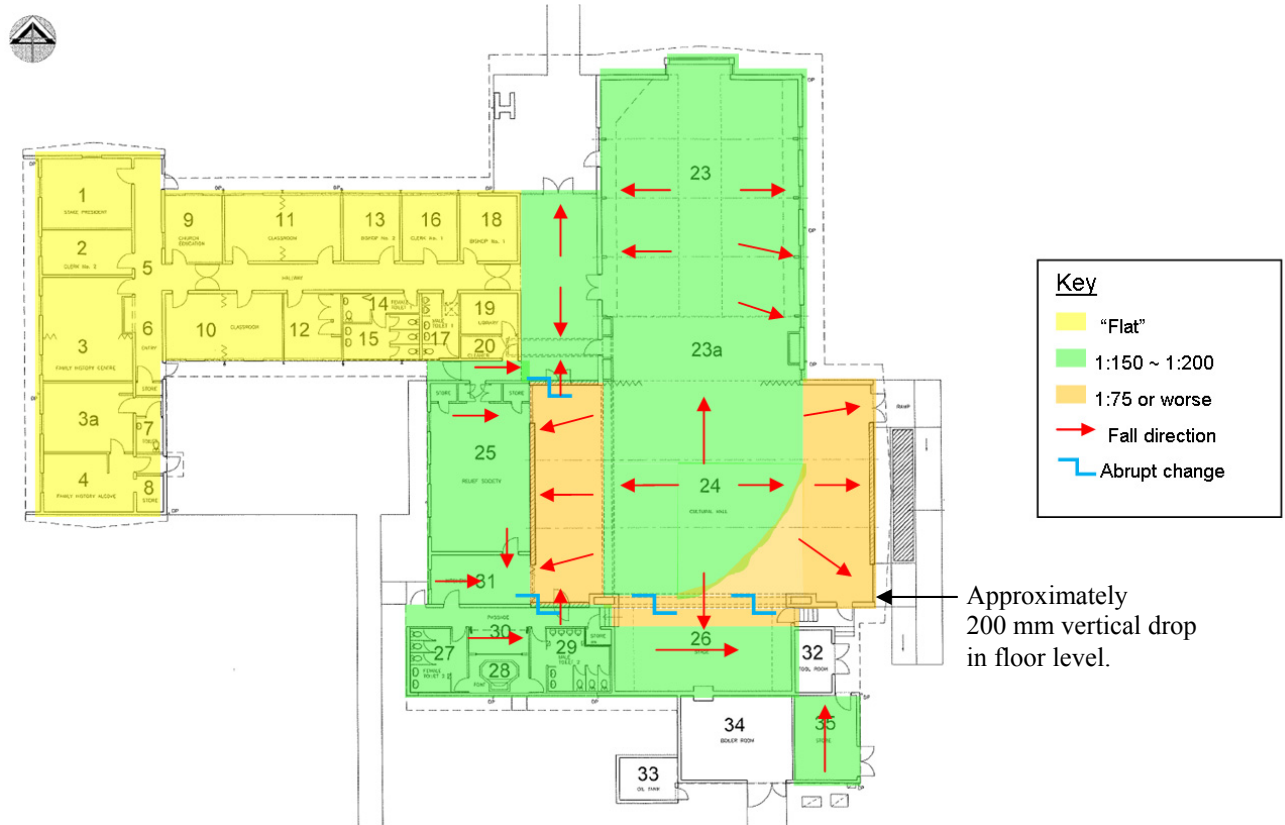
A survey of the floor levels across the building was undertaken. The resulting slopes in the floor due to differential settlement are presented in Figure 6 below. In general, it was observed that areas of the building with a floor slope no worse than 1:150 had suffered relatively little structural damage. These areas were proposed to be repaired and the floor slab to remain as it was, on the basis that the slabs were still structurally intact and the 1:150 slope was considered difficult to detect by the Church.

As shown in Figure 6 there had been a relatively significant level of settlement on the building's Eastern side, which is the side closest to the river. The pattern of settlement over the three most significant earthquakes had been similar in terms of location; each seismic event just increased the severity of the settlement. High differential settlement had also occurred at locations where the double height heavy masonry walls had plunged downwards resulting in a low point in the surrounding slab area. As a result the hall was the most critically damaged area. Two of the double height masonry walls had large diagonal cracks principally as a result of their brittle construction and movement imposed by the differential settlement and lateral spread towards the river (as shown in Figure 7). The

Figure 6. Floor slopes calculated from floor level surveys.

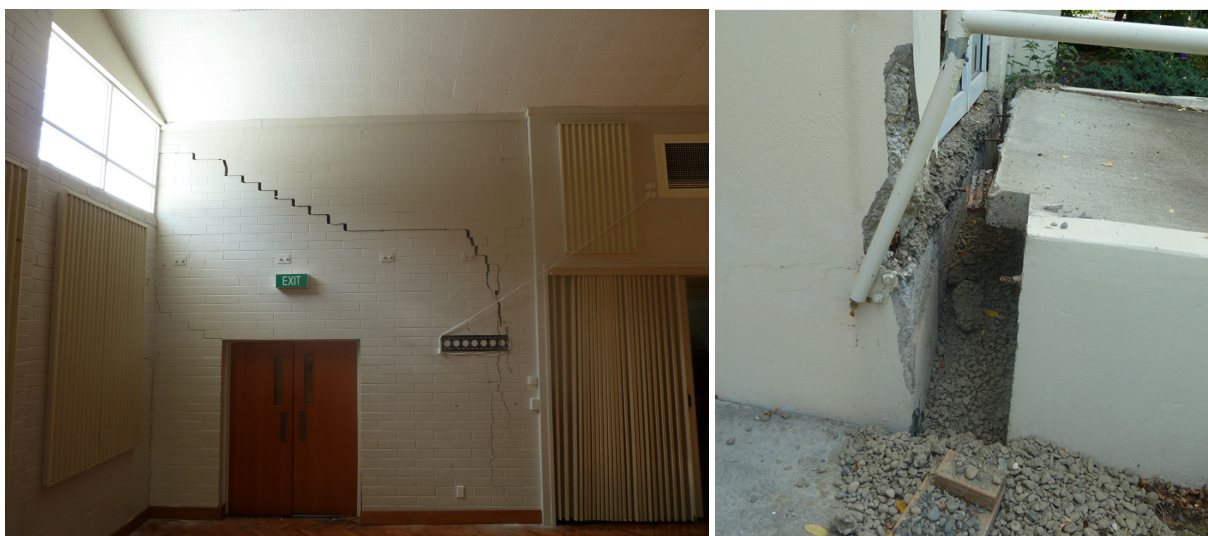
concrete slab underneath the hall's parquet floor also had sustained significant cracking and a noticeable slope.

Figure 7. Double height masonry wall in the hall exhibiting large diagonal cracks, and lateral movement of the access ramp on the Eastern side.

It was proposed to reduce the seismic weight of the structure by replacing the hall's double height masonry walls with light-weight timber walls (location shown in Figure 8). The masonry walls had been damaged significantly, such that more than a cosmetic repair was required. The new lightweight timber walls reduced the pressure under the existing foundations and they will also be more forgiving than masonry with potential movement from an earthquake (see Figure 9). Another major advantage of the removed mass was significantly reduced demand on the existing reinforced concrete shear walls, compensating for the Z factor increase from 0.22 to 0.3.

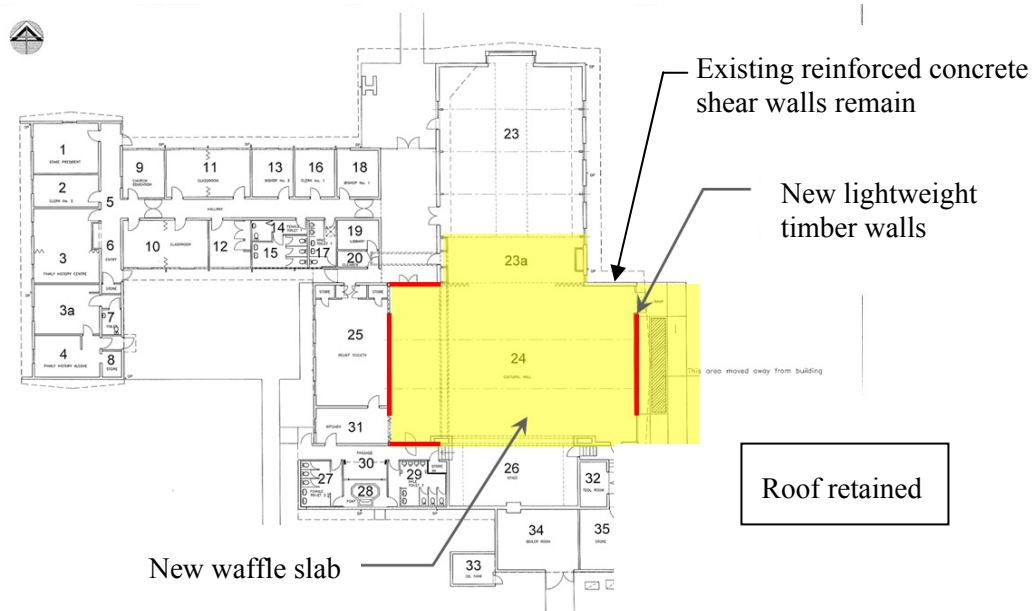
Figure 8. Location of features requiring replacement.

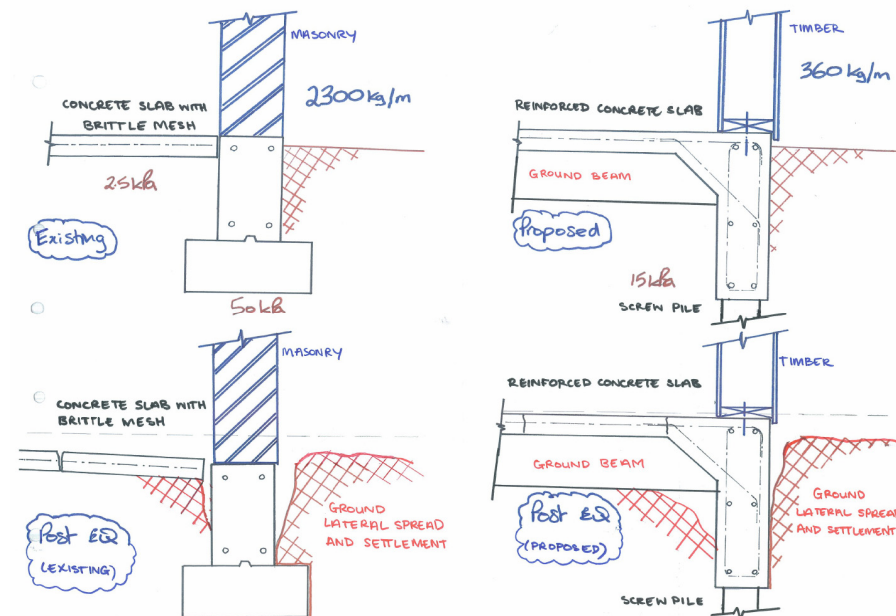
Figure 9. Existing and new foundation system, before and after a seismic event.

Four steel screw piles were installed along the eastern wall line only. The project team did not favour a more widespread use of piles, as they would tend to create high points when the building platform settles. Piles were however considered to be beneficial on the Eastern wall line to “temper” the magnitude of settlement in this zone which is close to the river. These piles were deliberately founded in a softer material than one might for a new building, as some settlement of the pile was seen to be

The screw pile shaft was well tied to the foundation beam, so as to be able to plastically deform in the event of lateral soil loading whilst maintaining gravity load support. The screw pile nearest the existing concrete shear wall also served to improve the overturning performance of that wall where it is most susceptible in the lateral spread zone. The screw pile was considered the ideal pile type given these objective and access constraints.

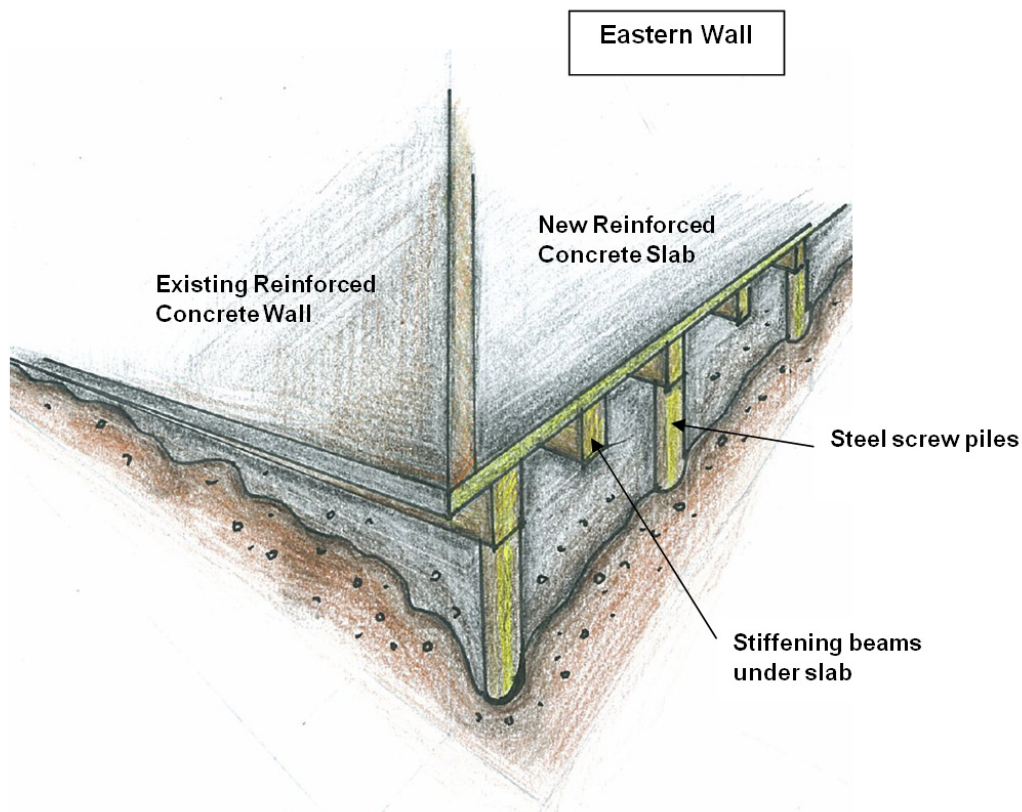
Figure 10. Damage mitigation solution, for the occurrence of lateral spread.

The existing slab in the hall was severely cracked and had settled irregularly to the extent that the floor sloped noticeably. This slab and the footings beneath the walls were replaced, and the new floor was constructed with small stiffening beams under it in a 2.5 x 5.0 m grid. This created a raft like slab system. The increased floor stiffness results in a reduced floor curvature in the event of differential settlement, therefore a reduced risk of future disruption of the hall parquet floor. The beams also act as ties, helping to hold the entire slab together and so to reduce movement of the Eastern wall towards the river. Furthermore, the beams enable the slab at the Eastern end of the hall to span clear of the ground onto the piles in the event that the ground drops away beneath the floor, see Figure 10 for a representation of this effect graphically.

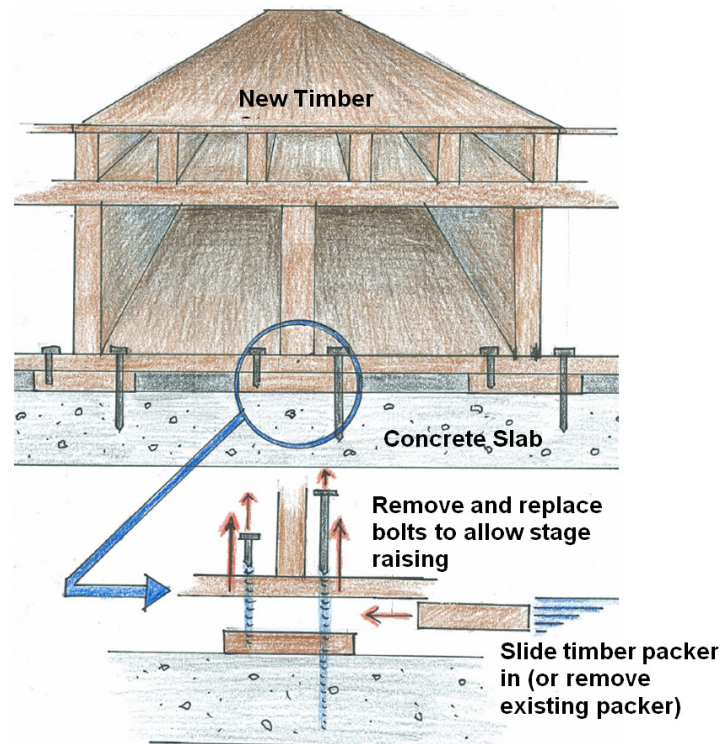
Figure 11. Stage rehabilitation solution, in the occurrence of ground settlement from a seismic event.

Adjacent to the hall, the slab and walls around the stage area did not require reconstruction. Therefore there is a higher risk of future settlement for the stage area than the adjoining hall area. To counter this, a timber support packer was detailed under the new stage, to make it relatively easy to re-level in the future (either raise or drop portions or the whole stage if necessary), see Figure 11.
