Performance of Brick Veneers. Do You Have Confidence In Your Ties?

M.A. Halliday, A.R. Laird & K.L. Reynolds

Opus International Consultants Ltd, Christchurch, New Zealand

2014 NZSEE
Conference

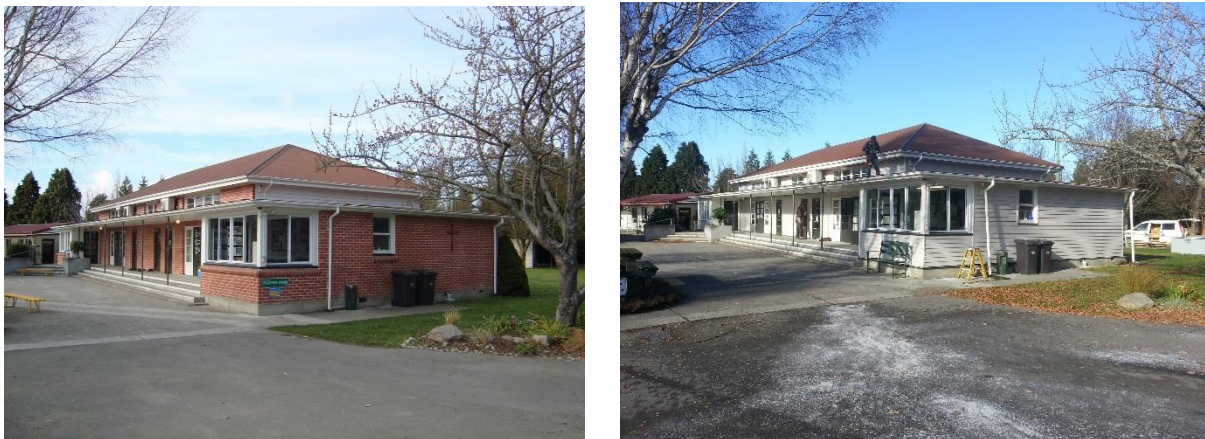
Figure 2 below shows a school where the brick veneer has been removed and replaced with weatherboard.

Figure 2. Before and after photo of a school showing replacement of brick veneer

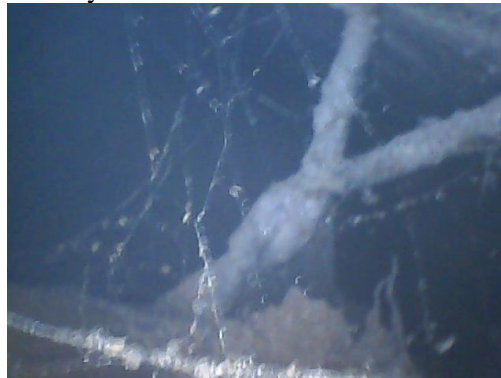
Figure 4. Internal view of a wire tie

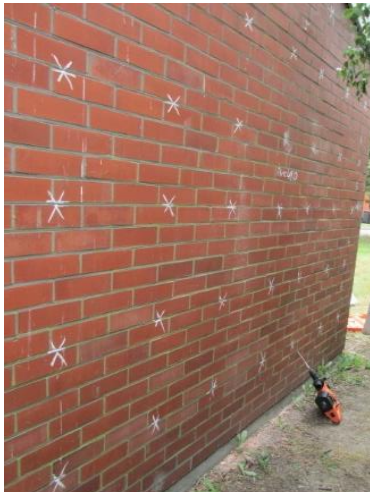
Figure 5. Marked brick veneer showing tie layout

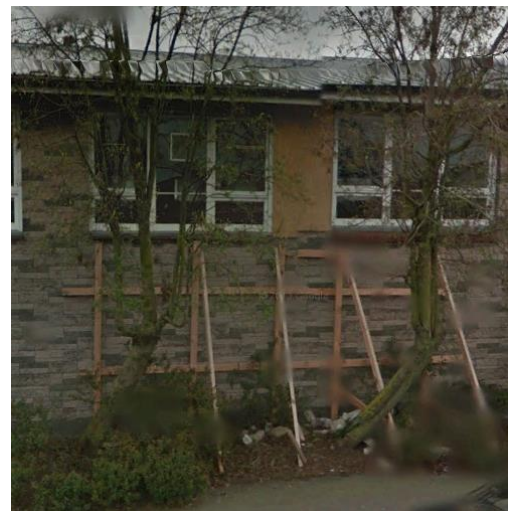
It has been observed that the crack pattern seen within the veneer during the investigation does not necessarily conform to the crack patterning in relation to tie placement seen during various seismic load testing by BRANZ within the last 10 years (Thurston & Beattie, Seismic performance of brick veneer houses. Phase 1 Cyclic and elemental testing of clay brick veneer construction, 2008) (Thurston, Critical properties of mortar for good seismic performance of brick veneer, 2011). In general, wire ties seem to have performed well with few showing signs of pull out from the mortar bed. Many failures can be attributed to workmanship; in particular a lack of ties. This may be missing ties or no ties in a particular section of wall; e.g. St Teresa's hall, Figure 6 which was subject to median peak ground acceleration of 0.15g on the 23rd of December 2011 which caused the brick to fall (Bradley & Hughes, 2012).

Figure 6. St Teresa's Hall (Google Earth, 2012)

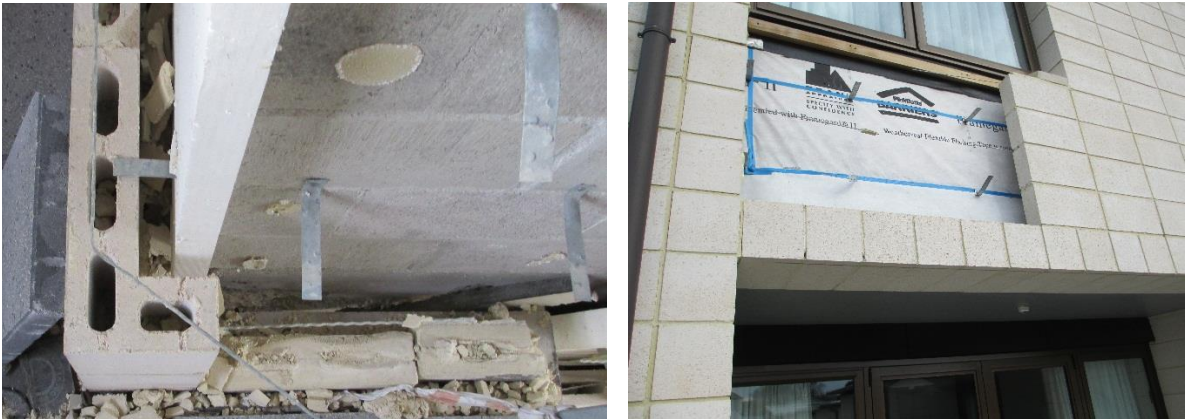
1. Generally, it was found that the veneers displayed a lack of cohesion between the masonry and mortar with 23% bonded with very poor condition mortar. Lack of cohesion can be seen where mortar has shown signs of deterioration.

Figure 7. Photos of ineffective mortar tie joints

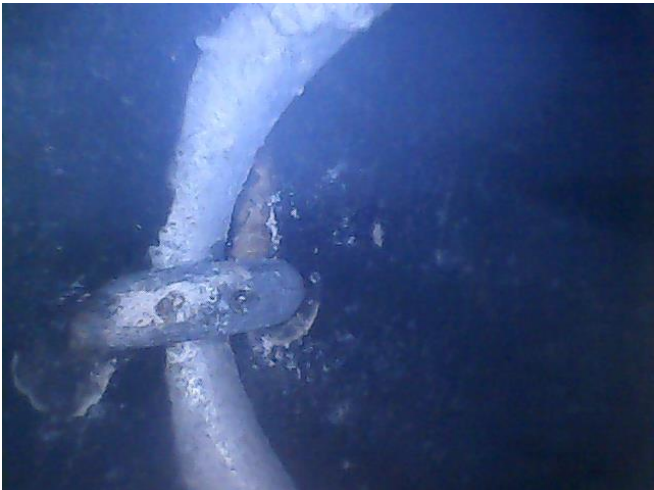
Two methods of tying have been observed to be less effective. Firstly the use of a wire tie being bent

at right angles and fixed to the face of the stud. See Figures 8 and 11. This appears to have been used in the period immediately after the introduction of building paper. The second is a tie that pulls out of the timber very easily, see Figure 10. The case that was encountered was used in 1994 when there was a supply problem with the normal tie. Other problems that may occur are that shown in Figure 9 which shows a tie that is not attached to the stud, or where the mortar has not been well bonded to the ties. This shown in Figure 7 which shows flat screwed ties that have no residual mortar attached to the ties. The building was constructed in 2007 and the block fall occurred over egress routes. We note that the level of shaking may have been high.

Figure 8. Wire tie attached to the face of a stud

Where ties do not meet the standard when installed, or the required, standard additional fixings are likely be required. One retrofit option is installing Helifix ties through the mortar bed from the outside into the timber stud. Consideration of ventilation adequacy is important to ensure longevity of the tie.

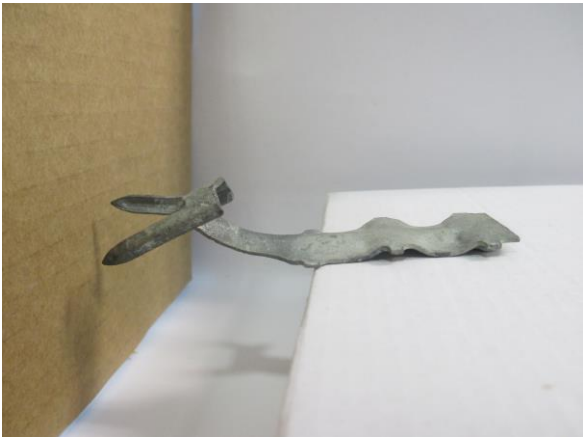
Figure 10. Detail of flat tie

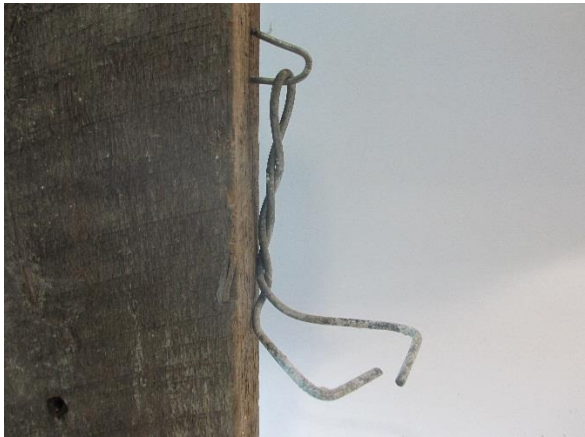
Figure 11. Detail of wire tie attached to face of stud
