Key factors in the liquefaction-induced damage to buildings and infrastructure in Christchurch: Preliminary findings

2014 NZSEE
Conference

ABSTRACT: The paper presents preliminary findings from comprehensive research studies on the liquefaction-induced damage to buildings and infrastructure in Christchurch during the 2010-2011 Canterbury earthquakes. It identifies key factors and mechanisms of damage to road bridges, shallow foundations of CBD buildings and buried pipelines, and highlights the implications of the findings for the seismic analysis and design of these structures.

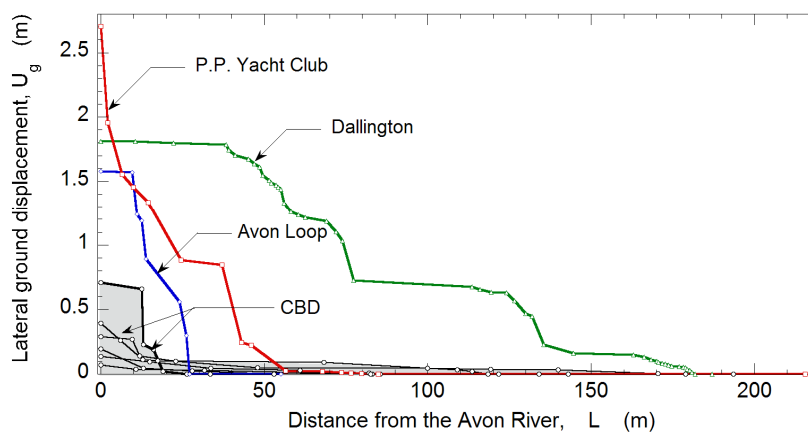
particularly severe and damaging along the Avon River where it was accompanied by substantial lateral spreading. Ground surveying measurements of lateral spreading at approximately 80 locations along the Avon River (Robinson et al., 2011; 2013) have shown that the magnitude of permanent ground displacements and the width of the zone affected by spreading generally increased heading down the Avon River, from the CBD towards the estuary. As shown in Figure 1, maximum spreading displacements within the CBD were predominantly between 10 and 30 cm, and were confined within a distance of 40-50 m from the river. The first more substantial lateral spreads with displacements greater than 1 m were observed at the Avon Loop, in the northeast corner of the CBD (the meandering loop before the Fitzgerald Bridge). Downstream from the Avon Loop, the spreading was more substantial and very damaging with permanent displacements often exceeding 0.5 m or even 1 m, and the zone of spreading extending up to 150 m to 200 m from the river. The spreading displacements were highly variable in their magnitude and spatial distribution even within a small area reflecting the complexities of the lateral spreads in the meandering loops of the Avon River (Cubrinovski et al., 2012). The largest permanent displacements of ~ 3 m were measured at the Pleasant Point Yacht Club, near the South Brighton Bridge where the Avon River discharges into the estuary.

Figure 1. Lateral spreading displacements along the Avon River measured by ground surveying after the Christchurch earthquake (Cubrinovski et al., 2014)

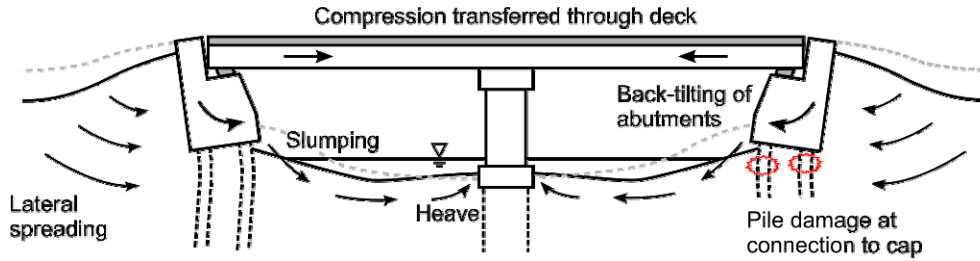
The road bridges of Christchurch are short- to moderate-length bridges typically with two or three short spans. Older bridges are integral systems while recent bridges are commonly precast concrete structures with movable joints. They all have sturdy configurations with rigid deck-wall or deck-girder superstructure providing large stiffness and strength in the longitudinal direction. Hence, when subjected to large spreading displacements of the ground and closing of the banks towards the river, the bridge superstructure resisted the ground movement through a deck-pinning or deck-strutting mechanism, as illustrated in Figure 2. This mechanism involves resistance to ground movement by the superstructure through deck-pinning (strutting), consequent back-rotation of the abutments with permanent displacement of the abutment piles towards the river, and substantial slumping of the approaches resulting in large vertical offsets between the approaches and pile-supported deck of the bridge. The permanent tilt of the abutments often reached 5-8 degrees and induced lateral movement of the abutment piles towards the river on the order of 20-30 cm. This deformation pattern consistently damaged the piles at their top with horizontal bending cracks occurring on the river-side and concrete crushing due to compression on the land-side of the piles (Figure 3). Clearly, the large lateral resistance of the bridge superstructure in conjunction with deck-pinning (strutting) played a key role in the development of the characteristic deformation (damage) mechanism of bridges induced by spreading of liquefied soils.

Figure 2. Schematics illustration of characteristic spreading-induced mechanism of deformation (damage) for short-span road bridges in Christchurch

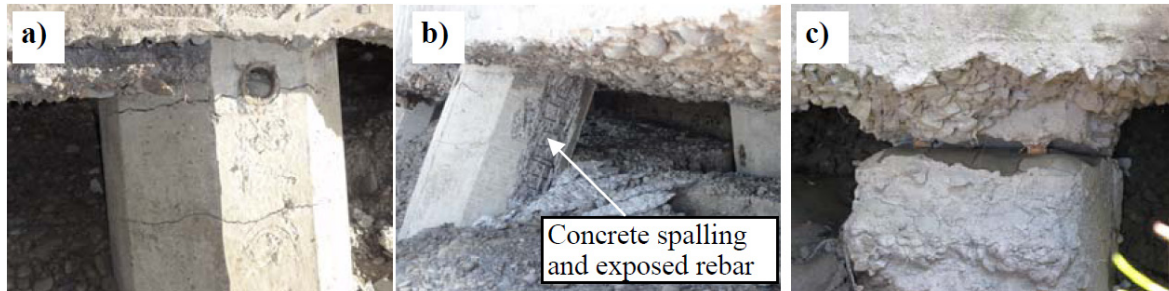
Figure 3. South Brighton Bridge: bending cracks at the top of abutment pile, on the river side (a) and concrete crushing on the land-side of abutment pile (b); Fitzgerald Bridge: failure of the northeast abutment pile (c)

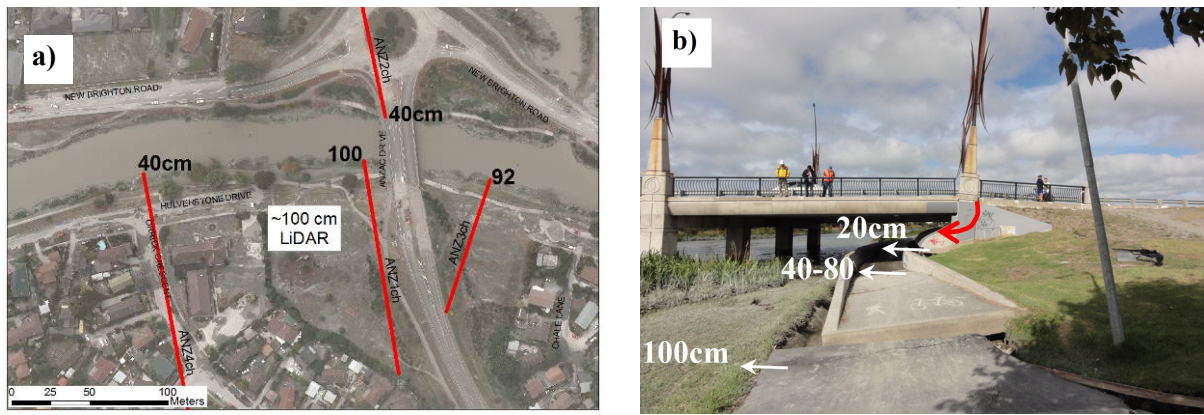
The ANZAC Bridge on the Woolston-Burwood expressway also exhibited the characteristic spreading-induced mechanism outlined above (as did all other bridges for that matter) and provided important details on the permanent ground movement in the foundation soils of the bridge abutments. Massive liquefaction occurred in the area of the bridge during the Christchurch earthquake with large volumes of sand ejecta seen particularly on the south side of the bridge. Figure 4a shows an aerial view of the bridge in which the solid lines indicate alignments of lateral spreading measurements (Robinson et al., 2013) with the numbers at the tip of the transects indicating maximum displacements at/near the river banks measured after the Christchurch earthquake. It is apparent that the south banks of the river moved approximately 1 m towards the river, in the free field. However, the large resistance to the ground movement provided by the bridge superstructure, as described earlier, reduced the movement of the foundations soils. The ANZAC bridge case history provides an excellent evidence for quantifying this reduction in movement of the foundations soils in relation to the permanent free field ground displacements.

Figure 4b illustrates the permanent movements at the south abutment of the bridge with the red arrow indicating an inward permanent tilt of the abutment of about 6 degrees. The horizontal arrows and associated displacements indicate permanent lateral displacements of ~ 20 cm at the bottom of the abutment (i.e. top of the abutment piles) resulting from the rotation of the abutment, lateral offset of the precast concrete underpass of 40 cm to 80 cm, and lateral movement of the surrounding free field soil of ~ 100 cm. These displacements infer a horizontal displacement at the top of the piles of about 20 cm (i.e. 16 cm due to abutment rotation, and 3-4 cm displacement required to close the gap between the abutment and the deck-girder). The pedestrian underpass was founded on independent foundations consisting of 6 m-long rigid RC (reinforced concrete) piles that effectively floated in the liquefied soil and moved together with the surrounding foundation soils. The lateral displacements of the south underpass relative to the abutment were about 20 cm at its edges and 50-60 cm in its central part (Cubrinovski et al., 2013). From these displacements, one can infer that lateral displacements of the foundations soils of the abutment were about 50 cm to 60 cm or approximately 50% of the displacements of the riverbanks in the free field.

These findings have an important implication for the analysis and design of piles based on the equivalent static or pseudo-static analysis in which ground displacements are applied to the piles as an input in the analysis. The common practice of applying full free field displacements to the piles is clearly overly conservative for bridges with a capacity to reduce ground movements through a deck-pinning or deck-strutting mechanism. Moreover in such cases, it is important to account for the global bridge response and effects of deck-strutting using a whole bridge model. Such model and analysis for the ANZAC bridge is shown in Figure 5 where maximum ground displacements of 66 cm and 36 cm (best estimates) were simultaneously applied to the south and north bridge abutments respectively, while smaller spreading displacements were applied to the pier piles. Details of these analyses are given in Cubrinovski et al. (2014) and are beyond the scope of this paper, however two key findings from the analyses are important to emphasize: (i) the whole bridge model (analysis) captured the characteristic spreading-induced mechanism and damage to the piles (bridge), and clearly demonstrated the need to consider the response of the bridge and its components using a global interaction model, and (ii) the analyses confirmed that lateral movements of the foundation soils were substantially smaller than (or approximately 50% of) the free field displacements of the riverbanks.

Figure 4. ANZAC Bridge: (a) aerial view showing transects and measured lateral spreading displacements in the free field; (b) side view of the south abutment indicating back-rotation of the abutment (red arrow), and permanent lateral displacements of the abutment base, adjacent pedestrian underpass and free field soils

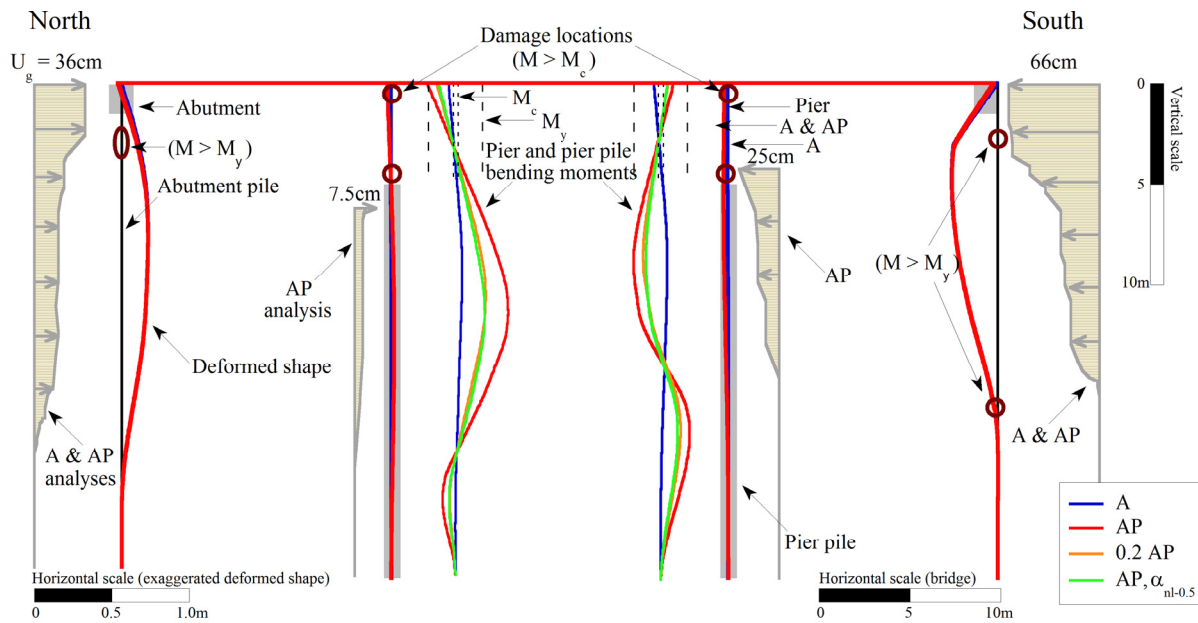
Figure 5. Schematic plot of global bridge model analysis showing applied ground displacement at the abutment piles, ground displacements applied along the pier piles, deformed shape of the bridge, damage locations where $M > M_y$, and bending moments along the piers and pier piles (Cubrinovski et al. 2014); A = Analysis in which ground displacements were applied to the abutment piles only; AP = Analysis in which ground displacements were applied to the abutment piles and pier piles.

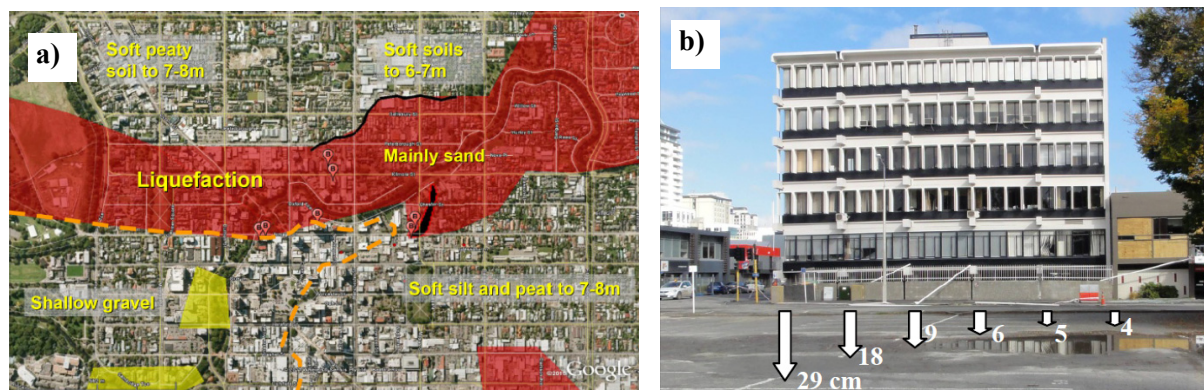
Figure 6a shows the observed liquefaction in the CBD as documented 10 days after the Christchurch earthquake. The principal zone of moderate-to-severe liquefaction (red area) stretches west to east through the CBD, from Hagley Park to the west, along the Avon River to the northeast boundary of the CBD at the Fitzgerald Avenue Bridge. This zone is of particular interest because moderate to severe liquefaction affected many high-rise buildings on shallow foundations and deep foundations in different ways. Even though the map shown in Figure 6a distinguishes the zone most significantly affected by liquefaction, the severity of liquefaction within this zone was not uniform. The manifestation of liquefaction was primarily of moderate intensity with relatively extensive areas and volumes of sediment ejecta. There were areas of low manifestation or only traces of liquefaction, but also pockets of severe liquefaction with very pronounced ground distortion, fissures, large settlements and substantial lateral ground movements. This non-uniformity in liquefaction manifestation reflects the complex and highly variable soil conditions even within the principal liquefaction zone in the CBD and the fact that this zone largely coincides with the path of the Avon River and network of old streams. The solid black lines (areas) indicate zones of pronounced ground distress caused by liquefaction. Within the area affected by liquefaction in the CBD, detailed investigations have been conducted in eight zones in a collaborative research study between the University of Canterbury and University of California, Berkeley (Cubrinovski et al., 2011a; Bray et al., 2014).

The case history presented herein is in the investigation Zone 8 at the intersection of Madras and Armagh Streets. At this site, the liquefaction was manifested by a well-defined, narrow zone of surface cracks, fissures, and depression of the ground surface about 50 m wide, as well as water and sand ejecta (Cubrinovski et al., 2011a). This liquefaction feature stretched from the Avon River towards south, and affected the southeast corner of the 6-storey CTUC building, shown in Figure 6b. The CTUC building was on shallow foundations consisting of 2.4 m x 2.4 m isolated footings (approximately 0.6 m deep) connected with tie beams and perimeter grade beams. A side view of the building looking towards the west, shown in the figure, indicates differential settlement of the southeast corner of the building of approximately 25 cm, which led to serious foundation and structural damage. Sand ejecta surrounded the southeast corner of the building presenting clear evidence that liquefaction was the most likely cause of the differential settlements.

Figure 6. (a) Liquefaction map for the CBD (Christchurch earthquake) indicating zones of moderate-to-severe liquefaction (red) and zones of pronounced ground distress (black); yellow areas indicate zones of low (traces) to moderate liquefaction; (b) liquefaction-induced settlements of CTUC building

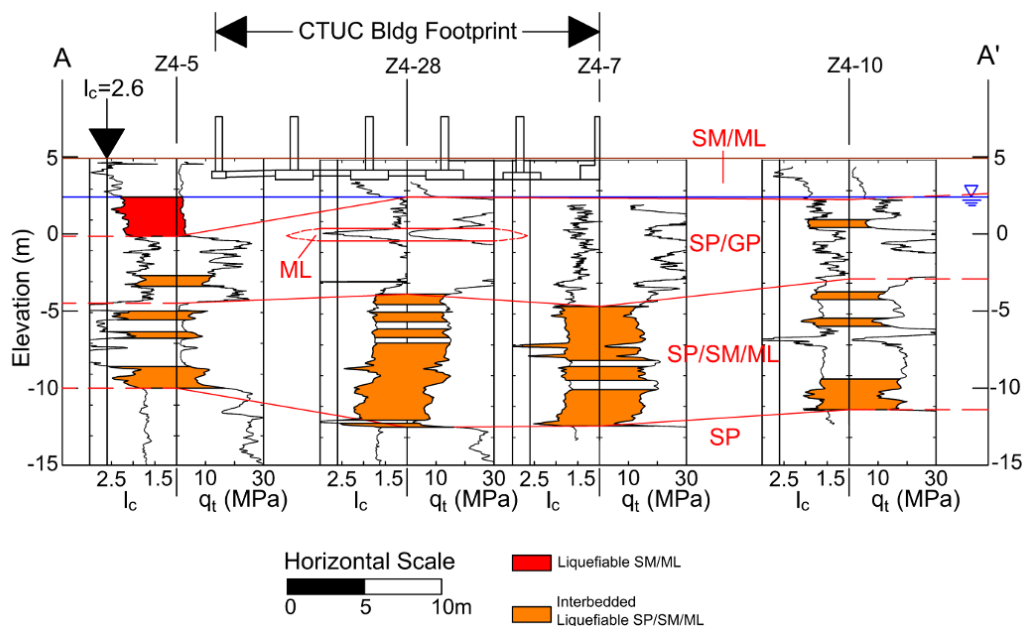
To further investigate the direct cause of the observed differential settlements, detailed CPT investigations were performed including 6 CPTs at the CTUC building site, and 15 CPTs at the nearby Armagh-Madras parking lot site (Bray et al., 2014). The latter involved closely spaced CPTs at 3m to 5m intervals aiming at depicting details of the ground profile across the previously mentioned liquefaction feature and its boundaries. Bray et al. (2014) used these data to develop detailed soil profile and investigate the variability of soil conditions over relatively short distances. They also conducted liquefaction triggering analyses based on the CPT data for the four most significant earthquakes affecting Christchurch in the 2010-2011 Canterbury earthquake sequence. Results of the triggering analyses are illustrated in Figure 7 where layers that have liquefied according to the triggering analysis are indicated in orange and red. The footprint of the CTUC building is also shown in the figure.

It is evident from Figure 7 that triggering of liquefaction is predicted at depths greater than 10 m across the whole area of interest. The distinguishing difference however is the presence of shallow liquefiable soils just beneath the foundations at the southeast corner of the building (CPT Z4-5 in Figure 7). This layer is not continuous however, and it was not present near the centre of the east side of the building or at the northeast corner of the building. This drastic change in the shallow soil conditions from the building's north end, which did not contain shallow liquefiable soils, to its south end, which contained shallow liquefiable soils, led to significant differential settlement over the southernmost spans of the building frame. Liquefaction of shallow soils just beneath the foundations of buildings was identified as a direct cause for excessive differential and total settlements of several other CBD buildings that were also subject of our detailed investigations clearly identifying the shallow liquefaction as a key factor in the poor performance of many CBD buildings on shallow foundations. Such damaging effects of shallow liquefaction for the buildings on shallow foundations were largely due to the direct disturbance of the foundation soils and loss of foundations soils due to sediment ejecta.

The shallow soils at the southeast corner of the building that were responsible for the shallow liquefaction and consequent large differential settlements were sandy silt to silty sands, with nonplastic fines of up to 50%, soil behaviour type index of $I_c = 2.0 - 2.5$, and cone tip resistance of about 3 MPa to 5 MPa. This information is important in the context of our on-going research efforts to identify the composition and conditions of the soils that were responsible for the extensive damage caused by liquefaction in Christchurch.

Figure 7. Subsurface conditions at CTUC building site indicating layers that have liquefied in the Christchurch earthquake according to CPT-based triggering analysis; note the presence of shallow liquefiable soils just beneath the foundations at the southeast corner where the largest settlement of ~30 cm was observed (Figure 6b)

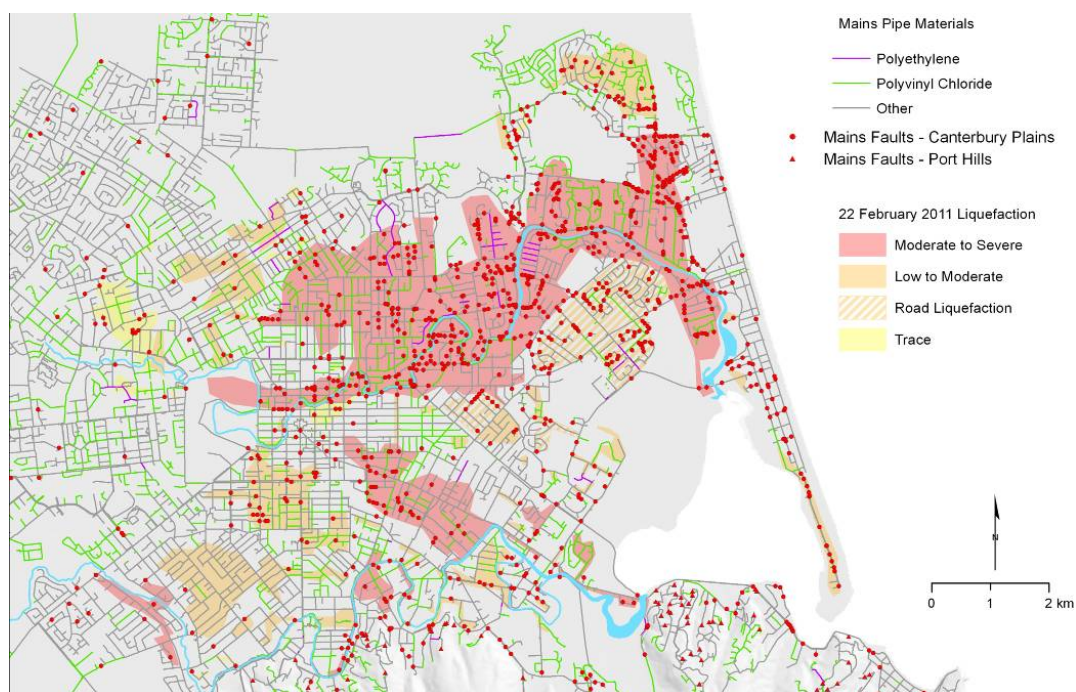
The potable water system was proven to be much more resilient. Even though a large number of breaks/repairs of the water pipes have been reported, the water supply service was quickly restored. In order to examine the relation between the repairs (faults) of the potable water system and observed liquefaction severity, GIS analyses were performed using the pipe network damage data and liquefaction observation maps (Cubrinovski et al., 2011b). Figure 8 shows the location of repairs/faults on the watermains network (red symbols) following the 22 February 2011 earthquake. Superimposed in the background of the figure (with red, orange and yellow colours) is the liquefaction map indicating the severity of liquefaction (and associated land damage) induced by this earthquake. According to the GIS analyses approximately 80% of the breaks occurred in areas affected by liquefaction.

Figure 8. Locations of breaks (repairs) to the watermains after the Christchurch earthquake; liquefaction map for the same event is shown in the background

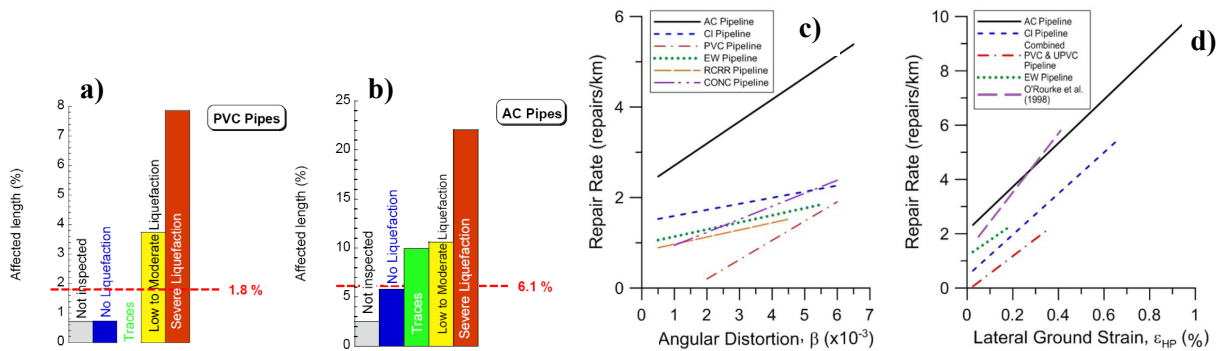
The analyses also revealed that more ductile pipelines (e.g. polyethylene - PE and polyvinyl chloride - PVC pipelines) suffered significantly less damage (three to five times less on average) than asbestos cement (AC), galvanized iron (GI) and other brittle material or 'rigid' pipelines. Figures 9a and 9b summarize the performance of different pipe materials (PVC and AC pipelines) and clearly indicate the difference in the performance of different pipe materials, and also the increase in the watermains damage with increasing liquefaction severity.

Figures 9c and 9d show the correlation between the damage to the pipes (in terms of repairs per kilometer) and ground distortion, expressed in terms of angular distortion and lateral ground strain as summarized by O'Rourke et al. (2014). The approximated linear relationships show clear increase in the damage to both water (AC, CI, PVC) and wastewater pipelines (EW, RCRR, CONC) with the angular distortion and lateral strain of the ground. Figure 9c shows that AC pipelines are especially vulnerable to differential vertical movement, with repair rates 1.5 to 3 times higher than those for CI pipelines at comparable levels of β . O'Rourke et al. (2014) attributed this vulnerability in part to the use of a relatively weak AC collar to join adjacent lengths of pipe which is susceptible to cracking in response to relative rotation caused by differential settlement.

Figure 9. (a,b) Summary of damage to PVC and AC watermain pipes due to the Christchurch earthquake (Cubrinovski et al., 2011b); (c, d) Repair rates for pipelines of different materials as a function of angular distortion and lateral ground strain (O'Rourke et al., 2014)
