Hydraulic uplift forces on basements subject to liquefaction

N.S. Luxford

Babbage Consultants Ltd

**2014 NZSEE
Conference**

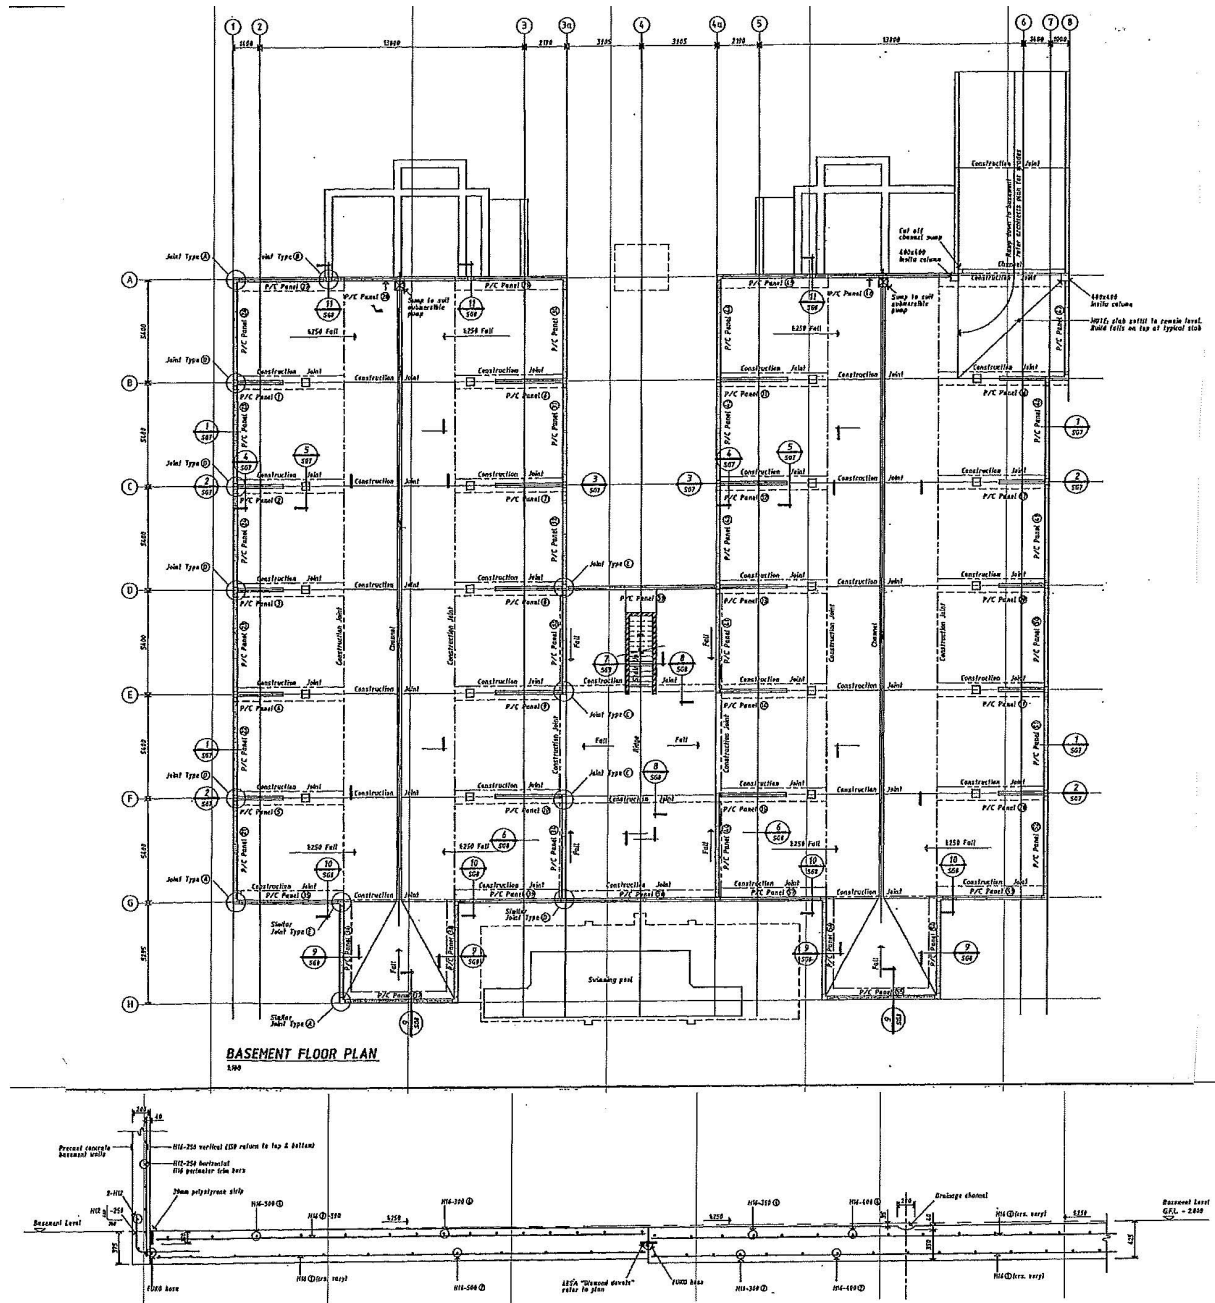
Figure 1. Layout of Basement and Slab Reinforcement Details

The basement walls were precast concrete and the basement slab was cast insitu concrete with internal columns resting on the basement slab. The general arrangement of the basement is shown in Figure 1. Along each side of the basement the insitu concrete basement slab was 375mm thick to 5.7m from the perimeter wall with thickening to 725mm beneath column points. The central 6m wide strip of slab was 425mm thick and a construction joint with water stops was formed between the central and outer portion of the slabs.

The connection between the central and outer slabs was designed to transfer uplift in shear using a system known as a Lesa diamond dowel which is designed to allow shrinkage movement across the

construction joint but no moment transfer. The Lesa dowel is a rectangular steel plate which is set into the edge of each side of the concrete slab at regular intervals with its diagonal axis aligned along the construction joint.

Several of the Lesa dowels were found to have failed following liquefaction at the site.

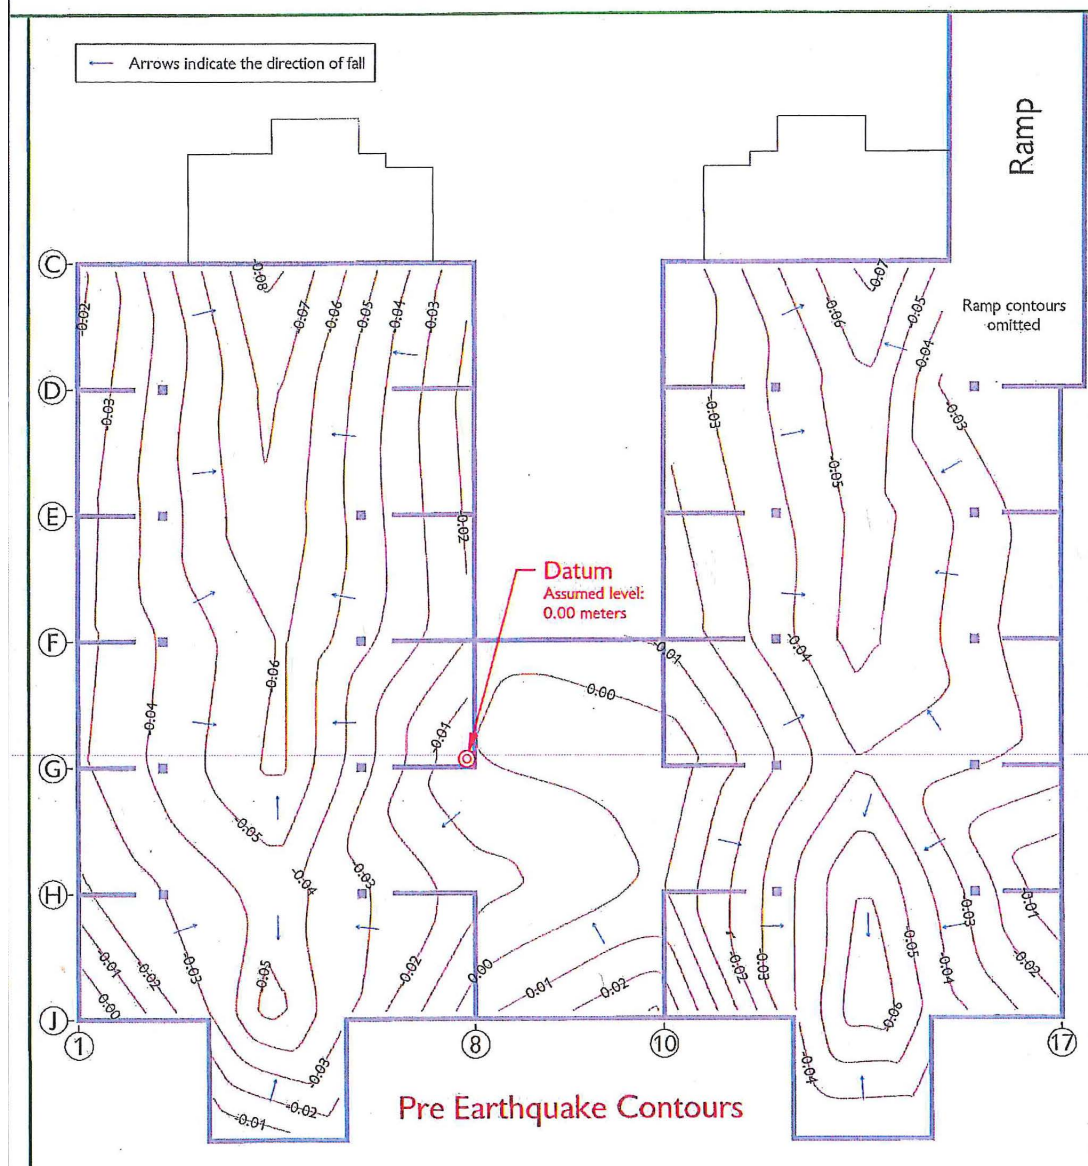
Figure 2. Levels on Basement Slab prior to Earthquakes

Because the building was under observation prior to the first earthquake levels had been obtained across the basement floor level. Contours showing the relative difference in level across the basement floor are shown on Figure 2. From this it is clear that the basement floor was constructed with a fall from south to north. These initial levels were tied into a benchmark established in the kerb on Bealey Ave. The benchmark was used to compare the results of the level survey conducted before the 4 September earthquake with those after the 4 September earthquake. No appreciable change in the basement floor levels was found as a result of the 4 September earthquake event confirming that no apparent liquefaction occurred at this site as a result of this event.

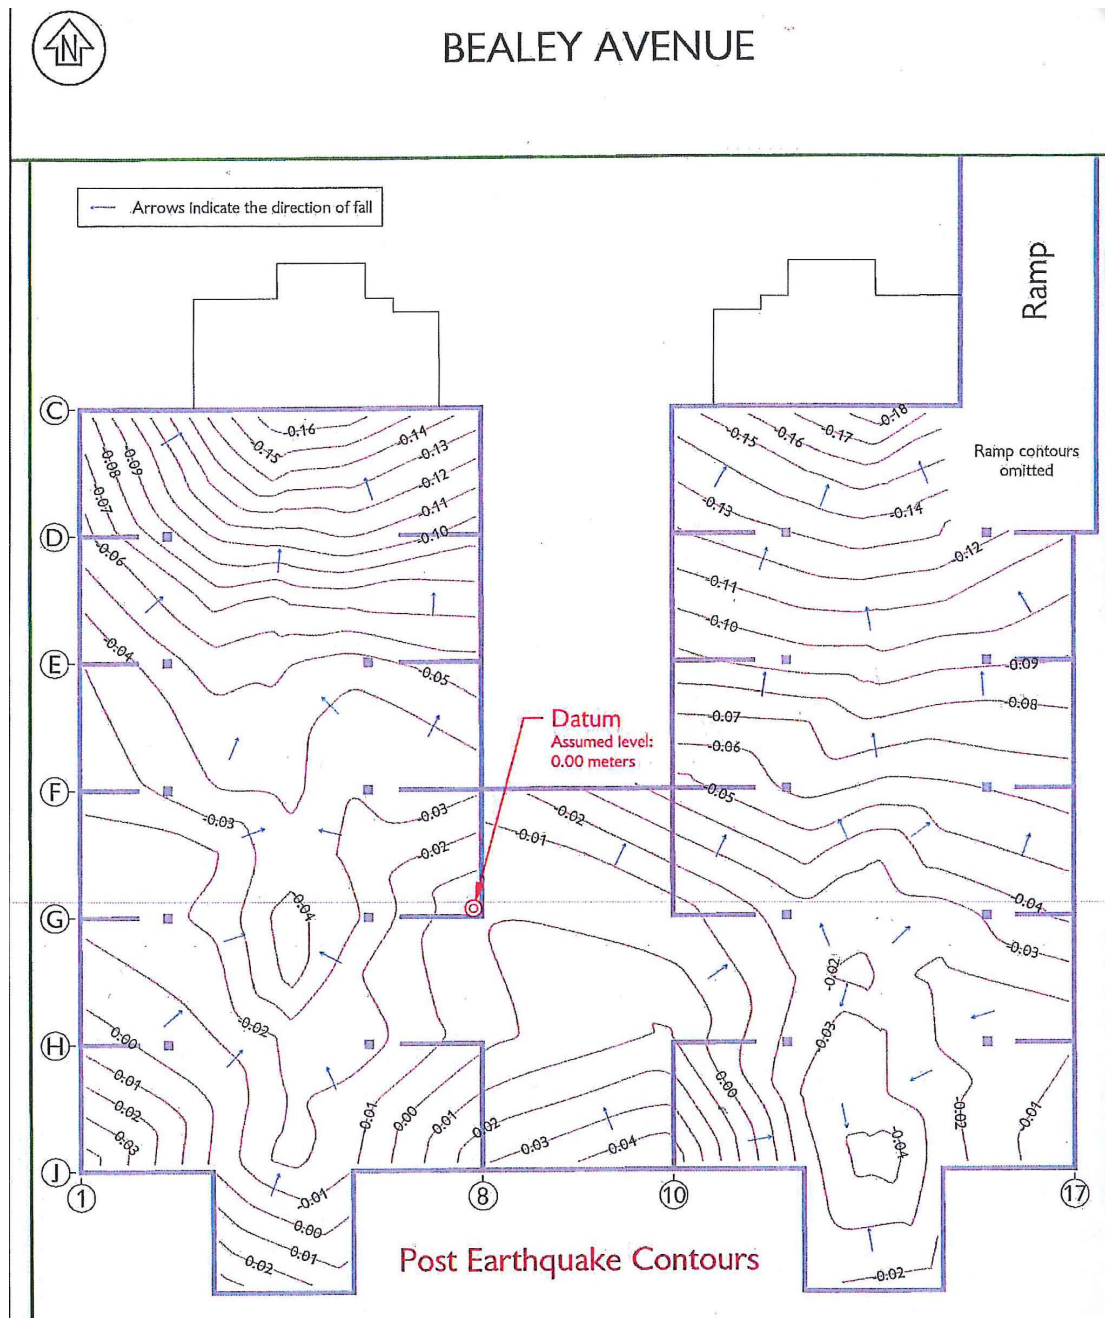
Figure 3. Changes in Basement Levels after February Earthquake

As a result of the 22 February 2011 earthquake movement occurred in the kerb and thus the benchmark in the kerb could not be relied on to obtain new absolute levels across the floor slab. However differences in levels depicted as contours in respect to the same origin within the basement are shown on Figure 3. This shows that post the 22 February earthquake the north end of the basement is 110 to 130mm lower than it was prior to the 22 February earthquake.

However, from these levels it cannot be determined whether the south end of the building has risen in relation to the north end or the north end has settled or a combination of both actions has taken place.

Had the settlement been relatively uniform around the basement then it most likely would have been due to settlement of loose backfill. Because the amount of settlement of the backfill is greatest at the south end and least at the north end it is probable that the south end of the basement has risen.
