# Practical examples of using qualitative assessment methods to assess the earthquake risk of historic structures in the Christchurch area

**2014 NZSEE  
Conference**

The buildings assessed are all managed by the Department of Conservation and include: Fort Jervis on Ripapa Island (1880), The Sign of the Packhorse Hut (1916) and Godley Head Battery (1940s).

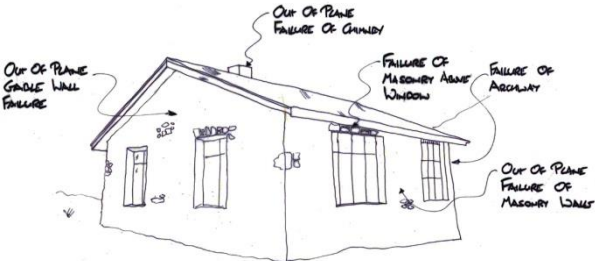
**Figure 7. Packhorse Hut**

In the case of a simple building, such as the Packhorse Hut, intuitive areas such as the chimney and gable walls were identified, but other areas such as the masonry above windows and the pier adjacent to the front entrance archway were also identified as potential weaknesses, see Figure 7.

elements such as the chimney and the gable walls and the roof structure. Although they had performed satisfactorily to date, rubble masonry typically has poor behaviour and so without adequate connections the building was considered earthquake-prone.

The Packhorse Hut repairs to the stone masonry, such as repointing and stitching of cracks with 'helibars' were recommended to return the walls to their original condition. A new timber ceiling diaphragm and connections to the walls were also recommended to ensure all masonry elements were tied together and could distribute lateral loads efficiently. The advantage to this form of alteration was that little original fabric was removed as the ceiling was not original and in poor condition.

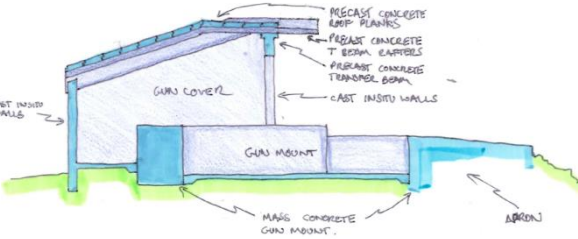
**Figure 8. Section through Godley Head Gun Emplacement**

At Godley Head the load path analysis of the bunker type buildings indicated they were incredibly robust. However, the overhead concrete gun shelters relied on connections between precast elements to remain stable, see Figure 8. These connections were quite clearly minimal and so were identified as critical structural weaknesses.

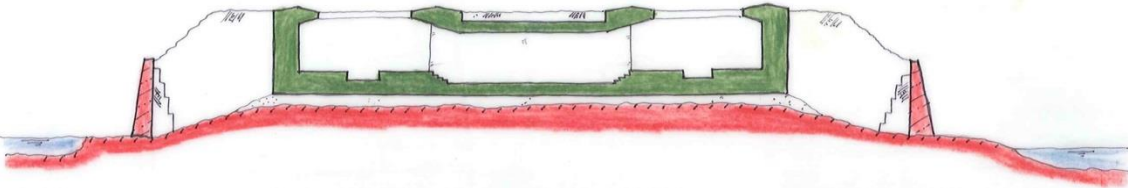
**Figure 9. Section through Fort Jervois**

At Fort Jervois the likely failures included the collapse of internal single skin brick walls, falling spalled concrete of the roof, and collapse of the parapet walls. The risk assessment identified the parapet walls as the greatest potential risk to life. These walls were checked with basic calculations (Griffith 2013) and were found not to be earthquake-prone due to favourable proportions. Since the masonry was of high quality with good mortar strength and there were no signs of existing damage this result was considered appropriate. In addition, the fort is rarely visited which reduces the risk even further. The building was therefore not considered to be earthquake-prone.

For Fort Jervis there were extensive repairs that would be required to return the building to its original state. The classification system was therefore used to give options for three levels of repair: *Urgent* - repair required to maintain structural integrity of the building, *Necessary* - repair recommended prior to reopening to the public, *Desirable* - largely cosmetic repair to reduce future deterioration. Repairs typically involved repointing, stitching of cracks, masonry repairs, and removing or repairing spalled concrete or corroded iron structural elements.

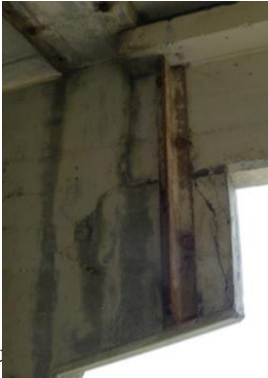
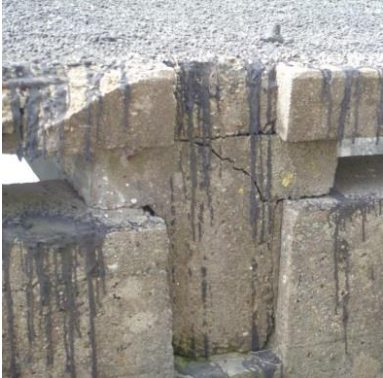
Figure 8: Joint between precast elements at Godley Head

At Godley Head the weaknesses at the connections between precast elements identified in the load path analysis correlated with the observed movement of these elements, confirming that this mode was in fact one of the lower bound failures of the structure. See Figure 10.

In the case of Godley Head gun shelters the evidence of movement of the precast roof elements, the deterioration of the connections and likelihood of further ground movements suggested a high risk of failure of the shelter structures as a whole. These were therefore considered to be earthquake-prone. The bunker type buildings, on the other hand, were incredibly robust and were not likely to cause risk to life even with further small ground movements.

The Godley Head recommendations included re-waterproofing the structures to avoid further deterioration, local repairs to damaged concrete, provide new or additional connections between the precast elements and to monitor the ground movements.

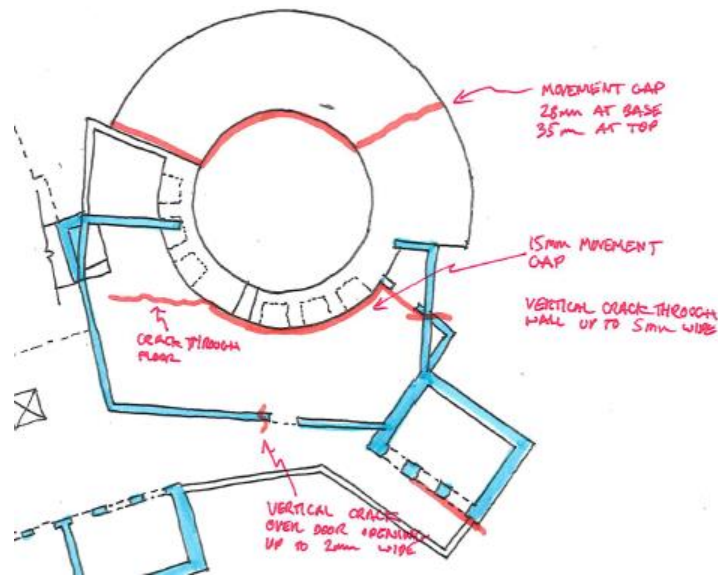
**Figure 11. Movement of the ground at Godley Head**

A lot of damage and movement to the gun emplacements at ground level was also observed. The explanation for this became clear when plotting all the damage on a plan shown in Figure 11. The damage related to movement in one direction towards the cliff edge, which determined the failure mode was slope failure of the non-engineered fill material under the structure as identified in the historic photos.
