Seismic performance of two water-storage dams during the Mw 6.6 Lake Grassmere Earthquake in August 2013

2017 NZSEE
Conference

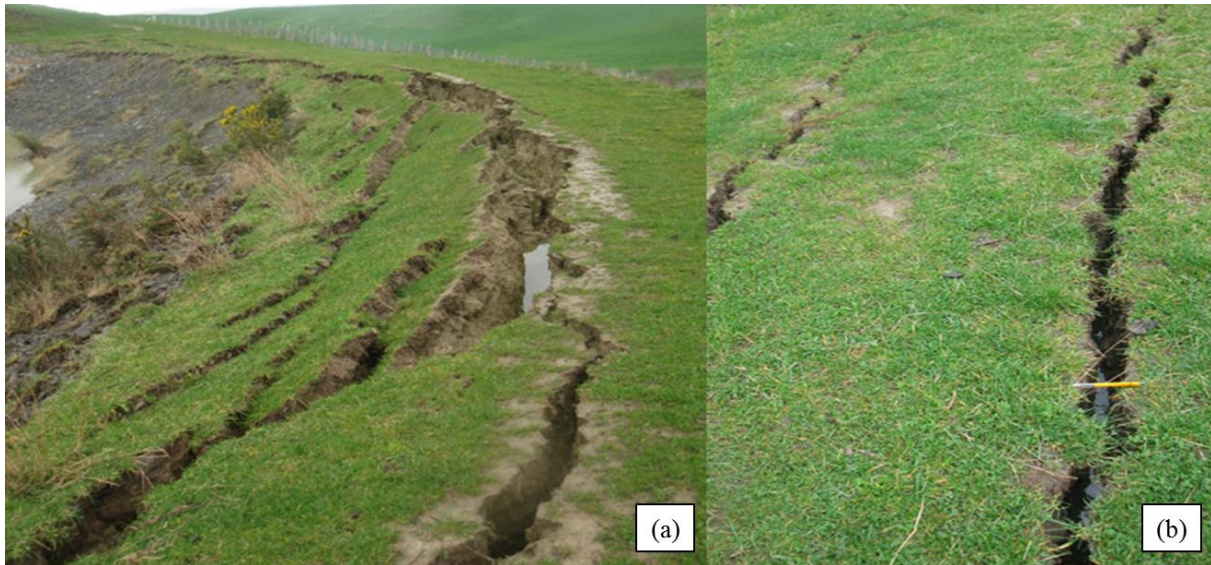
At the time of the Lake Grassmere Earthquake, the reservoir water level in both dams was only about 0.3m below crest level. Consequently, the Stage 2 fill was saturated and softened due to the lack of proper conditioning and compaction and because the chimney drain had not been raised. Deformation, slumping and cracking occurred as a result of the earthquake. At Dam 1, cracks up to 400mm wide happened in the upstream shoulder and crest as a result of slumping of the upstream shoulder at high elevations as indicated in Figure 2. At Dam 2, longitudinal cracks were evident in the downstream shoulder close to the crest. Longitudinal cracks and slumping were evident in the upstream shoulder at high elevations. Transverse cracks occurred near the eastern and western ends of the dam crest. Cracks were also evident on the slopes surrounding the reservoir. Figure 3 shows upstream slumping and a transverse crack at Dam 2.

Another factor is that the Lake Grassmere earthquake included some strong aftershocks. It is possible that the observed displacements are a combination of the cumulative effects of the main shock and aftershocks. The sensitive nature of the fill, i.e. being from loess origin, and the poor standard of compaction may have resulted in additional softening due to the development of excess pore pressures in the fill.

Figure 2. Dam 1: Lateral spreading cracks up to 400mm over (a) upstream shoulder and (b) crest following 2013 Grassmere Lake Earthquake

The remediation work for both dams was initiated by dewatering the reservoirs. Both dams were constructed back to their original design crest level. In the case of Dam 1, this was less than the constructed level which had exceeded the design level. The remediation works associated with Dam 1 consisted of removal of the substandard, poorly constructed fill as well as the installation of a new spillway to increase freeboard. The weak fill excavated from the crest and upstream shoulder of the embankment was then used to form an upstream buttress berm to enhance the stability of the dam as shown in Figure 6. The post-earthquake remediation work undertaken can be seen in Figure 7.

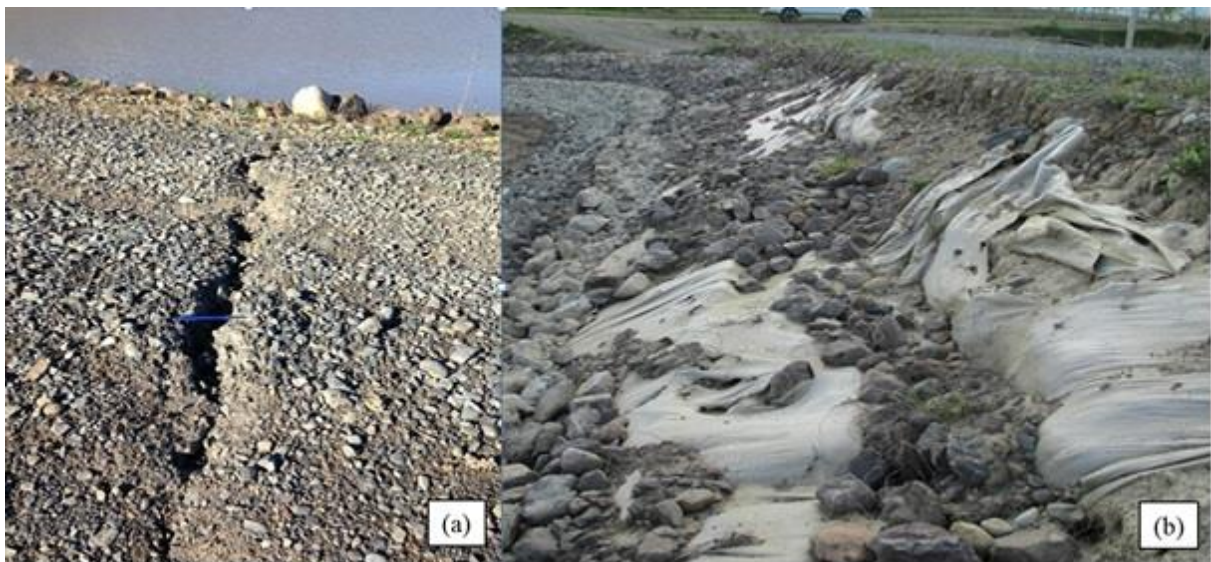
Figure 3. Dam 2: (a) transverse cracks up to 100mm at eastern and western ends of dam crest (b) longitudinal cracking and slumping up to 200mm along upstream face of dam

The remediation works associated with Dam 2 included the excavation and removal of poorly compacted fill over the upper 3 m portion of the embankment as well as the extension of the chimney drain as shown in Figure 8. Following the removal and disposal of the weak soil, suitable materials, i.e. weathered mudstone, were sourced from within the reservoir area to reconstruct the embankment to the design level as shown in Figure 9. The reservoir freeboard was also increased by the installation of a new primary spillway, consisted of a manhole inlet and outlet pipe, as well as the upgrade of the existing auxiliary spillway.

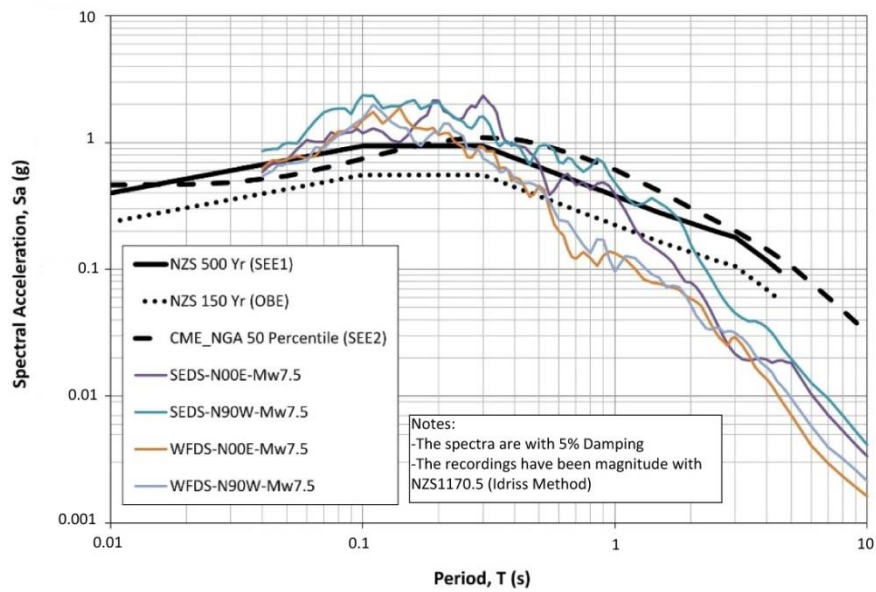
2004). The subsoil condition at SEDS is also Subsoil Class C based on Bradley and Cubrinovsky (2011). Dams 1 and 2 are founded on weathered mudstone which is equivalent to Subsoil Class B in accordance with NZS1170.5. Generally speaking, ground motions recorded at WDFS and SEDS could be expected to be greater than the ground motions at the dam sites. The recordings at the strong motion recorders provide an insight to the level of ground motion possibly experienced at the dam sites during earthquakes. A comparison between the design levels of ground motion for the dams and the recordings from WDFS and SEDS during the Lake Grassmere Earthquake are shown in Figure 4. The ground motions recorded at WDFS and SEDS exceed the SEE design level of ground motion (1 in 500 AEP) for spectral periods less than about 1 second. The ground motions recorded at WDFS and SEDS during the Kaikoura Earthquake are shown in Figure 5. Comparing Figures 4 and 5 show that the horizontal ground motion during the Kaikoura Earthquake are generally greater than the Lake Grassmere Earthquake at these strong motion recorders.

Figure 4. Comparison of the design level of ground motion for a low PIC dam and the strong motion recordings during Lake Grassmere Earthquake

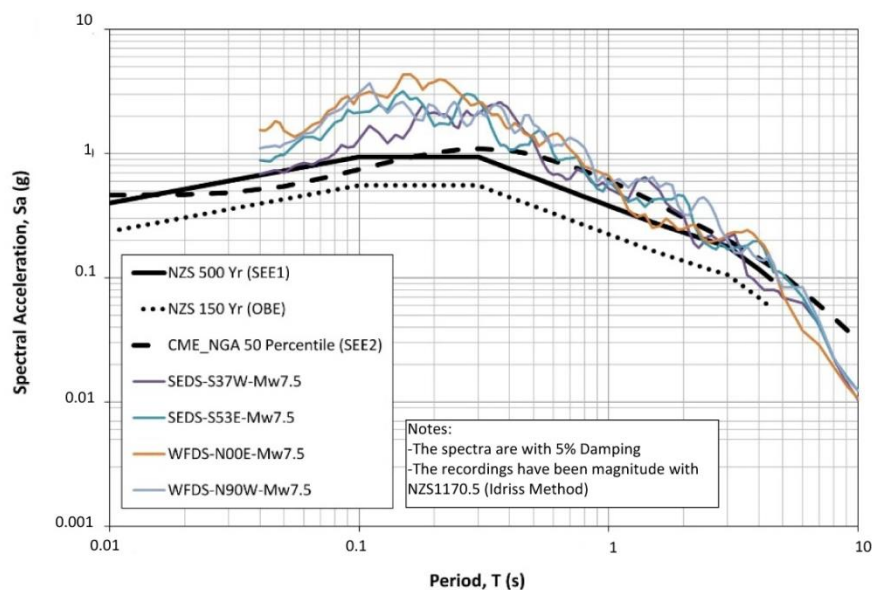
Figure 5. Comparison of the design level of ground motion for a low PIC dam and the strong motion recordings during Kaikoura Earthquake

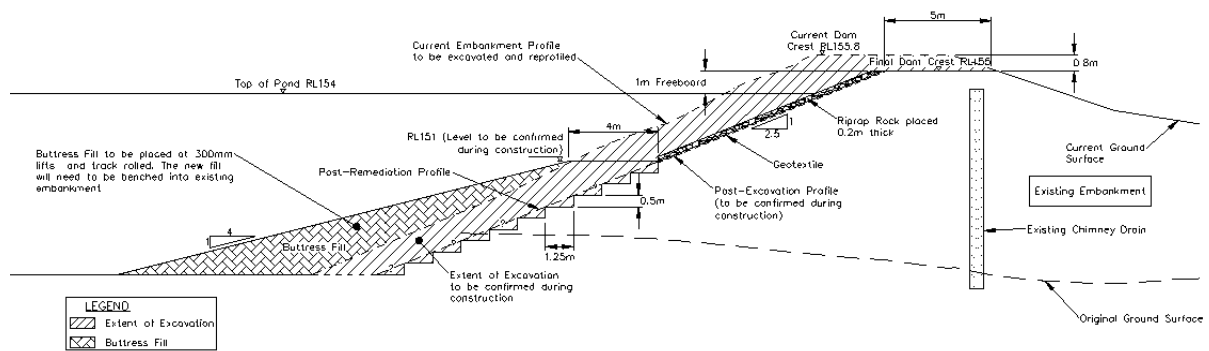
Figure 6. Typical cross section of remediated Dam 1

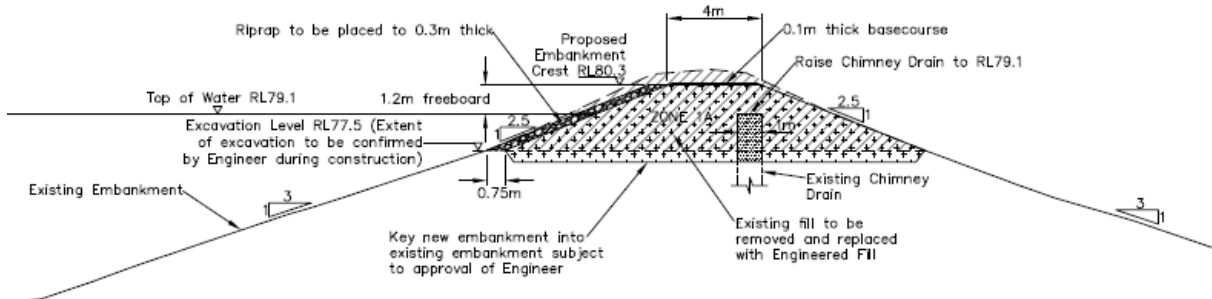
Figure 8. Typical cross section of remediated Dam 2

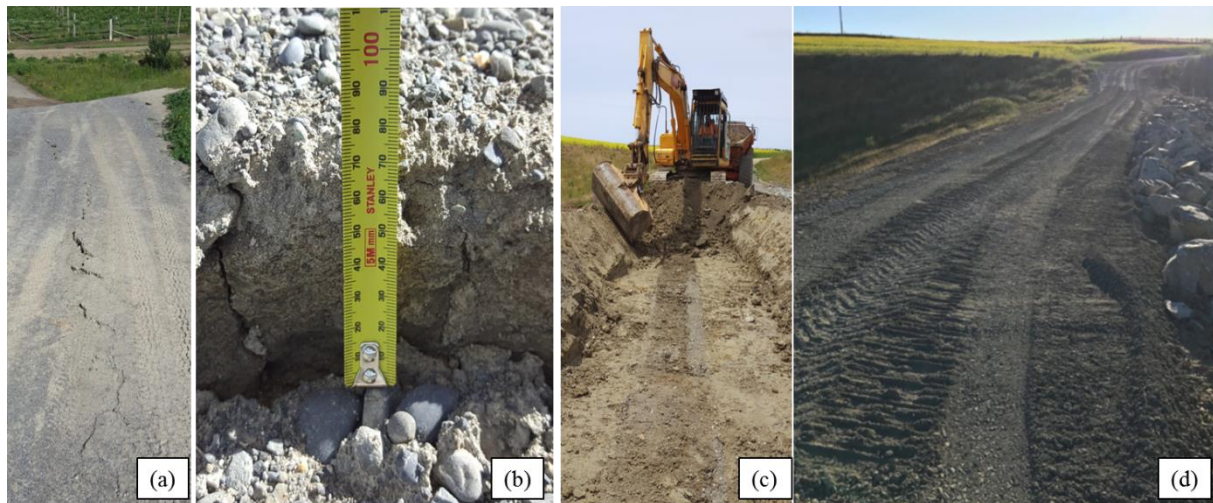
The performance of the two dams following remediation was examined by the Kaikoura Earthquake in 2016. Dam 1 performed satisfactorily and an inspection undertaken post-earthquake identified no significant damage or deformation. Dam 2 was subjected to further localised deformation and cracking. Longitudinal cracks up to 7 m in length were observed within the remediated fill following the earthquake as shown in Figure 10(a). The horizontal displacement up to 40 mm and vertical displacement up to 70 mm were observed in the cracked area (Figure 10(b)). A site investigation was carried out following the earthquake. The investigation consisted of excavating a series of test pits along the line of cracking at the same alignment as the chimney drain trench. The investigation shows that the cracking occurred within the backfill associated with the chimney drain. Following discussion with the contractor, it was revealed that the backfill of the chimney drain trench was not compacted to the same standard as the rest of the remediated fill. The contractor pointed out that while the bulk of the remediated fill was compacted using a 12-tonne pad foot compactor, an excavator's bucket was utilised for the compaction of the backfill. The loosely compacted backfill along the chimney drain was then sub-excavated, the trench was widened, and the material was re-conditioned, placed and compacted to

Figure 10. Dam 2: (a) longitudinal cracking with horizontal, (b) vertical displacements of up to 40mm and 70mm respectively, along chimney drain trench, (c) and (d) post-earthquake remediation work (2016 Kaikoura Earthquake)

adequate standard using a 12-tonne pad foot compactor. The post-earthquake remediation work undertaken for Dam 2 is shown in Figure 10 (c) and (d).
