Post-Seismic Capacity of Damaged and Repaired Reinforced Concrete Plastic Hinges Extracted from a Real Building

2017 NZSEE
Conference

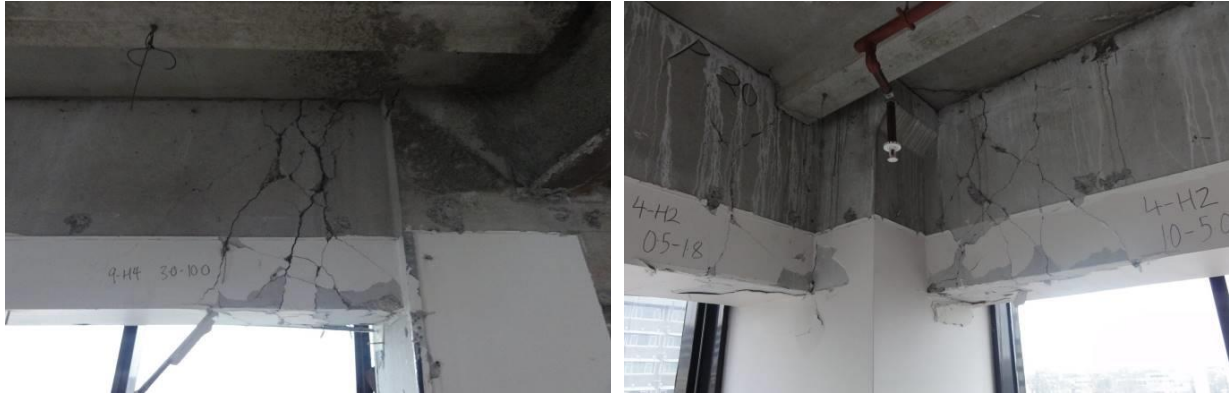
Interestingly enough, most of the observed cracks were within, instead of outside, the plastic hinge relocation detail (see Figure 2) which thus apparently did not work as intended per the original design. Residual drifts and tilting (due to liquefaction and lateral spreading) were also observed. More detailed information on the observed damage can be obtained in Giorgini et al. (2013) and Fleishman et al. (2014). The building was considered uneconomical to be repaired and consequently demolished in 2012. Four “H frames” were extracted from the 16th floor level during the demolition process for experimental purposes (see Figure 1).

Figure 2. Typical damage observed in the superstructure of the PWC building, level 9 interior unit H4 (left) and level 4 corner unit H2 (right) (Fleishman et al., 2014).

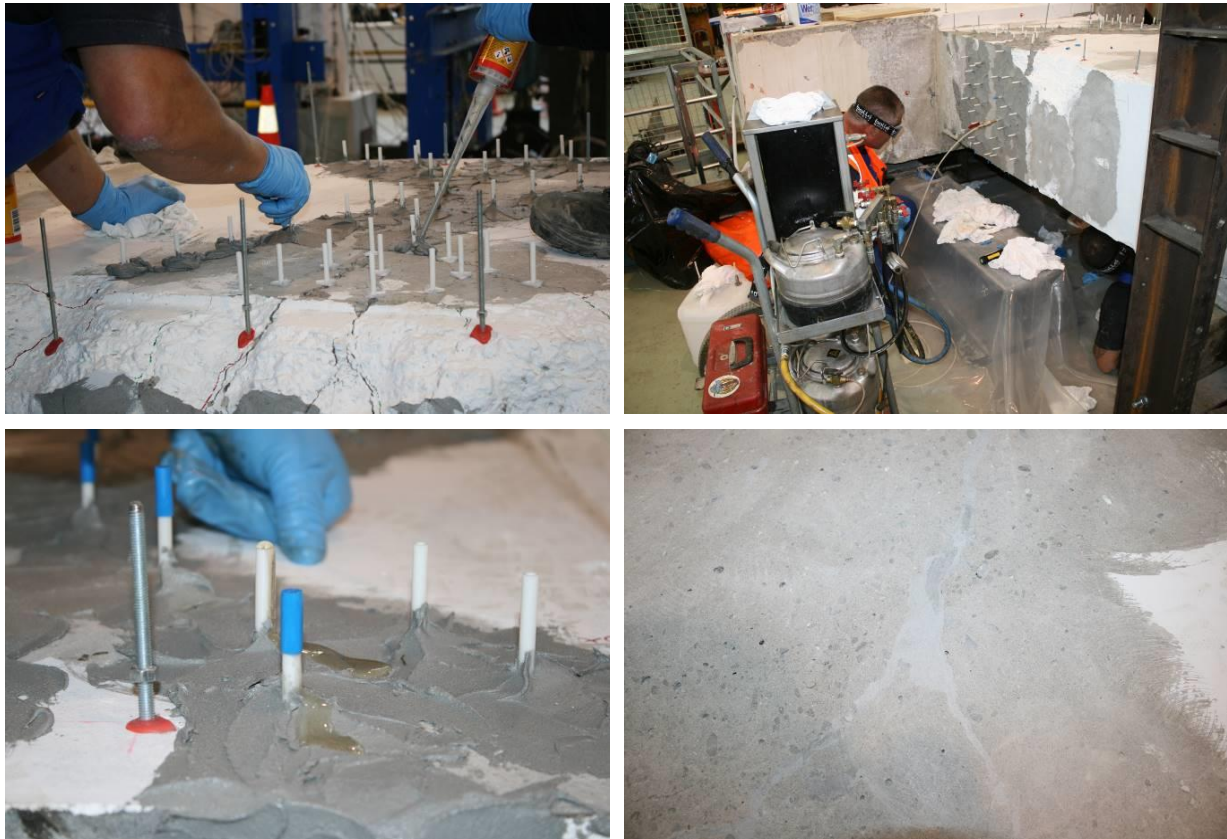
Figure 5. Epoxy repairs in specimen 3. Sealing process with epoxy mortar and installation of injection ports (upper-left); resin injection with an air-operated pump (upper-right); epoxy resin leaking from and sealing of the injection ports (lower-left); finish once the epoxy mortar has been removed (lower-right).

The repair works were conducted by BBR CONTECH, concrete specialists with broad experience on epoxy injection repairs in Christchurch following the CES, with the technical support from the product manufacturer. As shown in Figure 5, the damaged specimens were repaired in the same horizontal position as they were tested. The repair process started with grinding the surface along the crack lines to seal them with a well bonded epoxy mortar. It was necessary to seal both sides of the crack to prevent leakage. Injection ports were simultaneously installed at 100-200 mm crs. (sometimes closer depending on the cracking pattern). The epoxy material was mixed and the resin was injected under pressure via the injection ports through an air-operated pressure pump. The injection port was sequentially interchanged to allow the resin to travel and fill the interior cracks. The ports were sealed as the resin started leaking through them. Once the injection process was finished, the surface was cleaned off by removing the hardened epoxy mortar, leaving the surface flush. A total 4.8 L and 10.9 L of resin injected at 34.5 MPa (5 psi) were required to repair the specimens 2 and 3, respectively.

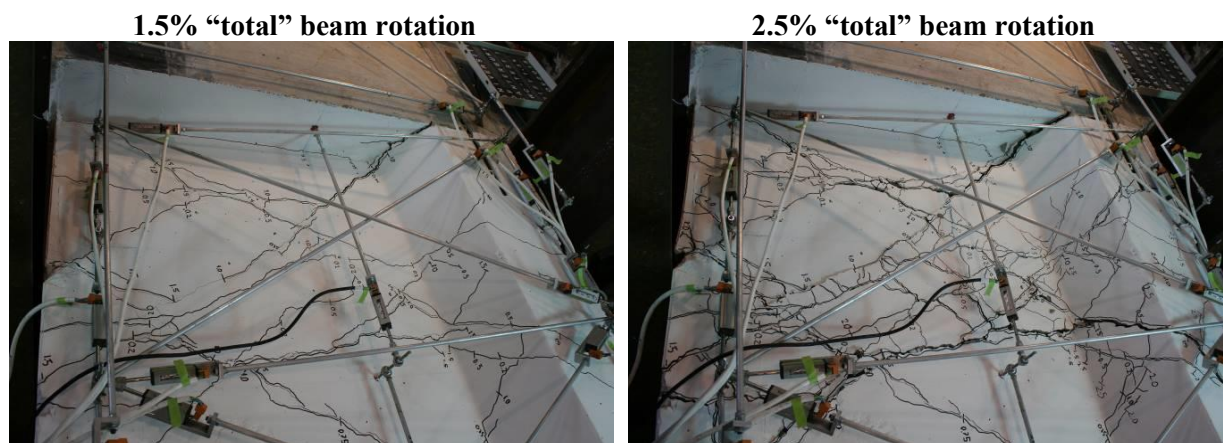
Cracks of 0.1mm in width opened up at 0.2% “total” beam rotation. These cracks might be pre-existing ones (earthquake induced) that closed due to the low level of inelastic action. At 1.5% total rotation most of the deformation was concentrated at a single diagonal crack 4-12 mm wide (see Figure 6), and shear distortions became more evident. The reason of these diagonal cracks could be excessive principal tensile stresses as a result of the diagonal compression strut induced by the hooked bars within the plastic hinge relocation detail. It was not possible to test the specimen up to failure due to the excessive and unexpected shear deformation (and sliding shear mechanism) of the specimen. The reaction frame was later modified in order to accommodate such displacement.

Figure 6. Residual racking pattern observed during Test 1, at 1.5% and 2.5% “total” beam rotation.

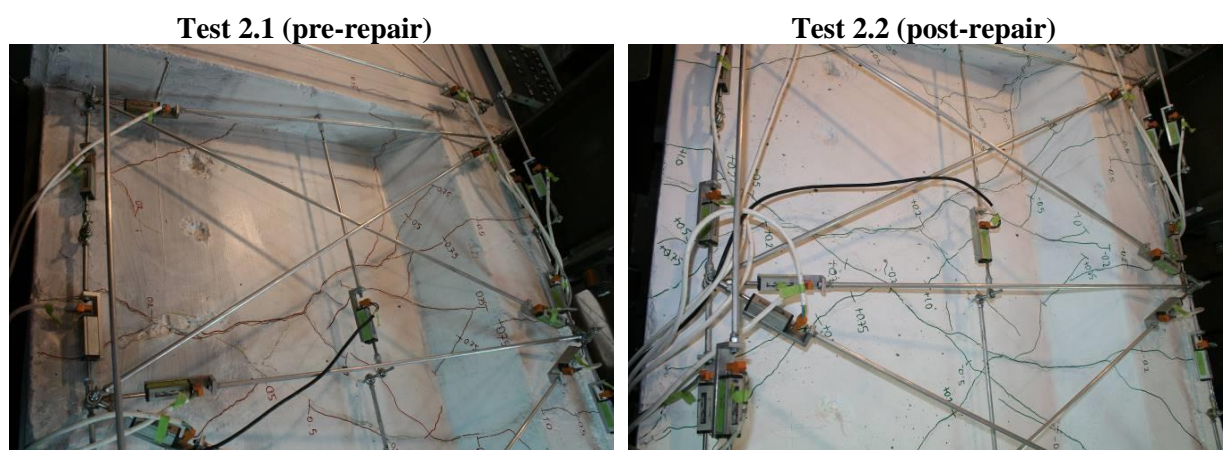
Cracks 0.1 mm wide were also observed at 0.2% “total” beam rotation. Maximum cracks of 3 mm in width were observed at 1% “total” beam rotation (see Figure 7). By comparing the cracking pattern before and after the test, it is believed that most of the (earthquake) pre-existing cracks were activated at this beam rotation level. Residual (static) cracks between 0.1 mm and 2.0 mm in width were observed at the end of the test.

Cracks of 0.1-0.2 mm in width started developing at 0.1% “total” beam rotation. A new crack extended from the column face towards the interior of the joint, and did not follow the injected crack path. At 0.75% “total” beam rotation, 0.1 mm-hairline cracks started developing outside the plastic hinge relocation detail. At beam rotations of 1.5%, residual (static) cracks started becoming comparable to the maximum observed (70-90% of the maximum crack width). Maximum cracks of 9-18 mm in width were observed at 2.5% “total” beam rotation. As shown in Figure 7, most of the repaired cracks re-opened up during the Test 2.2.

Figure 7. Residual cracking pattern observed during Test 2 at 1.0% “total” beam rotation.

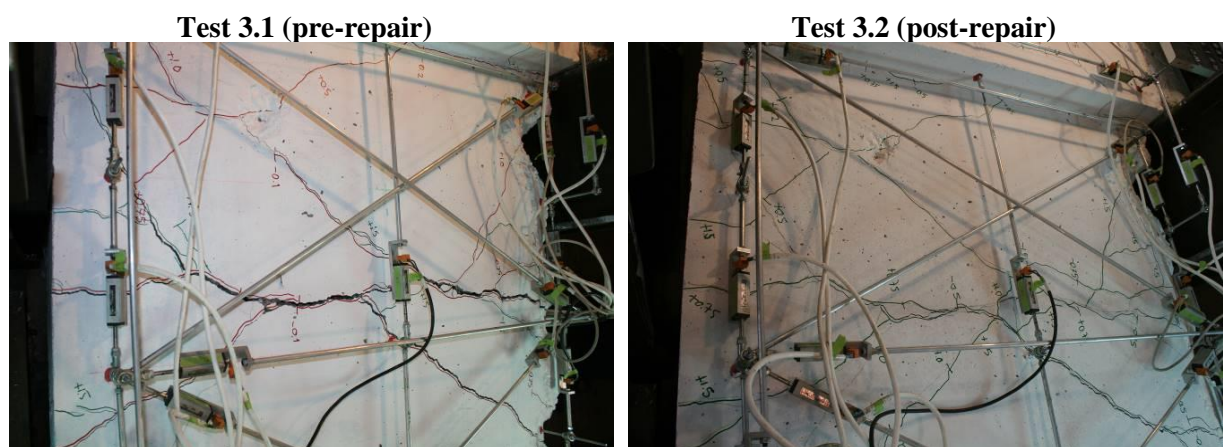
Existing cracks 0.1-0.15 mm wide opened up at 0.1% “total” beam rotation. The cracks continued increasing in quantity and in width, reaching 7 mm at 1.5% “total” beam rotation. As in the Test 2.2, residual cracks started becoming comparable to the maximum observed at this beam rotation level. Some sliding with diagonal cracking was observed at the wet joint close to the mid-span. Residual (static) cracks between 0.1 mm and 6 mm in width were observed at the end of the test.

Cracks 0.1 mm wide were observed at 0.1% “total” beam rotation. Sliding and diagonal cracking was observed at the cold joint, even at such low rotation level. New flexural cracks were observed outside the plastic hinge relocation detail. As in the Test 3.1, residual (diagonal) cracks started becoming comparable to the maximum observed at 1.5% “total” beam rotation level. Maximum cracks of 10mm in width were observed at 2.5% beam rotation. As shown in Figure 8, most of the repaired cracks opened up during the Test 3.2.

Figure 8. Residual cracking pattern observed during Test 3 at 1.5% “total” beam rotation.

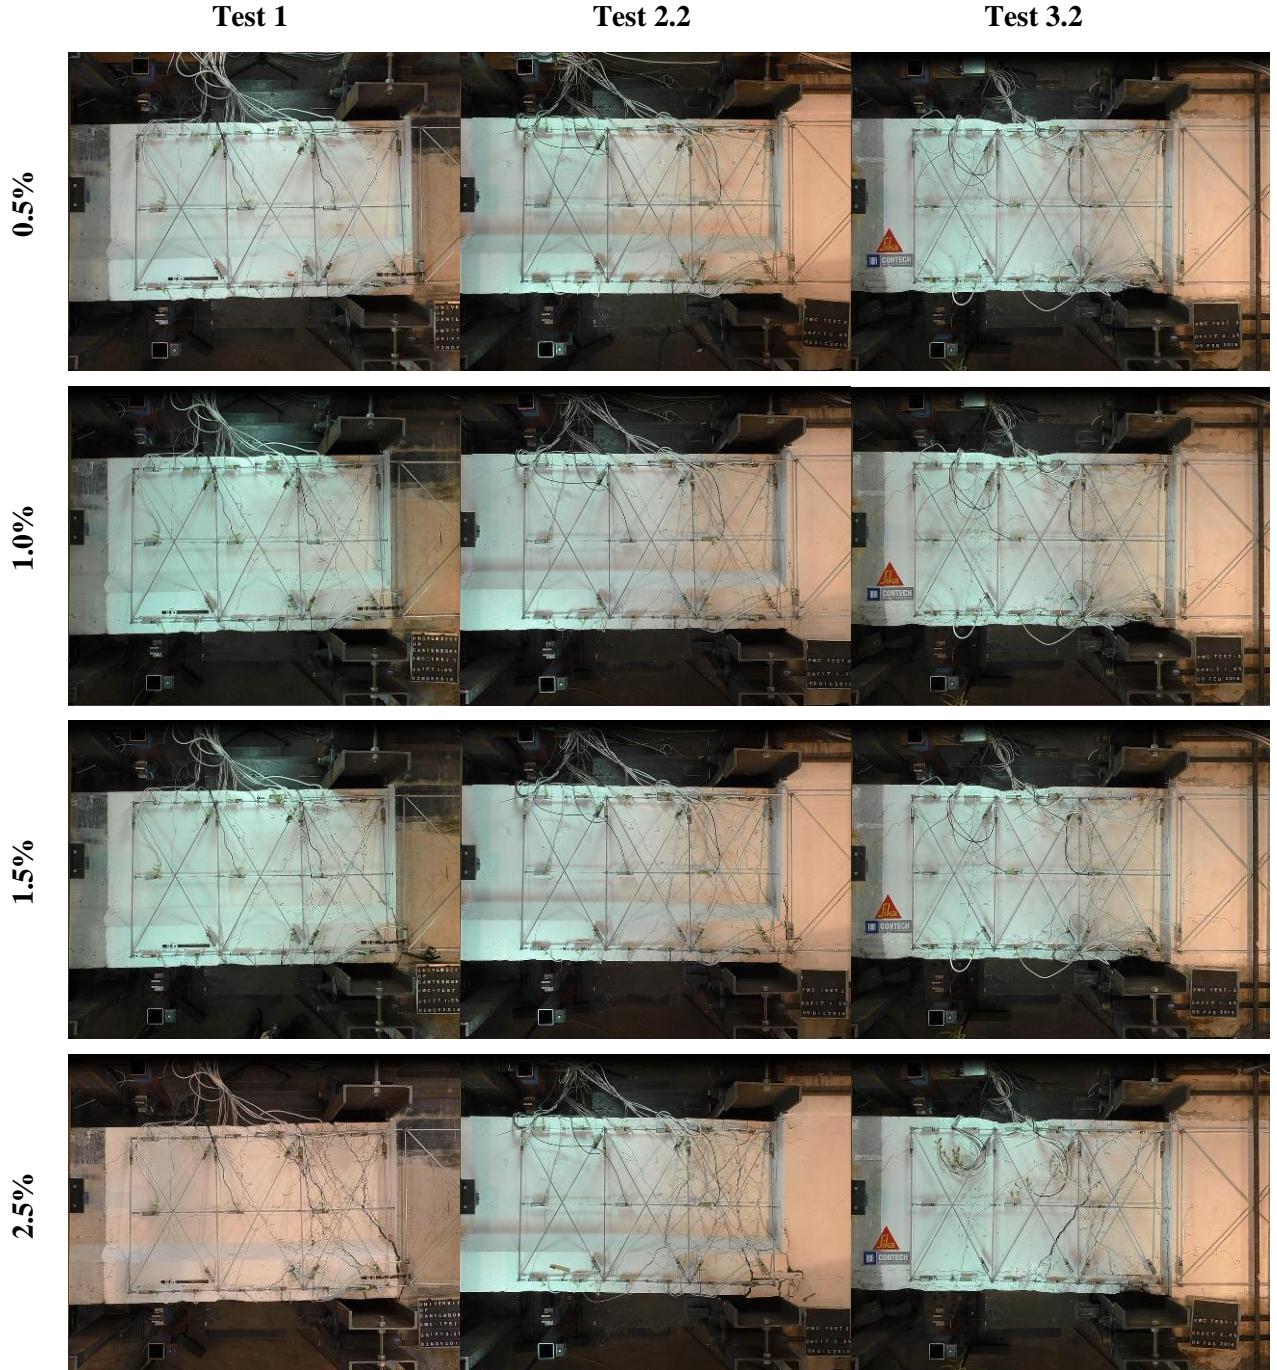
Figure 9 shows cracking patterns in Tests 1, 2.2 and 3.2, at different levels of “total” beam rotation. It is evident that the damage in Test 2.1 is more severe at lower (below 1.5%) rotation levels. Test 1 experienced the most severe damage at 2.5%, while Test 3.2 experienced the less damage at all rotation levels, with some of the damage in the form of flexural cracks outside the plastic hinge relocation detail.

Figure 9. Observed damaged at different beam rotations (in “total” displacement units).
