Behavior of Seismically Isolated Buildings during the 2016 Kumamoto Earthquakes

K. Morita & M. Takayama

Department of Architecture, Fukuoka University, Japan.

**2017 NZSEE
Conference**

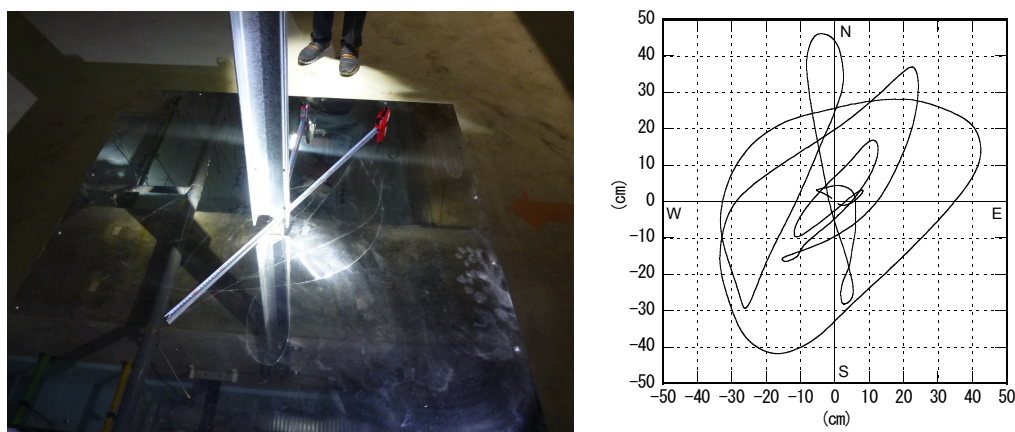
Figure 1. A scratch plate and an orbit of Medical Facility M

The seismograph station K-NET Ichinomiya, located close to Medical Facility **M** in Aso City, measured a seismic intensity of 6-lower during the main shock. The record on the scratch plate in the isolation level of Medical Facility **M** immediately after the foreshock showed a locus smaller than 5 mm in diameter. A single amplitude of 46 cm was recorded during the main shock, which indicates its severity. Also, the dominant period of the seismic motion measured at K-NET Ichinomiya was 3 seconds, and the amount of deformation of the isolation level estimated from the displacement response spectrum was well over 1 m. The large difference between this and the response deformation at the medical facility in Aso City requires investigation.

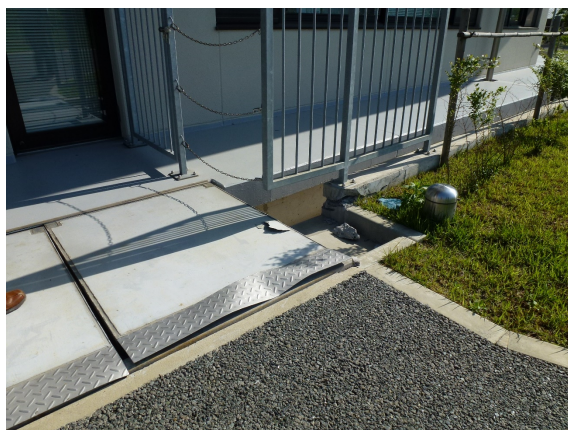
The Kumamoto earthquakes revealed several problems. In almost all of the buildings, we found that the expansion joints and gap covers connecting the seismically isolated building with seismic-resistant buildings were deformed. Figure 2 shows a deformed gap cover. During an earthquake, the expansion joints move without interfering with the movement of the seismically isolated building. However, when they are subject to large forces or move more than expected, the expansion joints and the gap covers may become deformed, although this does not impair the performance of the seismically isolated building. During the Kumamoto earthquakes, some of the joints showed greater deformation than expected, but there were no problems in terms of use.

Figure 2. A deformed gap cover

Compared to when seismically isolated structures first started to be employed in buildings, the gap covers installed near building entrances have become more sophisticated. They allow completely barrier-free access, and recently many are designed to make it look as though the building is not seismically isolated at all. However, some of the expansion joints and gap covers appeared to have suffered excessive deformation due to a lack of consideration by the designers, who appeared to have forgotten that “during an earthquake, there will be relative movement between the seismically isolated building and the ground surface or the seismic-resistant building.”
