# Seismic strengthening of a category 1 Heritage Building – St Mary of the Angels Wellington

A.G. Taylor & A.G. Park

*Clendon Burns & Park Ltd, Wellington.*

2017 NZSEE  
Conference

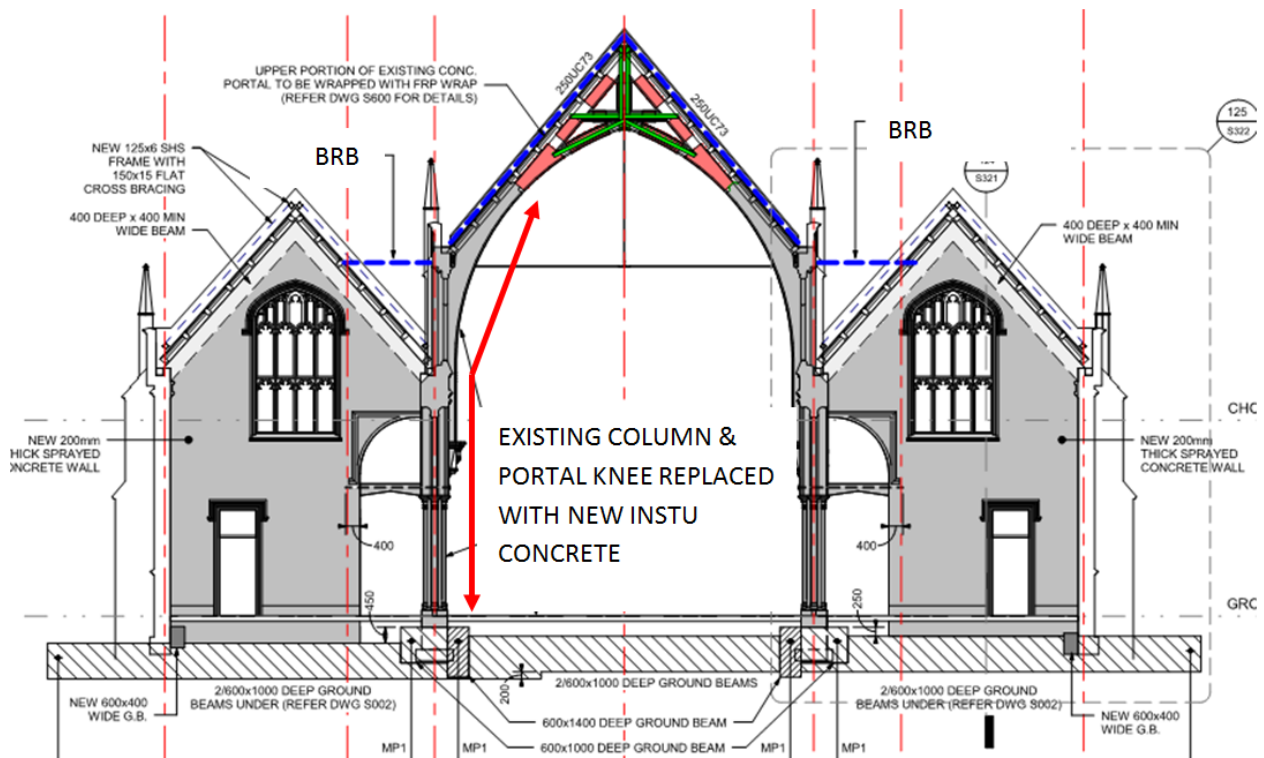
Figure 5. Section through Church at side chapel gable end wall location

As a new lateral resisting systems had been established the existing gravity system also had to be capable of withstanding lateral movement induced actions. A large part of this system was the concrete portals and internal gravity columns. Due to the very nominal amount of reinforcing steel present and the inadequate detailing a risk of damage and collapse was found. As such various strengthening options were investigated, however in the end it was agreed to replace the existing columns and portal knee joints with new insitu elements that had new well detailed reinforcement. The use of the point cloud information gave the contractor a re-usable formwork that took into account the unique column detailing, so that the reinforcing could be maximised, and reduce the amount of finishing works required. The top part of the portals were kept and strengthening with FRP (fibre reinforced polymer) wrap, with connected to the steel roof diaphragm using bolted connections through the depth of the portal. Lateral resistant of the top of the columns and bottom of the portal legs was done using steel x-braced diaphragms to the side aisle and side chapel roofs.

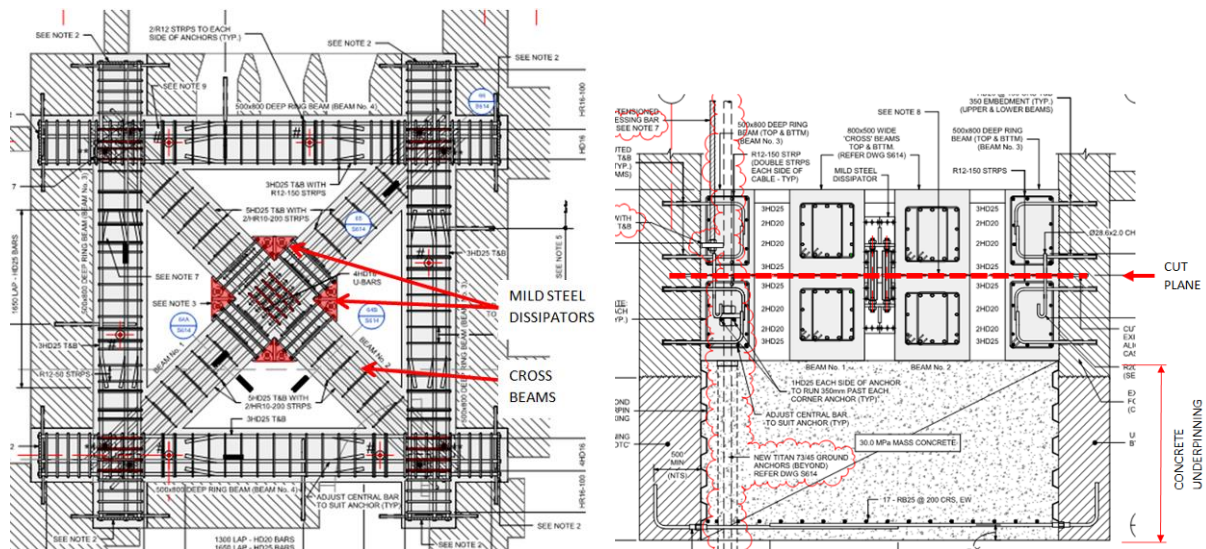
Figure 6. Typical plan and section through tower foundations

Located to the front of the building the two towers, either side of the main church entry, are in the order of 25-30m high, from the crypt floor, and are only approximately 3.5-4.0m square. The existing foundations were found to be no larger than the tower walls.

It was proposed to strengthen the foundations to give a rigid block to which a rocking tower arrangement could be sort. By installing two levels of beams, the bottom to be part of the foundation, the top level to be part of the tower, a cut to the original tower walls gives a rocking plane. To help with energy dissipation plug & play mild steel dissipaters were installed to the centre of the towers, by using a series of cruciform beams. The dissipaters bridge the rocking/cut plane between the two levels of beams, to give energy dissipation that will work in all directions of the tower rocking. The rocking

arrangement gives a low-damage structural arrangement for the towers, where the energy dissipation can be replaced if required in the future.

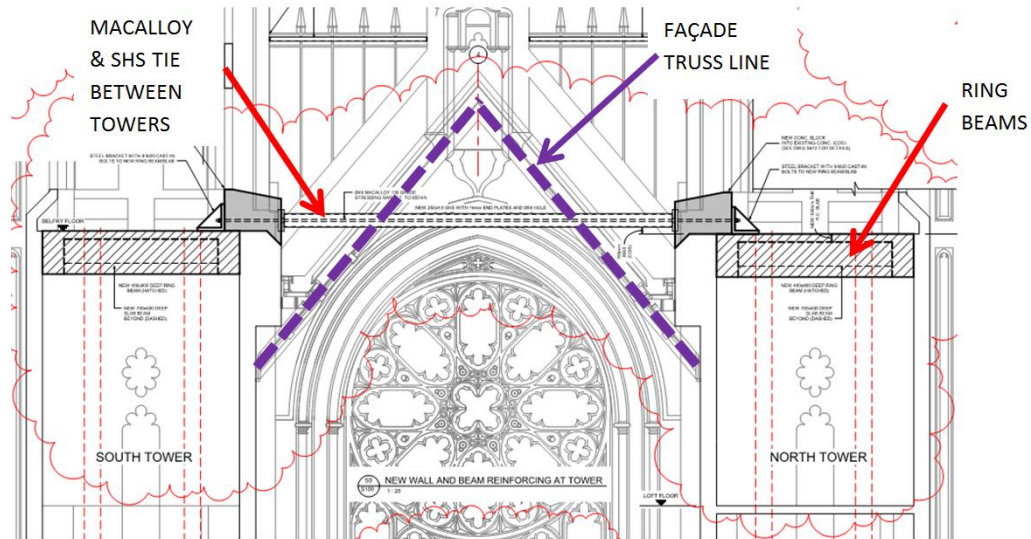
Figure 7. Top of towers and front façade elevation indicating main structural components

The top of the towers had steel braces installed as part of the previous strengthening. This was adequate for elastic actions to the top of the towers. As the two towers are separated by the main entry a tie between the towers across the front façade was installed to ensure that the towers would keep in phase with each other and reduce the risk of collapse to the front façade. A tie was located between the two Belfry slabs, with a Macalloy stressing bar tie to the centre of a large SHS strut. The Macalloy bar is designed to take the tension tie loads and the SHS strut will take the compression forces. The SHS was not connected to the towers but has steel bearing plates so that it can rotate without damage, therefore giving a low-damage arrangement.

The front façade between the towers consists of a large rose window within the gable end of the main nave roof. The gable end has two skins of concrete walls. As such the top of the wall skins were tied together with a new steel truss that will restrain the top of the front façade spanning between the towers, along the sloping roof lines.
