# Exemplar seismic retrofits of Christchurch URM buildings

2017 NZSEE  
Conference

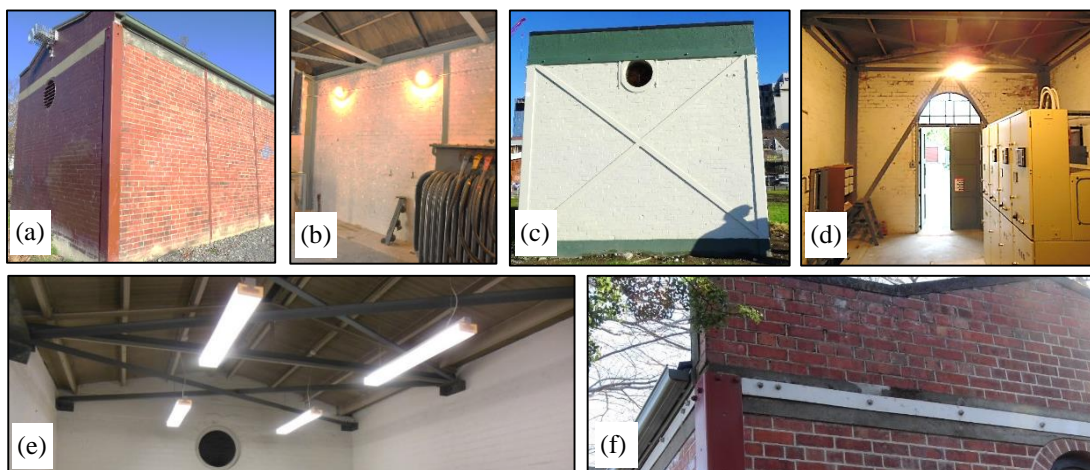
Figure 1. Orion Power substation wall and roof retrofit examples: (a) External vertical steel plates and angles; (b) Internal vertical steel plates and angles; (c) External diagonal steel plates; (d) Internal diagonal steel plates; (e) Typical roof bracing of flexible diaphragm; (f) Steel plates mounted on perimeter beam.

corners and vertical steel plates were located at intervals along the walls of the buildings (Figures 1a, b, c, d), with diagonal steel members generally mounted at the entrance and on the rear walls (Figures 1c, d). Frames were connected to the walls with anchored steel ties. Roofs were strengthened by either installing steel bracing across the roof diaphragm (Figure 1e), bolting steel brackets to purlins, or mounting steel plates on perimeter beams at eaves level (Figure 1f).

Most of the buildings survived the Canterbury earthquakes with minor damage and only four of the substation buildings were severely damaged (Massie & Watson, 2011). Power was restored to 90% of customers in one day following the 4 September 2010 earthquake and to all customers in ten days following the 22 February 2011 event. NZ\$6 million was spent over fifteen years to strengthen the substation buildings, with an estimated cost of NZ\$21,000 per building. Orion was assessed to have saved approximately NZ\$60 million in direct asset replacement costs following the Canterbury earthquakes (Orion New Zealand Limited, 2012), and the community benefits associated with having the power only briefly being interrupted following the Canterbury earthquakes was clearly profound.

Seismic retrofit work on the substation buildings began in 1996 and progressed systematically for fifteen years. Walls were strengthened in-plane and out-of-plane with internal or external steel braced frames consisting of vertical and diagonal steel members. Vertical steel angles were commonly placed at the

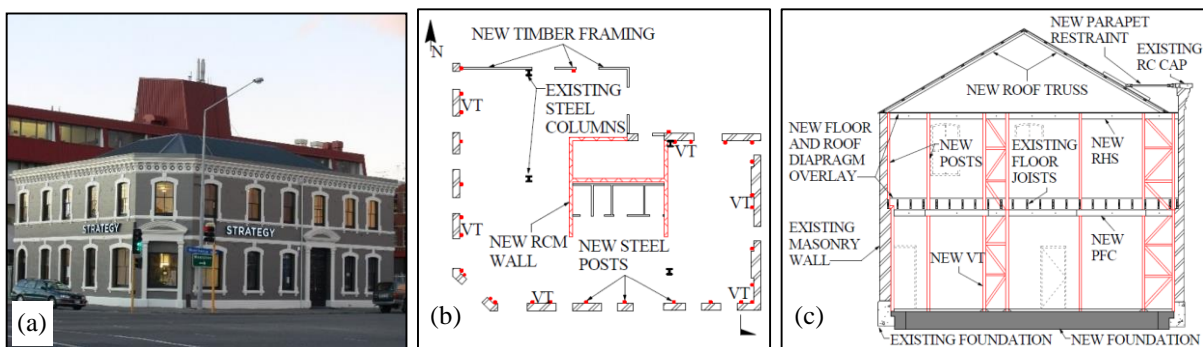
Figure 2. Retrofit of Grosvenor Tavern, 367 Moorhouse Avenue: (a) Exterior view of southwest corner after retrofit; (b) Ground floor plan showing retrofit, VT = vertical truss; (c) East elevation showing retrofit.

The first stage of retrofit work had been completed when the September 2010 earthquake occurred. The brick façade experienced only minor cracking and no further damage was reported. The seismic strengthening aspects of the building were installed before the February 2011 earthquake, including the vertical steel trusses, concrete block shear core, and new timber roof trusses, and no damage was reported in that earthquake. Steel trusses remained attached to the masonry walls, there was no cracking in the RCM walls, and there was no differential movement observed between the walls and floor diaphragm.

Work on the seismic retrofit of the former Grosvenor Tavern began when new owners purchased the property in 2010, after the building had been vacant for nine years. The first stage of the seismic retrofit involved reducing the seismic weight of the building by removing heavy clay roof tiles, lath and plaster on the interior walls, and two single storey concrete block annexes. The second stage of the retrofit combined several methods to seismically strengthen the building. Vertically oriented steel trusses were installed along the interior of the existing brick wall. New RCM walls were constructed to surround a new centrally located stair case and were topped with a concrete lid so that the area would act as a shear core. New exterior timber framed walls were installed to replace decaying timber framed walls on the north end of the building. New floor and roof diaphragms were installed over existing flooring and the parapet was restrained. (Figures 2b, c).

The use of vertical steel trusses and posts as a retrofit solution allowed the interior brickwork to be maintained. On the building exterior, heritage features of the façade were accentuated by being painted a bright white against the grey paint on the masonry (Figure 2a). The vertical steel trusses and posts are evenly spaced between windows in order to retain views from the building. Windows in the new timber walls are detailed such that they are nearly identical to the façade windows. The building was awarded a Civic Trust award in 2011 for significant restoration of a heritage building and for the maximisation of complimentary use of a heritage building (Christchurch Civil Trust, 2011).

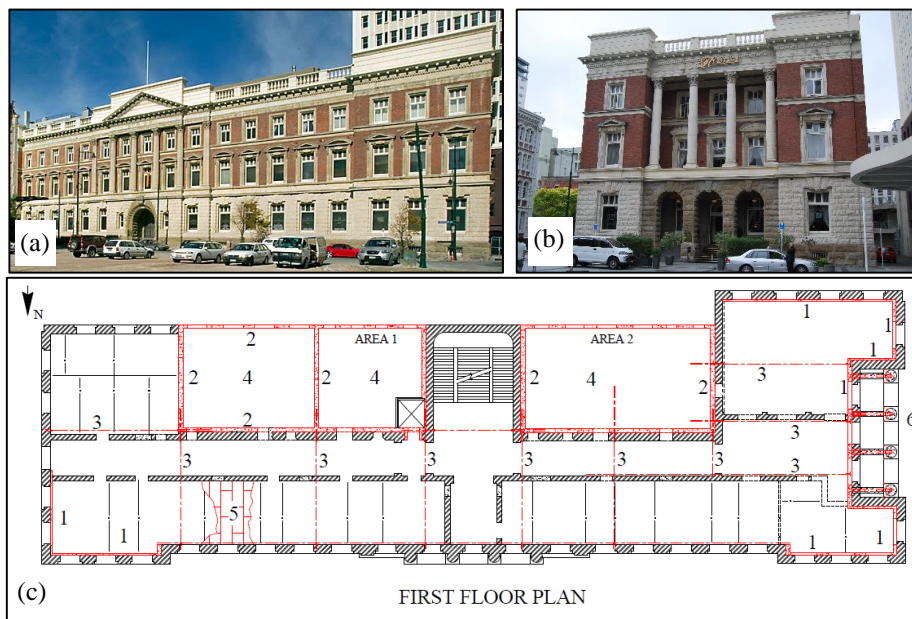
Figure 3. Retrofit of the Heritage Hotel, 30 Cathedral Square: (a) Exterior view of north elevation; (b) Exterior view of west elevation; (c) First floor plan. 1. New concrete skin walls; 2. New concrete shear walls; 3. New steel floor ties; 4. New hollow core concrete flooring; 5. New plywood overlay to existing flooring (typical); 6. Prestressing cables at centres of existing masonry columns

The building suffered only minor cracking in the September 2010 earthquake and required minimal repairs. The February 2011 earthquake caused minor cracking in the URM walls, minor cracking in the south elevation core wall, some damage to external stonework, and flooding in the basement. Overall, the building behaved as expected, with a majority of the forces transferring to the shear core. Repairs were made following the earthquakes, and further strengthening was not necessary. The building likely would have remained operational following the earthquakes, but damage to neighbouring buildings prevented its reopening until later in 2011.

Seismic retrofit work was undertaken in 1995, after Christchurch City Council purchased the building to prevent its demolition. The initial project scope called for the building to be strengthened to 67% NBS (IL 3) in 1995. Two strengthening strategies were proposed, and for minimal (approximately 2%) extra cost, designers determined that the building could be strengthened to 100% NBS (IL 3). The seismic design required partial demolition of the building (Area 1 and Area 2 in Figure 3c). RC shear walls were constructed to act as shear cores in these areas. Detailing of the foundation beams under the new lateral load resisting elements utilised the full capacity of existing piles.

The existing flooring was strengthened with a new heavily nailed plywood overlays, and hollow core concrete flooring with a 100 mm topping was constructed in the new shear core areas. The timber diaphragms were tied to the shear cores with heavy steel flats running through the floor and into the shear walls (Figure 3c). The roof was strengthened with a RC topping over an existing lightweight concrete slab from a previous intervention and a concrete bond beam was cast around the perimeter of the roof. The stone columns of the west façade were diamond cored full height and lightly stressed prestressing cables were cast in to control cracking of the stone columns (Figure 3c).

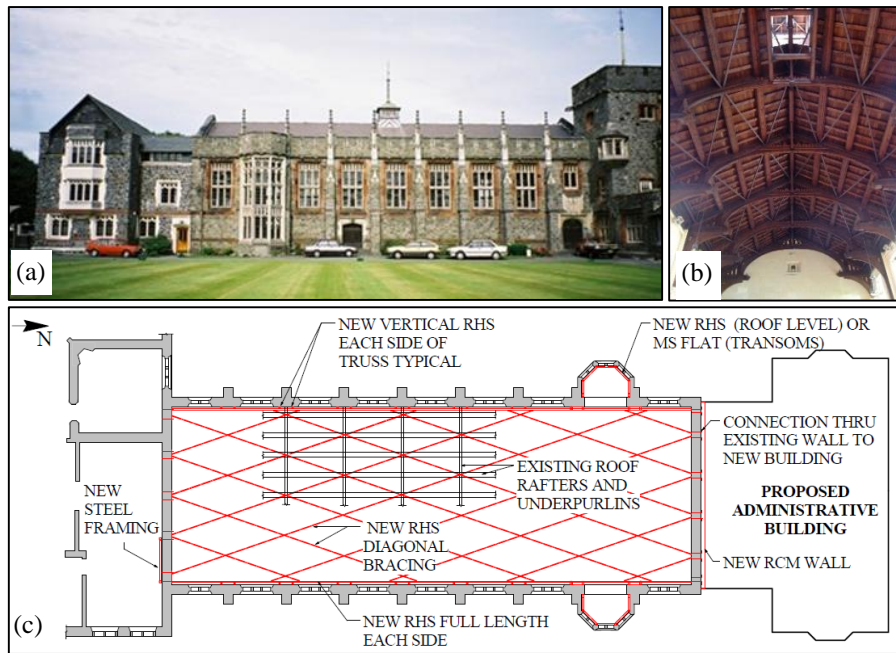
Figure 4. Retrofit of Christ's College Memorial Dining Hall, 33 Rolleston Avenue: (a) Exterior view of west façade. Taken by Melanie Lovell-Smith, NZHPT; (b) Interior view of roof strengthening; (c) Plan.

No damage was reported following the September 2010 earthquake and only minor damage was reported following the February 2011 earthquake. Some welds on the diagonal roof bracing fractured, but overall the bracing successfully tied the building together. A wall of an adjacent building damaged a wall of the Dining Hall due to pounding effects. Other reported damage included minor cracking to stonework, particularly around the windows, and damage to pinnacles. Damage to the windows was not unexpected because only the transoms were strengthened in the retrofit, and the mullion strengthening had been deferred for cost reasons. There was also settlement of the heavy stone walls. Overall, the damage did

The Memorial Dining Hall was seismically retrofitted in 1988 as part of the college's ongoing effort to upgrade their buildings. Diagonal steel braces made of rectangular hollow sections (RHS) were fixed between roof trusses. The braces were connected to the east and west walls of the building by a new RHS that extends the full length of the walls and connected to the north and south walls with bolts through the existing walls (Figures 4b, c). A new reinforced concrete masonry (RCM) wall was constructed on the north wall as part of the proposed administrative building, and a new vertical steel truss comprised of RHSs was constructed on the south wall (Figure 4b). Vertical RHSs were installed internally on each side of the trusses and epoxy anchored into the existing walls. The oriel-bay windows were secured with a new RHS at roof level and mild steel (ms) flats were bolted to stone transoms. The parapets were braced, and the pinnacles were taken apart, pinned, and secured to the roof.

not disrupt use of the building, and repairs such as repointing of mortar and releveling of the floors were made soon after the earthquake.
