Performance of Concrete Buildings in the 2016 Kumamoto Earthquake – Can NZ learn from others?

**2017 NZSEE
Conference**

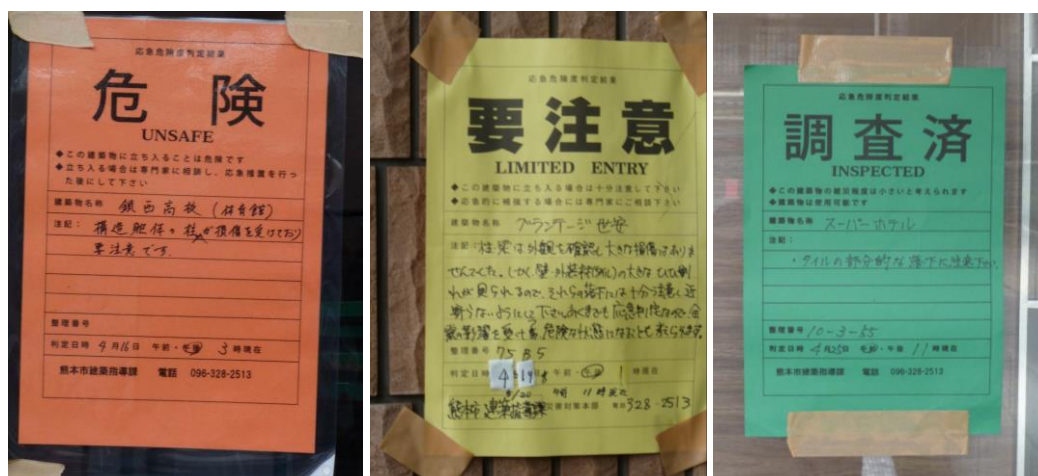
Figure 3. Post earthquake inspection placards Kumamoto City

Unlike the New Zealand system however, the building tags are advisory only, and although they were generally observed by the public, this is not strictly enforced. Fencing around damaged buildings was relatively limited in nature compared with those erected in New Zealand reflecting the advisory nature of such notices. This approach allowed owners and tenants to enter and occupy yellow and red placarded buildings post-earthquake if they wanted. The reconnaissance team observed people retrieving belongings from damaged buildings during our visit and even some people occupying yellow tagged buildings.

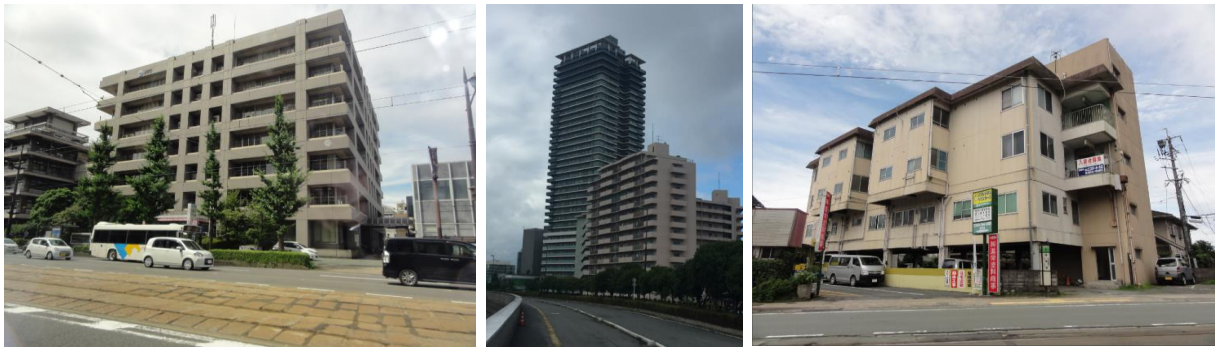
Figure 4. Examples of multi-storey buildings with no damage.

Multi-storey concrete and steel buildings generally performed very well, most enabling immediate occupancy after the earthquakes. Damaged multi-storey buildings were generally constructed prior to 1981, when the Japanese Building code was updated following the 1978 Miyagi Earthquake.

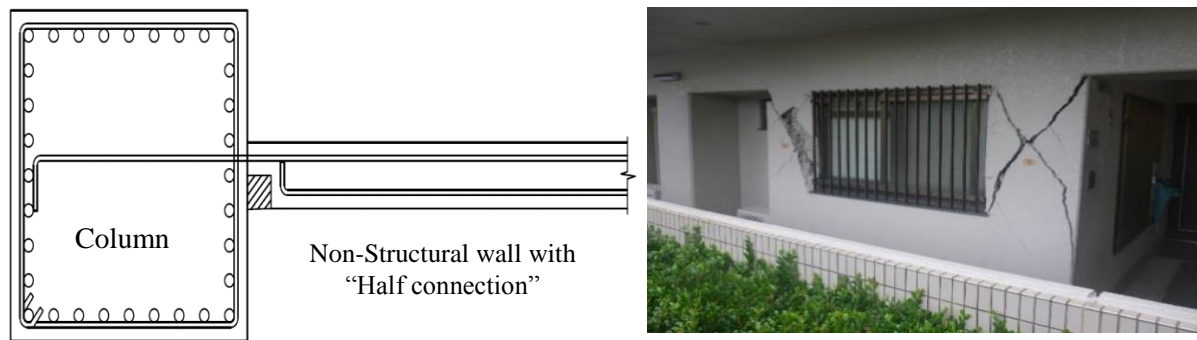
A common observation in modern multistory reinforced concrete residential buildings was shear failure in “non-structural walls”. These non-structural wall components were made of reinforced concrete and were commonly tied into the structural system with what Japanese designers referred to as “half connections”. This connection is shown in Figure 5, where only half of the thickness of the wall has reinforcement extending into the lateral force resisting system. These walls are not considered to contribute to the lateral strength of the building during design, but are accounted for when determining the stiffness of the structure. This practice appears to be a contributing factor to the lower ductility behavior of the observed reinforced concrete structures.

Figure 5. Typical Non-structural wall connection and example of damage to “non-structural” wall.

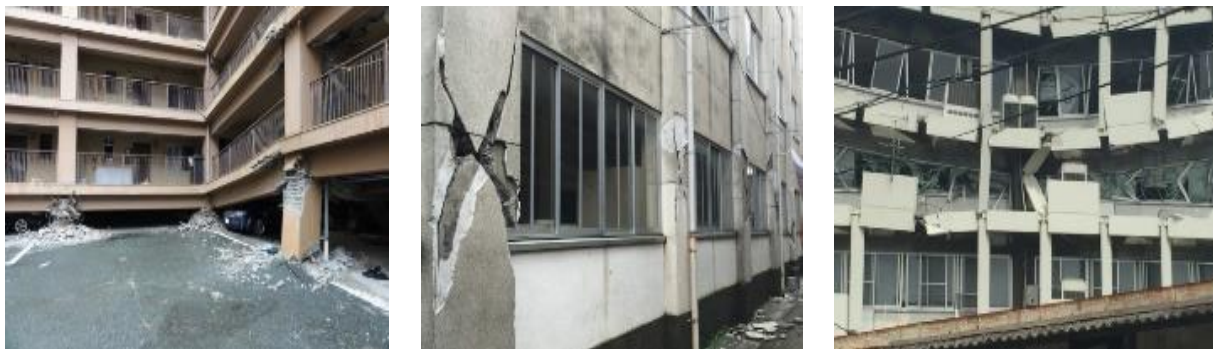
Figure 6. Examples of damage to pre-1980s concrete buildings

Figure 6 provides three examples of pre-1980s concrete buildings with severe damage to columns and beam-column joints. Damage observed in such buildings often tended to be concentrated in the open ground floor, (used for parking) while “non-structural walls” provided additional stiffness on upper stories.

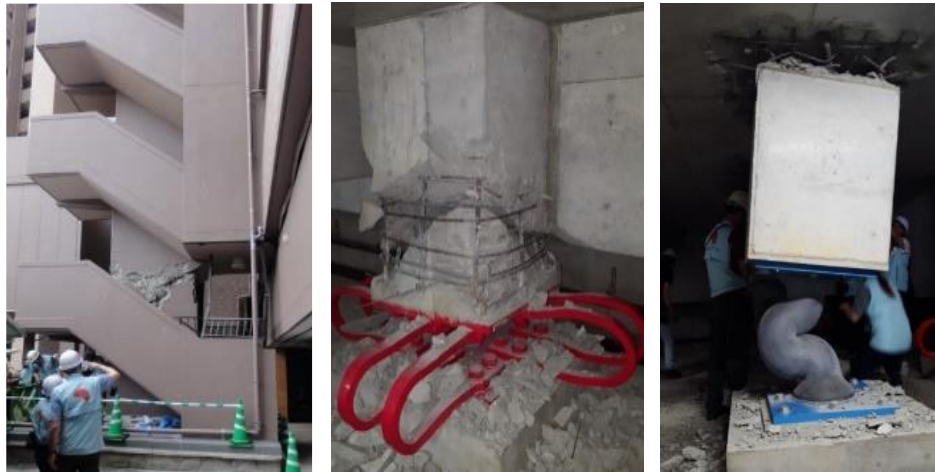
In one building the plane of isolation was generally located on the first floor but with the external stairs extending to ground level supported on a slider. It appears the base of the stair did not slide as intended resulting in significant cracking and damage to the stair concrete walls and associated elements between ground and first floor. Approximately 300mm of residual displacement was observed in this and the adjacent base isolated building. No internal access was gained to either building to inspect any possible damage to the isolators.

Access was gained to the basement area of the third building where the isolators and dampers were located. Observations of the damage indicate that while the main building structure including the laminated elastomeric bearing isolators performed well, due to some unconventional design choices, the structure supporting the damping system, a combination of steel and lead dampers, sustained heavy damage. The stub columns connecting the dampers to the structure above were observed to be significantly damaged along with the ground floor slab in these areas as they were not well connected to the main structural system. Figure 7 provides some examples of the damage observed.

Figure 7. Damage to external stair to one base isolated building, Damage to stub columns at steel and lead dampers to another base isolated building.
