The Christchurch Club rebuild and restoration project

F.C.Cooke-Willis & J.B Heenan

Beca Ltd., Christchurch

2017 NZSEE
Conference

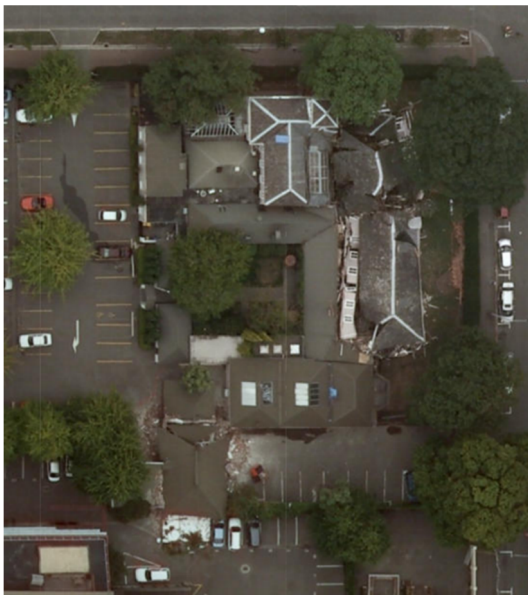
Repairs to the Latimer wing were underway during the Christchurch earthquakes of 2011 and the wing collapsed. The Mountfort building suffered extensive damage.

The collapse of the Latimer wing was unusual in the respect that all of the main heavy elements had been removed from the building including a portion of the lath and plaster lining. The experience from the Christchurch earthquakes suggests typically light weight timber frame buildings do not collapse under reasonably high levels of ground shaking. In this instance the building was a two storey light weight timber frame structure with a medium / heavy roof with light weight wall cladding. Collapse would not normally be expected. The lateral load capacity of the original timber framed walls was provided by a continuous diagonal brace between the top and bottom plates, with the studs framed above and below the brace, and the in plane capacity of the lath and plaster wall lining. The internal lath and plaster had been partially removed for repairs after the September 2010 event, along with the heavy chimney elements. With no continuity of the studs between the top and bottom plates, and the connection between the top and bottom plates and the brace unable to sustain significant tension actions, the walls under repair at the time of the February 22 2011 earthquake are considered to have had little lateral load capacity even with the significant reduction in building mass.

Figure 5: Aerial image of club showing collapsed Latimer wing (Canterbury maps 24 February 2011)

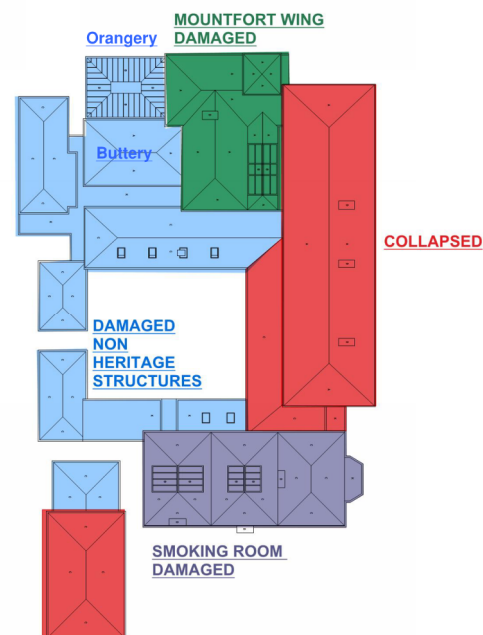
Figure 6: Plan of club showing state of buildings post February 2011 Christchurch earthquake. (background Warren and Mahoney 2012)

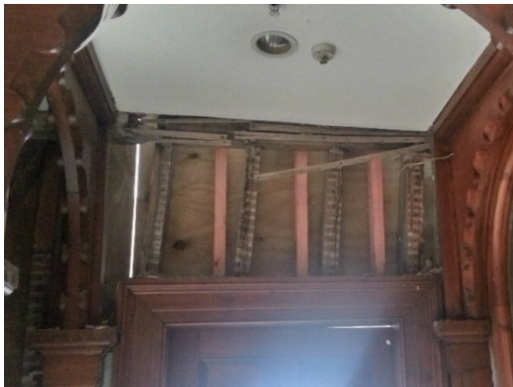
- Damage to lath and plaster walls, and ceilings
- Ground settlement and spread
- Diaphragm disconnection (Wall bottom plate to timber floor connection)
- Cracking, spalling and dislodgment of bricks from URM piles, cellar walls and fireplaces
- Connection failure for the Timber beams supporting the tower water tanks
- In some of the timber framed walls the jack studs had displaced.

Figure 9: Jack studs in timber walls displaced

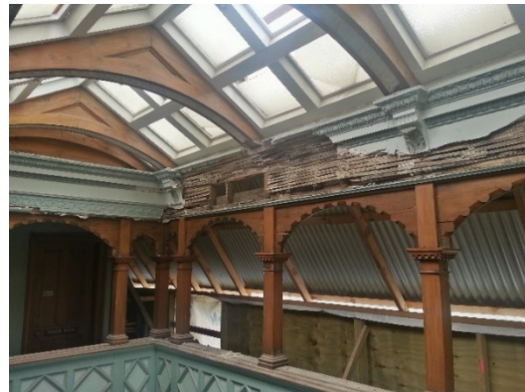
Figure 10: damage to lathe and plaster linings in atrium

The condition of the building after the earthquakes required that the building be completely relined to reinstate the damaged lath and plaster linings. Combined with the degradation of the timber framing throughout the building, replacement of timber members was required, which in turn is undertaken using modern construction techniques and materials. Any new timber introduced to replace degraded timber or to strengthen existing framing was provided as treated timber where the existing timber was not treated. The section sizes in the original construction were not typically comparable to that currently available which resulted in bespoke timber sections having to be procured for the project.

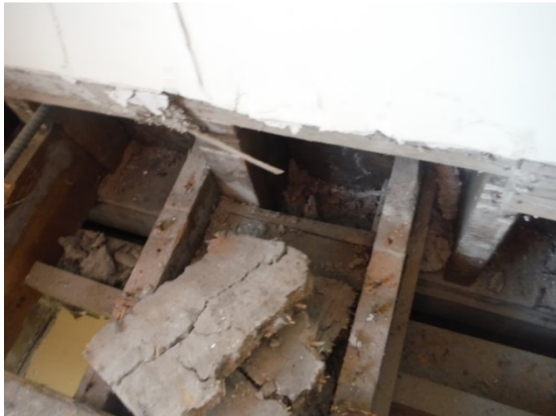
1860's in-floor acoustic insulation was found in the floor cavity between the timber floor boards and the lathe and plaster ceiling. Supported by an intermediate level of timber battens, the insulation was approximately 40mm deep and appeared to be a mixture of straw and dry pugging. Not only did this add additional mass to the structure but made removal of ceilings more difficult for the contractor and presented some health and safety risks.

Figure 11: 1860's In floor insulation

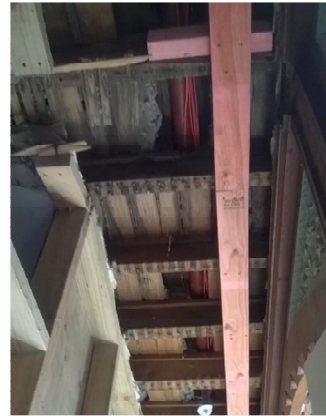
Figure 12: Underside of floor with ceiling removed. Timber battens supporting insulation visible

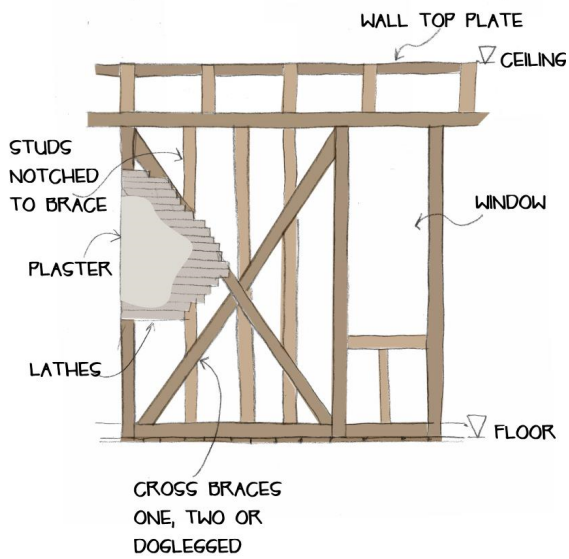
The framing of the 150 x 75 and 150x 50 (neat) walls appears to have been dictated by construction stability. The wall's external studs and a diagonal brace were erected first, creating a stable construction frame. The internal load bearing studs were then cut to suit each side of the brace and doweled into the main diagonal brace. The studs are connected to the plates with a mortise and tenon type connection with the floor joists bearing on the bottom plate between the studs and no plate provided above floor level and no blocking between the floor joists and the studs. The lateral load path at this connection is tenuous and the ability to transfer out of plane loads from the wall construction to the floors is limited and some displacement was observed.

Figure 13: Schematic of typical wall construction

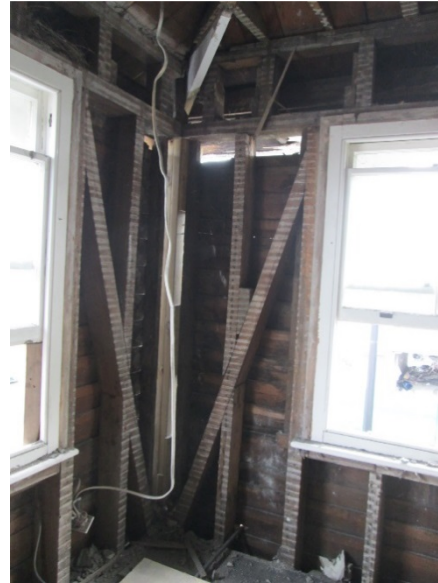
Figure 14: wall framing on first floor

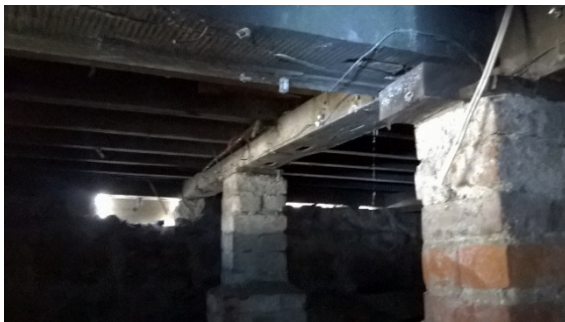
The wall framing extended below the floor level to the bottom plate where this typically was supported directly on the bearers. The bearers were irregular in both size, orientation (flat/edge) and spacing. The bearers were then packed out to URM piles- which although were at regular spacing's, varied in width and height due to an uneven ground space. There had been a number of extensions and alterations to the Mountfort building at ground floor level with no regular layout of subfloor framing adding to the instability of the sub floor framing.

Figure 15: Foundation system – bearers and wall bottom plates all of different sizes (note the packing off the piles), supported on URM piles.

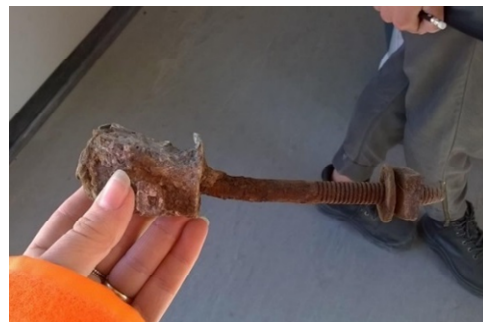
Figure 16: Bottom plate to foundation 'chemical' anchor system.

The external wall bottom plates bear directly on the perimeter stone foundation beam. The connection into the beam was an innovative 1860s, 'chemical' anchor system. A hole was chiselled into the stone beam, an apparent molten lead was used to fill it and the bolt was cast in.

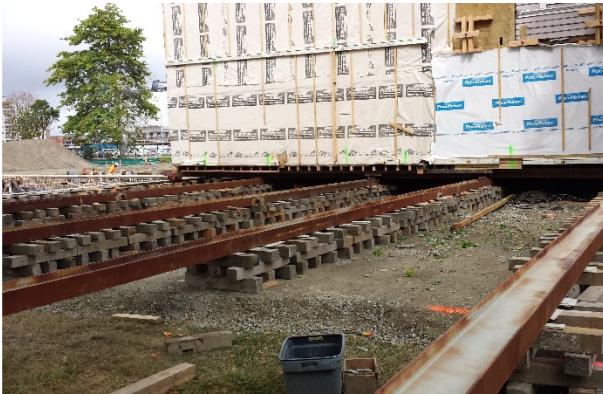
Figure 17: Shifting beams set up on dunnage

Notably the shifting of a damaged 150 year old structure is not without challenges. The building needed to have significant temporary strengthening for the shift and for the period of construction prior to it being moved to its final position. Due to the concern regarding the floor to wall connection, tie rods were tensioned through the building to prevent lateral spreading of the walls due to the lack of connection and discontinuous studs. Continuity of the floor diaphragms was extended over the entry atrium and some additional temporary ply bracing walls were introduced to the building to provide an additional degree of resilience with respect to the shifting stresses expected. Typically all of the existing wall linings were maintained prior to the shift

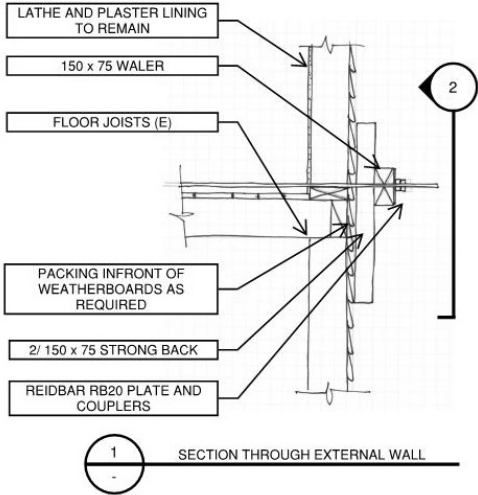
Figure 18: First floor temporary works detailing for Reid brace floor diaphragm.

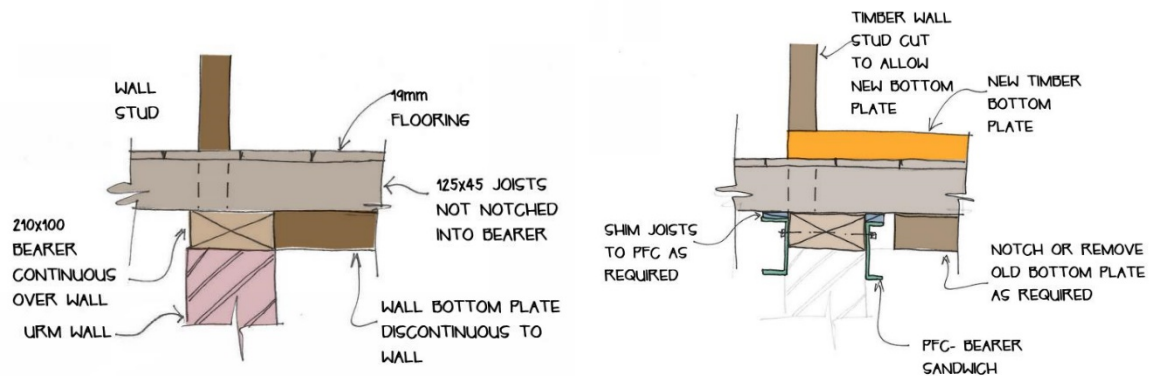
210 x 100 continuous bearer, joists unnotched existing (left), strengthened (right)

Figure 19: Schematic examples of subfloor framing variations and strengthening

The existing bearers needed to be strengthened to fit the new foundation beam spacing. Extra flexibility in the design was required due to the inconsistencies in the subfloor. The solution came in the form of two steel PFC’s sandwiched to the existing timber bearers. Figure 35 below illustrates the variation in the subfloor framing and the solution proposed
