2019 Pacific Conference on Earthquake Engineering

The consequences of ‘mostly’ base isolating a building

G. Cole, H. Tatham & R. Jury

Beca Ltd, Wellington.

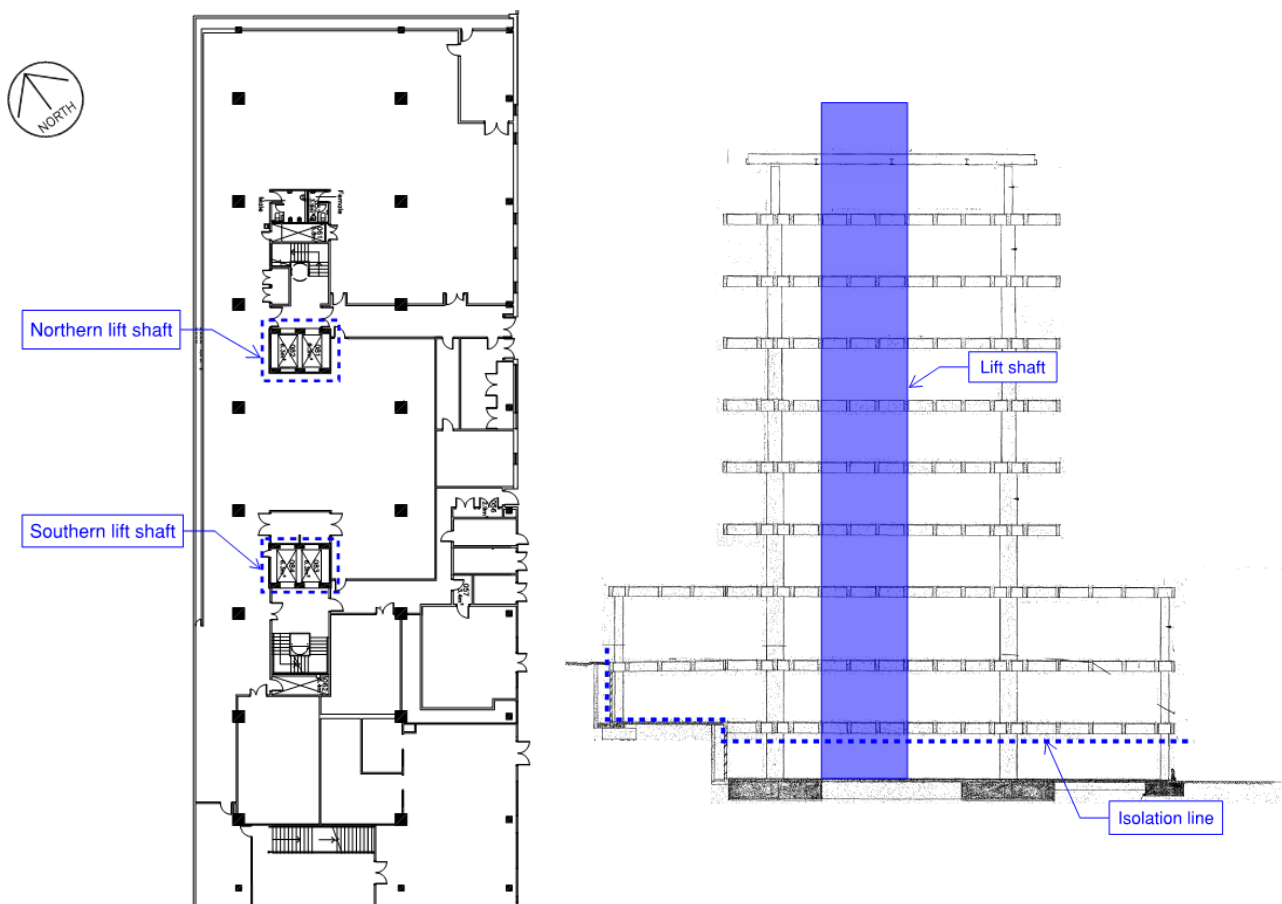
Figure 1: Building ground floor plan and transverse section

Rankine Brown was originally constructed in 1960 and is a nine storey reinforced concrete building (Figure 1). This comprises three podium floors and six tower floors. The flooring is mostly post-tensioned waffle slab, with large central columns and smaller perimeter columns.

The building was base isolated via retrofit in 2002 by another consultancy. The base isolation added lead-rubber bearings (LRBs) to the central columns and provided a movement detail to the perimeter columns. This isolation was installed just below the first floor, and included details to permit horizontal moment for the structural elements crossing the isolation plane. However, the two lift shafts in the building were not retrofitted to accommodate movements across the isolation plane.

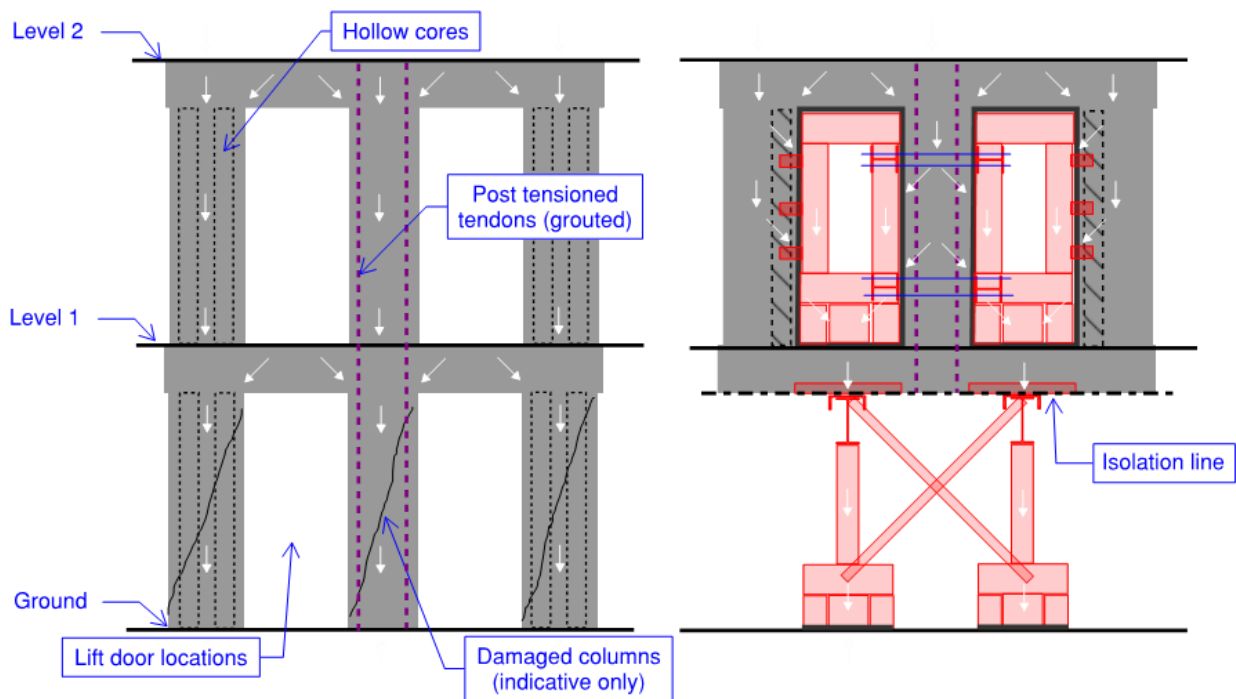
Figure 2: A) Structural configuration of lift shaft. B) temporary shoring. White arrows show gravity loadpath.

The lift shafts are self-supporting structures from a gravity perspective, but rely on the wider building for lateral support. The north and south faces of each lift shaft's structure includes a precast concrete beam at each floor, supported by three columns between each floor (Figure 2A). The gaps between these columns form the lift doorways. The two outer columns contain voids similar to conventional hollow core flooring and are connected top and bottom to the floor level beams by steel flats located on each column centreline. The central column is solid and includes six grouted, post tensioned tendons. The east and west walls of the lift shaft are light weight timber, and are not structural components.

Prior to reviewing the drawings, the damage observed in Rankine Brown following the Kaikoura earthquake did not cause much concern. Large diagonal cracks could be observed in GIB linings at the ground floor around the lift shaft, however the lift shaft appeared to have gravity support by the surrounding RC frame structure at each individual floor. However, once the drawings were reviewed, the importance of these lift columns was realised. After removal of the GIB linings, a large single crack was observed in all twelve concrete columns at ground floor (six in each lift shaft). The damage was consistent with a shear failure in each column, due to the two lift shafts effectively trying to resist the building's entire base shear across the isolation plane. Minimal flexural cracking was observed.

1. An expedited design and construction of temporary shoring which made the building accessible to the public and staff (Figure 2B), but without lift access. This phase was completed (including design, fabrication and installation) within 16 weeks.
2. Design and construction of a new permanent isolation detail for the lift shafts, reinstating lift access while the building remained occupied.
3. Completion of a Detailed Seismic Assessment and strengthening of the rest of the structure to achieve our client's desired %NBS rating.

The provided temporary shoring comprised two floors of structural steel (refer Figure 2B). Where the shoring steel crossed the isolation line at the underside of the Level 1 concrete beam, a sliding surface was provided. To facilitate this, the bottom of the Level 1 concrete beam was armoured with a steel plate. PTFE (Teflon) was attached to the surface of this plate to reduce the induced friction in an earthquake event.
