The Mibar Building - an Architect's and Engineer's perspective on the seismic strengthening of a heritage building

M. Geddes, F. Vessey & C. Ashby

WSP Opus, Wellington.

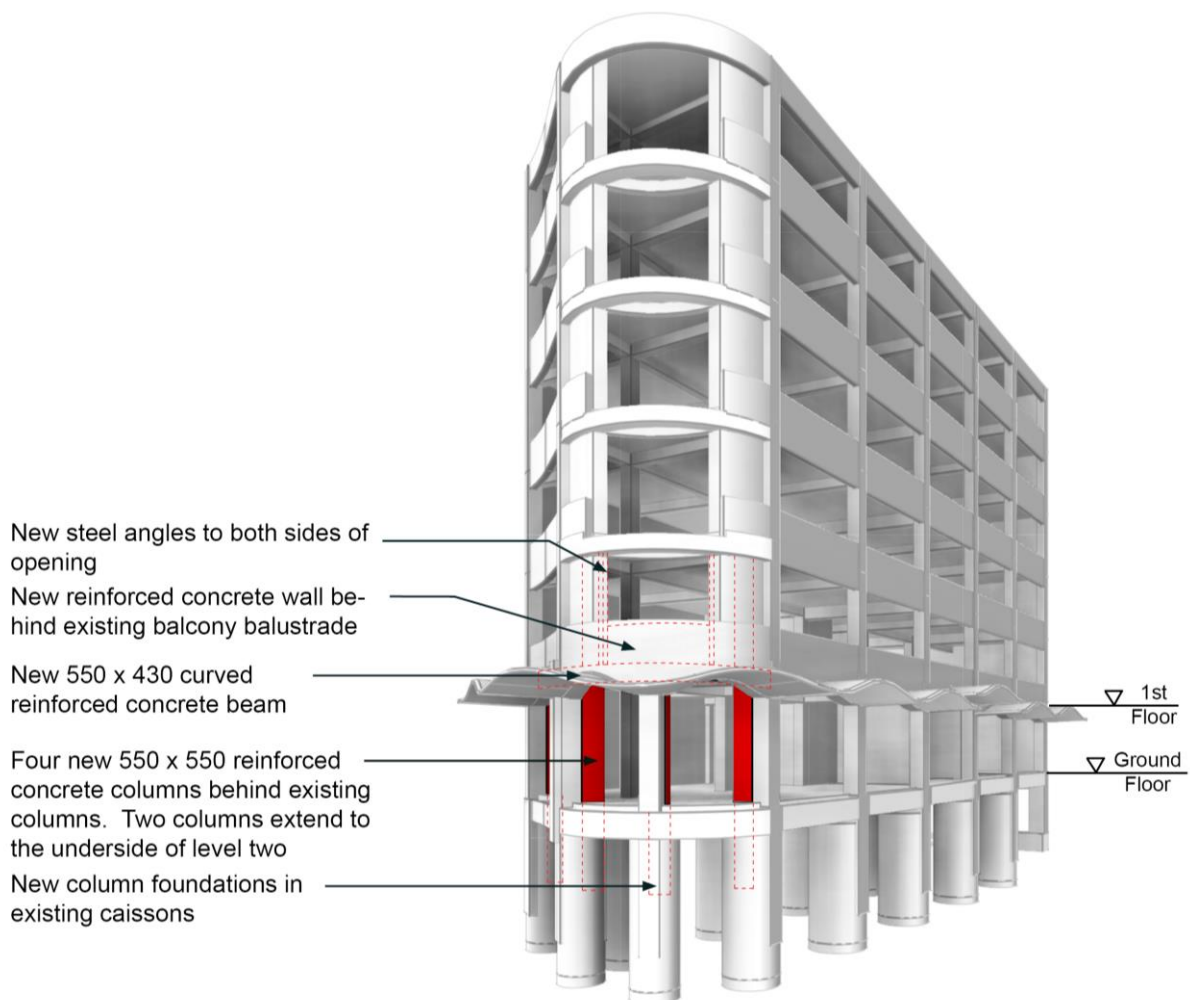
Figure 6: Strengthening Scheme

There are two wall piers on the curved north elevation that help to control the torsional response of the building. The piers go between the roof and the first floor but do not continue to ground; they terminate at first floor on a curved transfer/spandrel beam (Fig. 6). This beam forms a moment frame with four columns that continue to ground floor. The assessment found that these elements are highly loaded and had the potential to fail in shear which would compromise gravity load paths.

The strengthening has removed the critical weakness at the ground floor on the curved north elevation, where the beam and columns had the potential to fail in shear and compromise gravity load paths. As seen in Fig. 6 the work was confined to this relatively small portion of the building. By targeting this weakness the building's inherent strength provided by the numerous shear walls (Fig. 5) is able to be better utilised.

Multiple strengthening concepts were presented to the client and the concept that best met the project requirements was selected. This was to achieve 40-50%NBS by targeting the critical curved north elevation. New concrete elements were overlaid behind the existing columns, first floor beam and balcony balustrade wall, and steel angles bolted to the wall piers (Fig. 6). The demands on one of the concrete columns were such that an embedded steel UC section was used rather than conventional reinforcing.

The strengthened beam and columns are now limited by flexure rather than shear to protect the gravity load paths. To account for potential degradation of shear capacity in existing elements, due to the lack of ductile detailing, we assigned a shear capacity threshold 1.5 times higher than the flexural capacity.

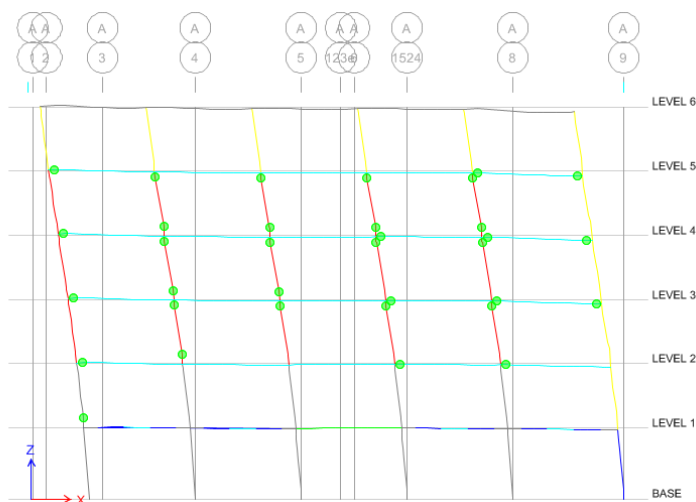
Figure 7: Plastic hinge formation in ETABS model on gridline A

Linear analysis methods were used in accordance with NZS 1170.5 however these were supplemented with a nonlinear static analysis to review the building's post-elastic behaviour. With reference to ASCE 41-13, nonlinear hinges were assigned to the ETABS model at locations with potential to yield. An example of the plastic hinge formation in the longitudinal direction is shown below (Fig. 7).

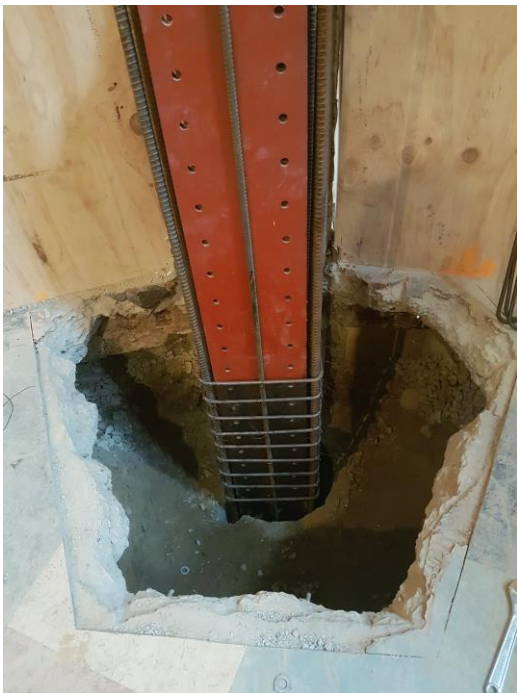
Although it was a reasonably conventional concrete strengthening, several construction challenges were encountered. The caisson that the new steel UC column was to found in was completely filled with concrete; a 500mm dia., 1200mm deep core was drilled and removed with some difficulty to give the UC adequate embedment. Fig. 8 shows the UC seated in the cored hole. Another caisson was letting in groundwater through a crack in its concrete lining. The saturated fill in the caisson was hydro vacuum excavated and the reinforcing placed (Fig. 9). During this time the caisson filled with water again and had to be de-watered.

Figures 8 and 9: Steel UC and reinforcing cored into caisson; Ground water in caisson

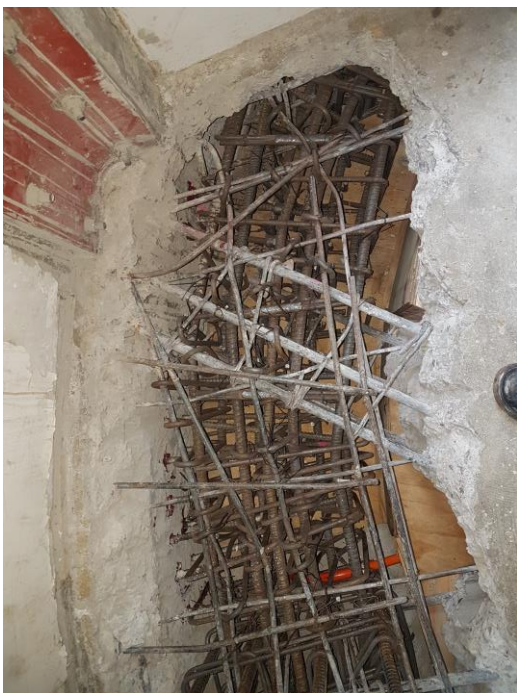
The new curved beam proved to be the greatest construction challenge. Lapped/coupled curved bars, transverse reinforcement and dowel bars at close centres were all pieced together within existing beam reinforcing (e.g. Fig. 10). The contractor aptly described the process as “knitting steel”.

Figures 10 and 11: Looking down on the curved beam; Column reinforcing

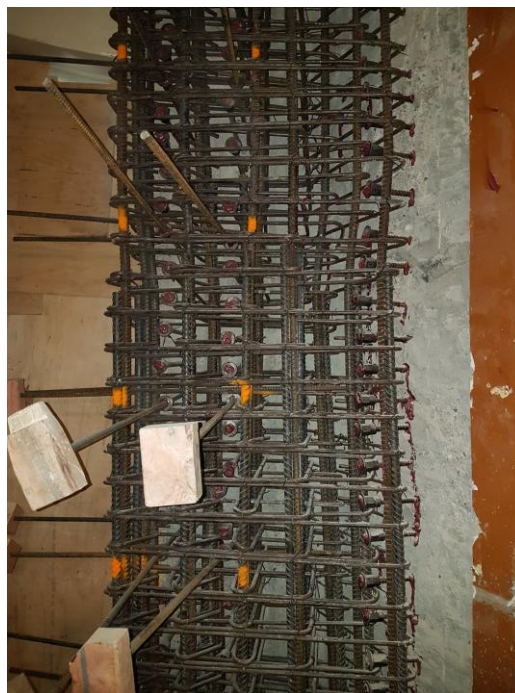
Similarly to the beam, the new columns had substantial transverse reinforcement and dowel bars (Fig. 11) that made conventional vibration compaction difficult. The contractor decided on the innovative approach of pumping self-compacting concrete from the base of the columns. We had seen this method used successfully on another project and this proved to be the case on this project, providing a uniform finish.

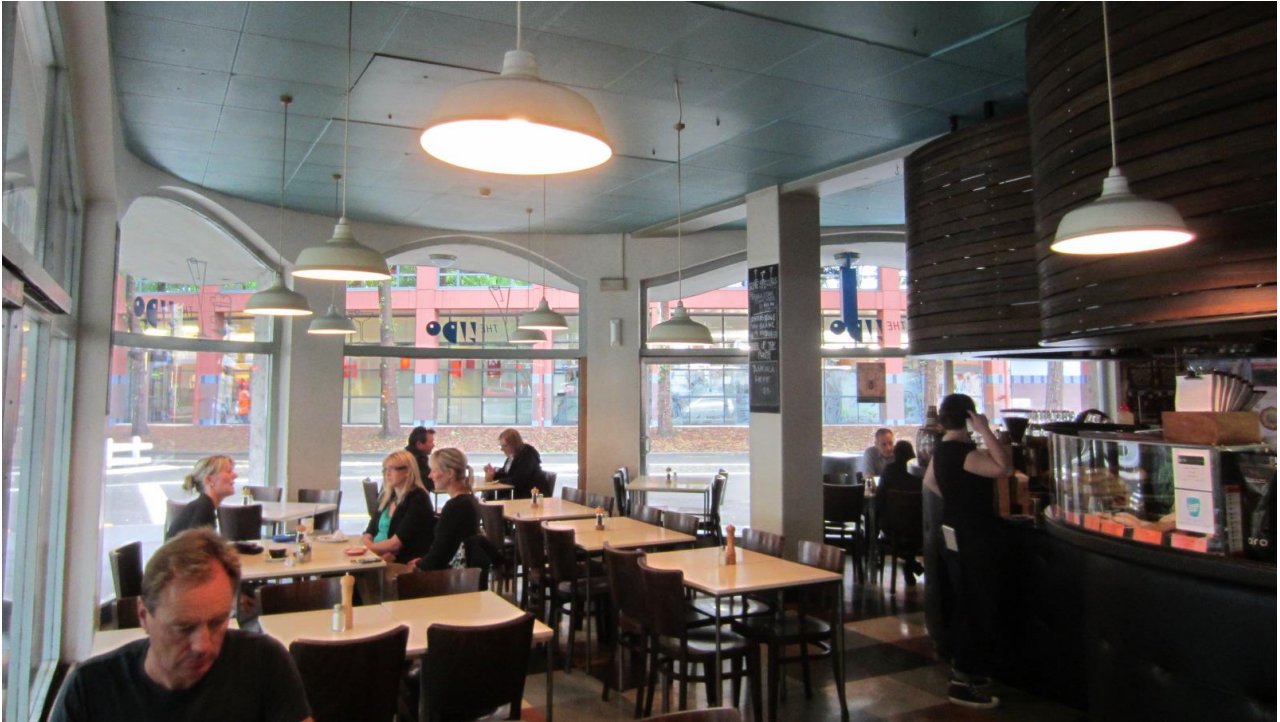
Figure 12: Pre-strengthening view inside Lido Café, ground floor (2012)

Figs. 12 and 13 are ‘before’ and ‘after’ images taken inside the Lido café. Note the new overlay to the perimeter columns which does reduce floor space but enhances the function of the space by providing more privacy for seating arrangements. The old ceiling was removed and the first-floor structure painted, creating a light and lofty feel. The new curved beam is exposed but sits above the arch of the windows, and blends in seamlessly with the existing beams, making it appear to be part of the existing structure.
