NEW ZEALAND SOCIETY FOR EARTHQUAKE ENGINEERING  
**2019 Pacific Conference on  
Earthquake Engineering**  
TURNING HAZARD AWARENESS INTO RISK MITIGATION  
4 – 6 April | SkyCity, Auckland | New Zealand

# Lessons learned and need for appropriate philosophy for the design of stone column ground improvement under seismic scenarios

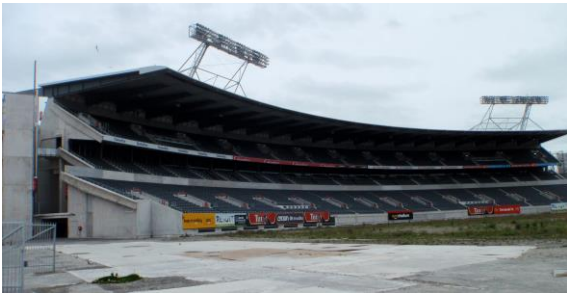
Figure 1: Deans Stand after Canterbury earthquake sequence

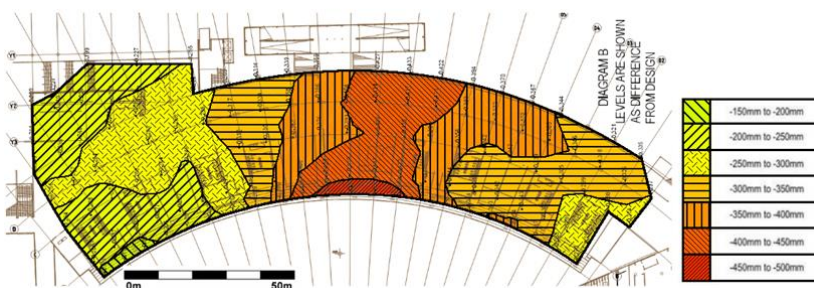
Ground level changes and building settlements were measured by level surveys and by reference to LiDAR data from before and after the earthquakes. Marked differential settlement was apparent between elements of structures on different foundation types, and across the structures themselves. The main body of the Deans Stand settled between 200 and 500mm, with each end tilting backwards around 100mm and the central portion settled approximately 300mm relative to the ends and tilted towards the field by 150mm. Those parts of the Deans Stand supported on screw piles settled less, typically 150 to 200mm. The pattern of settlement is shown on Figure 3. Examples of surface expressions of ground damage at the Deans Stand are shown in the photographs in Figure 4.

*Figure 3: Deans Stand surveyed settlement contours*

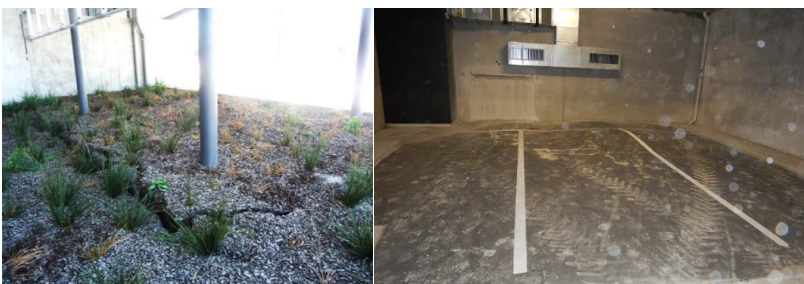
*Figure 4: Ground surface disruption (left); pavement bulging between ground beams (right)*

It is further postulated that the stone columns filled with fine silty sand during the initial significant liquefaction event. Some of that material was observed to have made its way through the ground level pavement in the Deans Stand and manifested as ejecta causing bulging of the asphalt surface (Figure 4). The liquefied sand is assumed to have stopped flowing once liquefaction induced subsidence ceased. A comparison of gradation curves is shown in Figure 7 and clearly demonstrates the higher fines content in the contaminated (dirty) sample.

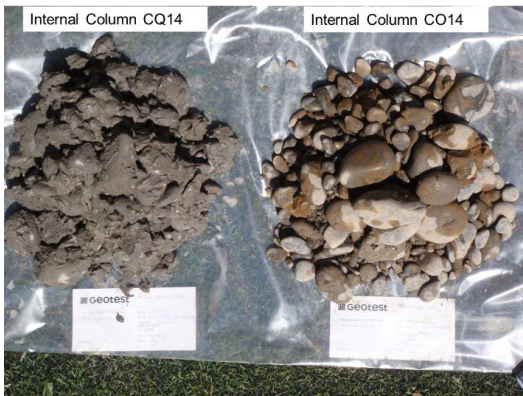
Figure 5: Dirty and clean samples of stone column material

Most of the stone columns exposed in pits beneath the Deans Stand showed evidence of fine silty sand contamination, while most of the pits excavated beyond the stand on the field side show the columns to be relatively clean. Photographs of samples recovered from near the top of stone columns are presented in Figure 5, and deeper samples from bores put down through columns are shown in Figure 6.

It is postulated that the weight of the structure drove liquefied soils beneath and surrounding the stone columns into and up the columns directly beneath the stand, and that the effect was much less pronounced within the perimeter columns.

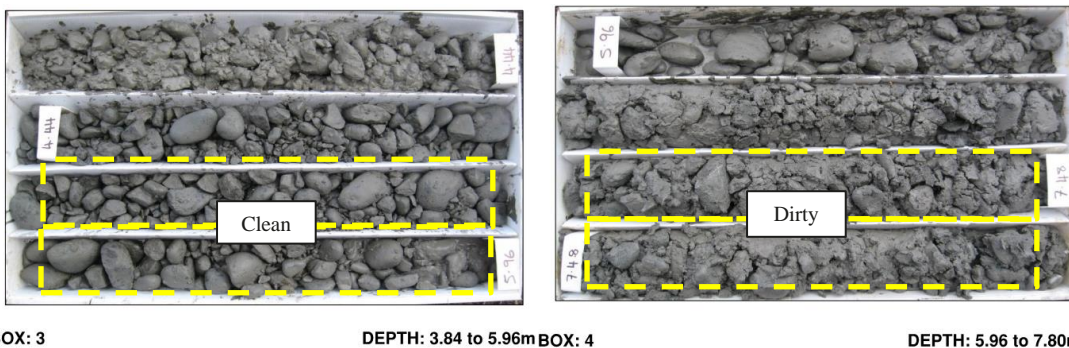
Figure 6: Dirty and clean samples of stone column material – deeper samples (BH3001)

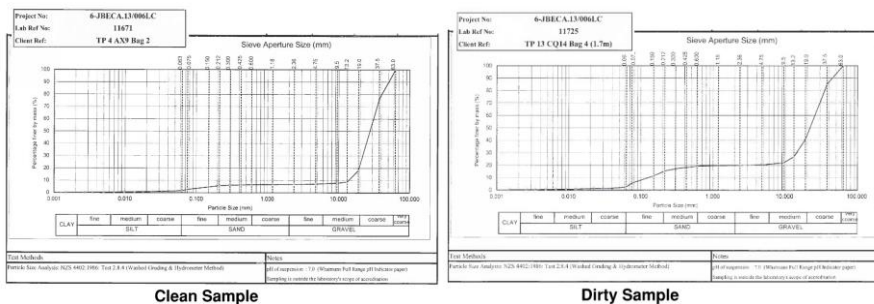
Figure 7: Grading curves of clean and dirty stone column materials (shallow samples)

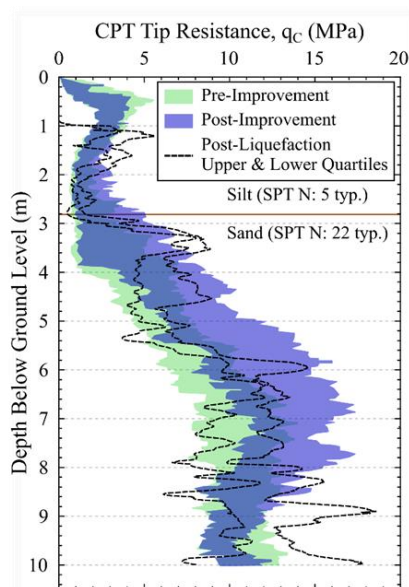
Stone column construction densifies surrounding sandy soils, locking in increased lateral stresses. Liquefaction of soil between the columns leads to the loss of these locked in stresses, returning the ground to a normally consolidated state. Furthermore, the post-shaking dissipation of excess pore water pressure from liquefied layers upwards and downwards to non-liquefied layers leads to a degree of strength loss in those non-liquefied layers.

We initially investigated four locations at the Deans Stand, carefully exposing groups of stone columns so we could locate cone penetration tests (CPTs) mid-way between columns. More recent investigations, (Alexander et al. 2019, in press) have included direct push cross hole (DPCH) and shear wave velocity testing at three locations in the Deans Stand and one location in the playing field. The test results show the ground between the stone columns to largely have returned to its pre-improvement, normally consolidated, state. This is demonstrated by the upper and lower quartile plots of CPT tip resistance presented in Figure 8, which are overlaid on the equivalent range of pre- and post-improvement CPTs.

Figure 8: CPT data comparison
