NEW ZEALAND SOCIETY FOR EARTHQUAKE ENGINEERING  
**2019 Pacific Conference on  
Earthquake Engineering**  
TURNING HAZARD AWARENESS INTO RISK MITIGATION  
4 – 6 April | SkyCity, Auckland | New Zealand

# A conspectus of wine storage tank damage data following the 2013 and 2016 New Zealand earthquakes

*M. Yazdanian, J.M. Ingham & D. Dizhur*

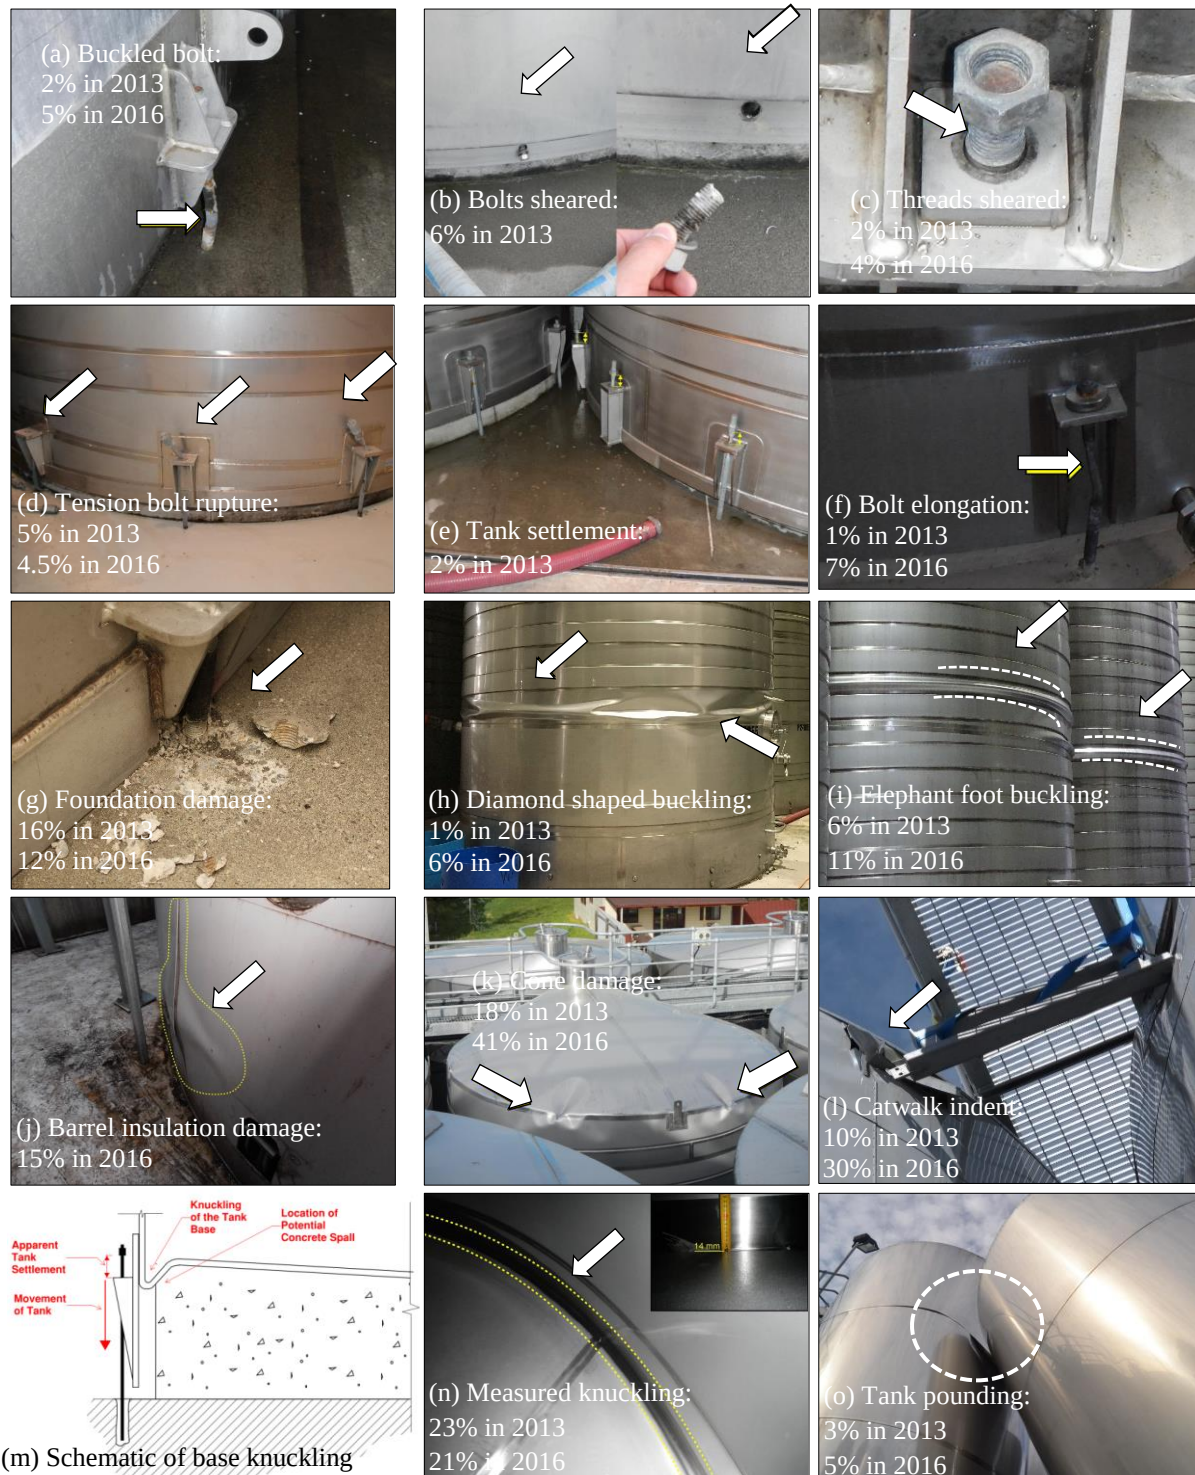
*Figure 2: Typical damage to the flat-based tanks and percentage of each damage type among all tanks in the inventory*

Typical damage examples of flat-based tanks and percentage of their damage type in the tank inventory can be seen in Figure 2. Figure 3a,b shows that although wineries sustained typically lower PGA in the 2013 earthquake, flat-based tanks sustained slightly more damage in the 2013 earthquakes (73%, 404 out of 546 tanks), compared with the 2016 earthquake (69%, 557 out of 802 tanks). Following the substantial losses during the 2013 earthquakes, wineries started to account for earthquake resilience in their short-term and

In the 2016 earthquake, elephant-foot buckling (11%) and diamond shaped buckling (6.1%) caused the highest percentage of severe (section replacement) damage to the barrel (Yazdanian et al. 2018), where above 90% of the buckled tanks required remedial works (see Figure 3g). Elephant-foot buckling (see Figure 2i) generally occurs in tanks that are mostly fully filled, is an elastic-plastic type of instability (NZSEE 2009), (Sobhan, Rofooei, and Attari 2017), (Spritzer and Guzey 2017), , and can be described as an outward bulge of the tank shell. Diamond shaped buckling (see Figure 2h) is a type of elastic instability (NZSEE 2009), (Sobhan, Rofooei, and Attari 2017), (Spritzer and Guzey 2017). Sobhan et al. (2017) stated that elephant-foot buckling of the steel tank wall is caused by the interaction of both circumferential tensile stress close to the yield strength and by axial compressive stress exceeding the critical stress, whilst diamond shaped buckling is caused by severe axial compressive stresses. A vast majority of the anchors with earthquake related damage (94%) in the 2016 earthquake required replacement (see Figure 3i,j).

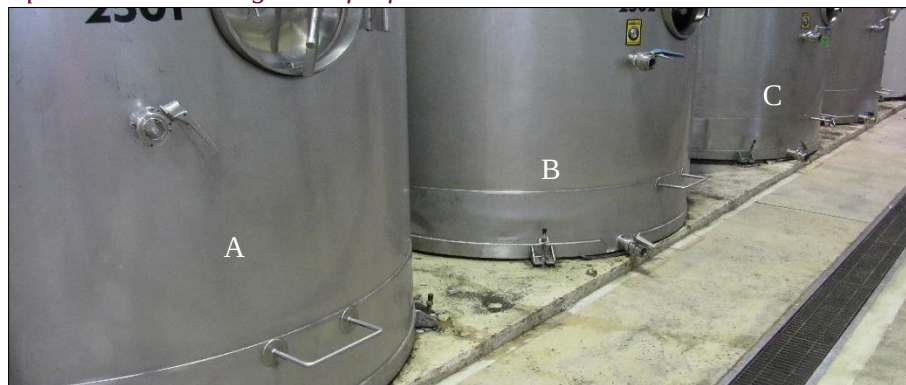
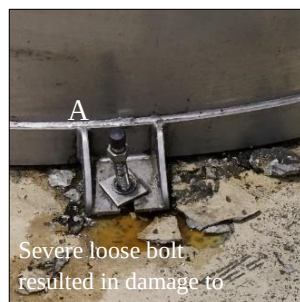
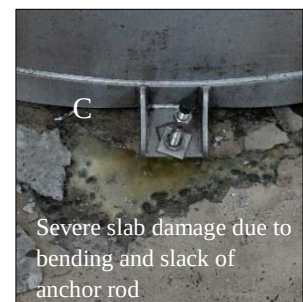
Figure 4: Damaged small capacity (25 kL) flat-based wine tanks

Tank capacity was a parameter that had a significant influence on the extent of damage to wine flat-based tanks (see Figure 3c,d). In the 2016 earthquake, inspected wine tanks with a volume between 20-40 kL sustained the largest damage among all ranges of capacities. During the site inspection following the 2016 earthquakes, it was identified that wineries placed emphasis on strengthening of larger capacity wine tanks, leaving smaller wine tanks mostly un-anchored or with outdated anchorage systems (see Figure 4). In the 2013 earthquakes, there was a substantial decline in the percentage of damaged tanks with capacity of larger than 300 kL (59%, 13 out of 22 tanks) and tanks with capacity range of between 150 kL and 300 kL (see Figure 3c). Such large capacity tanks (above 300 kL) were typically used for water storage and sustained minor (tank base shell) or no damage due to having a low height to radius aspect ratio and continued their operation following the earthquakes (see Figure 5).

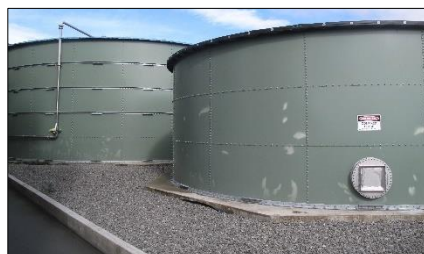
(a) No particular damage to the anchors around the tanks

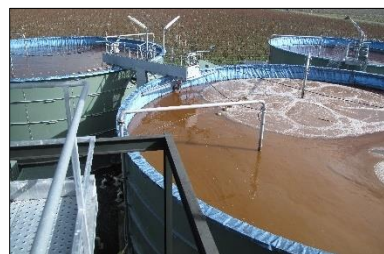
(b) Continual operation of tanks following earthquake

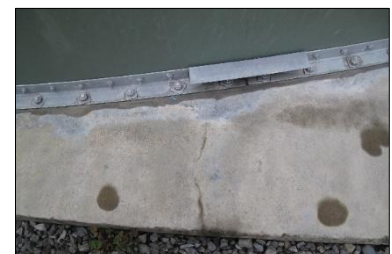
(c) Minor cracks on concrete slab

- Broad water treatment flat-based tanks performed well compared with flat-based wine tanks, where 13 tanks (59%) sustained mostly minor damage of the tank base shell.

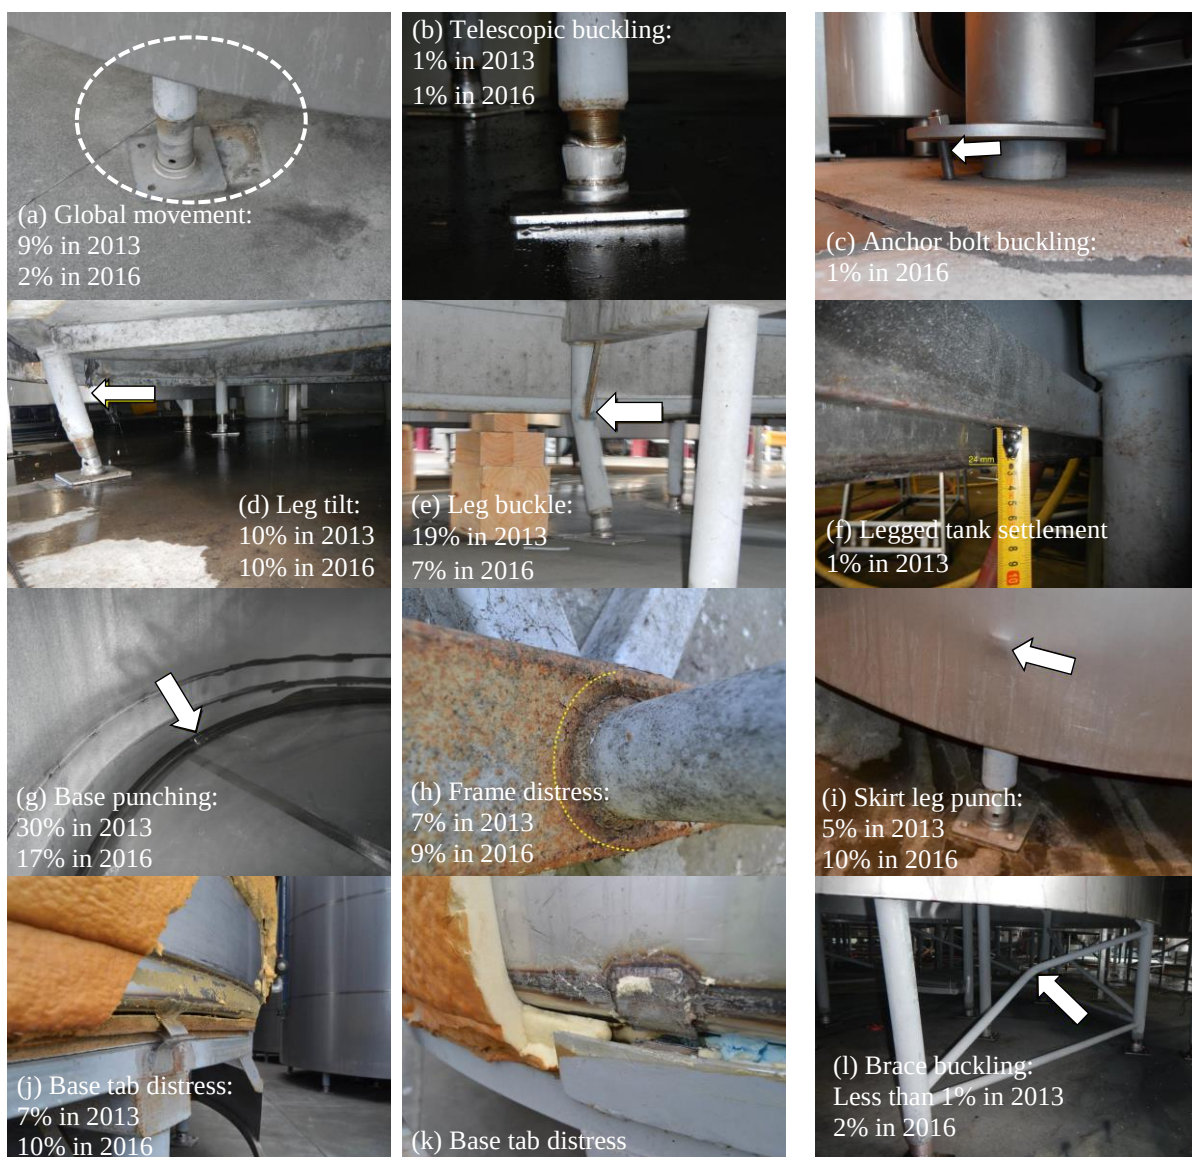
Figure 6: Typical damage to the legged tanks and percentage of each damage type among all tanks in the inventory

Examples of typical damage to legged wine tanks and percentage of each damage type for all legged tanks in the inventory can be seen in Figure 6. In the 2013 earthquakes, 50% (756 tanks) of the 1512-legged tanks in the inventory sustained damage (see Figure 7a). Out of 599-legged wine tanks that were inspected following the 2016 earthquake, 57% (341 out of 599 tanks) sustained damage (see Figure 7b). The effect of tank capacity was more severe for the legged wine tanks compared with the flat-based wine tanks, where in the 2013 and 2016 earthquakes, percentage of damaged legged wine tanks increased with increasing tank capacity (see Figure 7c,d).

Damage to the frame/legs of legged wine tanks had the highest percentage among the tank elements in the 2013 (40%) and 2016 (44%) earthquakes (see Figure 7g,h). The second most damaged parts of the legged wine tanks were the tank base shell, with 39% in 2013 and 43% in the 2016 earthquake, where almost 68% of the tanks with base shell related damage required section replacement (see Figure 7j). Rippled base, knuckle deformation (see Figure 6m,n), and settlement (see Figure 6 f) in the 2013 earthquake (see Figure 7i) was summarised to base deformation in 2016 (see Figure 7j).
