NEW ZEALAND SOCIETY FOR EARTHQUAKE ENGINEERING  
**2019 Pacific Conference on  
Earthquake Engineering**  
TURNING HAZARD AWARENESS INTO RISK MITIGATION  
4 – 6 April | SkyCity, Auckland | New Zealand

# Post-earthquake recovery phase of winery facilities. A case study in the Marlborough area

*G. Loporcaro, A. Palermo, W.J. Campbell & D.C. Hyndman*

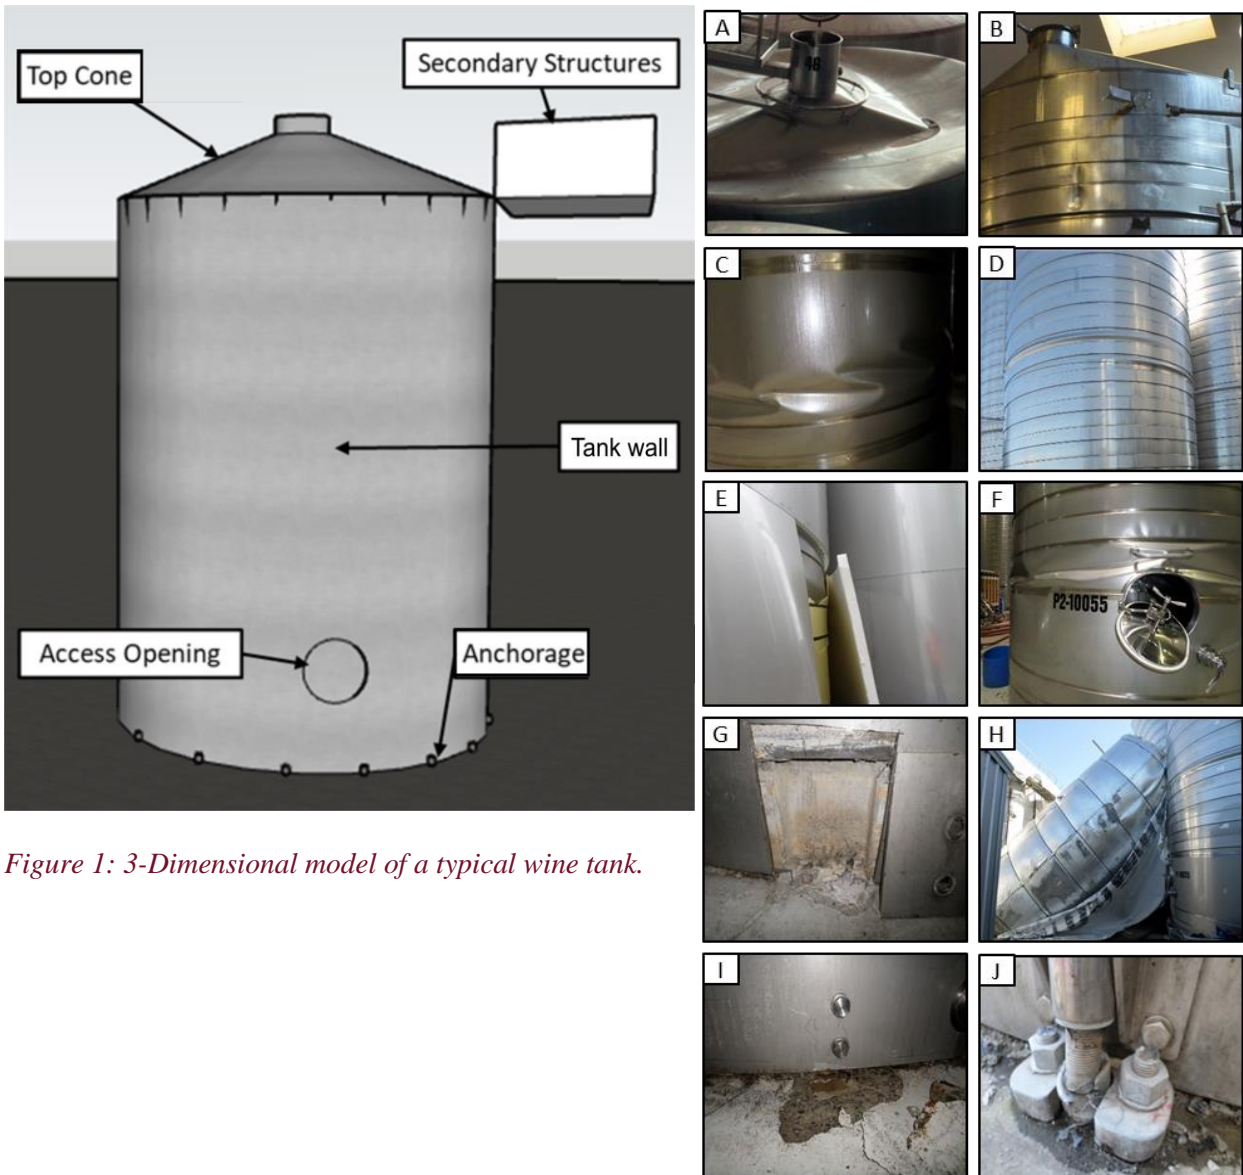
Reconnaissance of winery facilities after seismic events show that the prevalent wine tank failure modes can be categorised in four main failure modes: top cone damage, wall buckling including damage to access opening, anchorage and secondary structures failure (Figure 1 and Figure 2). Deformation of the top cone tanks is caused by wine sloshing. This causes an upward force up against the top of the tank deforming the cone. The moving fluid also changes the pressure within the tanks which can cause a pressure difference with the outside ambient pressure. The pressure difference can cause the top cone to be sucked [Figure 2(A)]. Often damage involves failure of secondary structures such as catwalks and pipes. The catwalks are lightweight structures either fixed to the tank or free standing. Fixed catwalks are connected by a sliding connection to the top of the tanks that allows for movement between the tank and catwalk. Free standing catwalks are independent structure, with a gap between them and the tank, allowing for tank displacement

without hitting the catwalk. Issues arise when the earthquake produces tank displacements greater than the sliding connection gap allowance. In such cases, the catwalk can pound against the top of the tank. Damage from the catwalk can be seen in [Figure 2(B)]. Wall buckling consists of inelastic deformation of the thin layer of stainless steel that constitutes the tank wall and comprises of two types: diamond buckling [(Figure 2(C)] and elephant foot [(Figure 2(D)].

*Figure 2: Main failure modes of wine tanks; (A) top cone damage; (B) secondary structure damage to tank; (C) Diamond buckling; (D) elephant foot buckling; (E) Panel failure; (F) stress concentrations causing buckling around access opening; (G) Anchor rod fracture; (H) Tank collapse; (I) concrete spalling around anchor; (J) anchor failure (thread stripping) (Photos courtesy of Structex)*

Diamond buckling assumes a diamond pattern and is caused by high axial compression forces on the slender walls of the tank. On the other hand, elephant-foot buckling is an outward bulge caused by vertical compressive stresses higher than the yield limit of the steel wall. In the case of insulated tanks, buckling may cause the panels to separate from the tank as seen in Figure 2(E). Also, openings and penetrations in the tank walls cause discontinuities that can lead to stress concentrations in these areas. The stress concentrations can be much greater than that in the rest of the tank, local buckling can occur as seen in Figure 2(F). Another very common failure mechanism observed was the damage of the bolts connecting the tank to the foundations, known as anchorage failure. Three main failure modes were observed: rupture [Figure 2(G)], pull out and stripping thread [Figure 2(J)]. Rupture can be either in tension or compression from the bolt yielding in the tension cycle then in the compression cycle the bar can buckle or fracture. If the bar does not fracture in the compression cycle, in the next tension cycle, the yielding limit may be exceeded, causing fracture of the steel anchorage. Pull out failure occurs when usually the concrete foundation is thin (around 200 mm or similar) and the post-installed anchors do not develop enough development length. The failure mechanism can result in full pull-out or spalling of concrete around the top of the bolt as seen in [Figure 2(I)]. Bolt failure might also occur when the thread at the top of the bolt strips, causing the loss of the hold down ability (Hamdan, 2000).

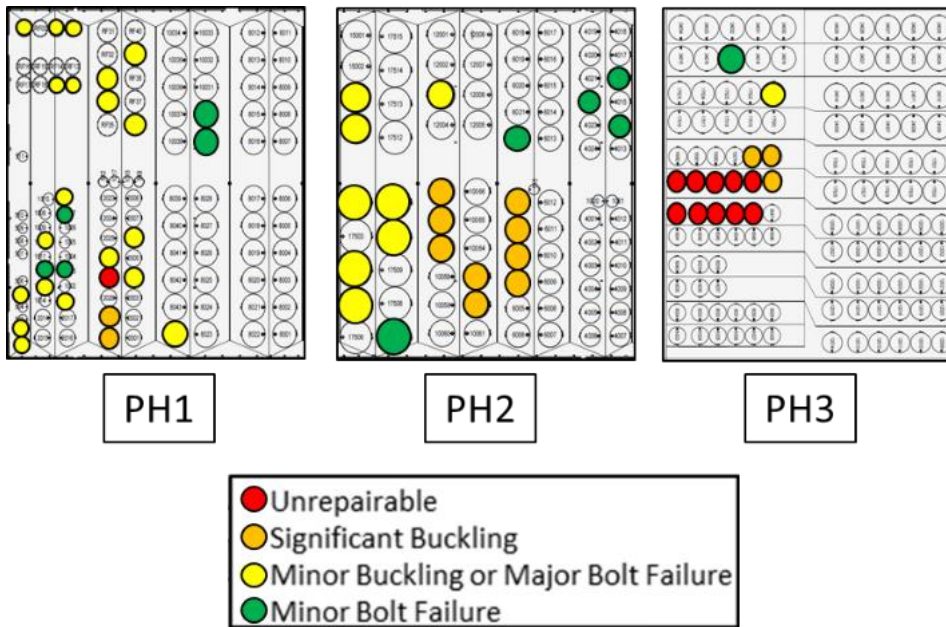
In Figure 4, a simplified layout of the tanks in the three production halls (PH) of the winery is represented. The production halls do not have the same wine capacity. PH 1, PH2, and PH3 have a capacity of approximately 10%, 40%, and 50%, respectively. The different colours (red, orange, yellow, and green) identify the severity of the damage in each tank. The damage mechanisms recorded in the winery, organized per number of tanks subjected to that specific failure mode are summarised in Table 2. The most common failure mechanism was the damage of the anchorage at the bottom of the tanks. However, in most cases this was easily repairable by replacement of the bolts or reinstatement of the spalled concrete. In this case, the tanks are still fully operational. On the other hand, buckling of the tanks, including elephant foot, diamond and wall buckling, substantially limited the operability of the tanks. The repairing phase required the tanks to be completely empty and the damaged area to be removed and replaced with new material. Often, buckled tanks had to be removed from the location to be repaired off-site. This caused logistics problem; in fact, in the case of tanks located in the middle of a row, the front tanks had to be removed (even if not damaged), to have access to the damaged tanks. In some cases, damage of the anchorage then led to wall buckling, as the tanks were free to rock, creating higher compression forces in the walls.

Figure 4: Winery layout and severity of damage to the tanks (Courtesy of Structex)

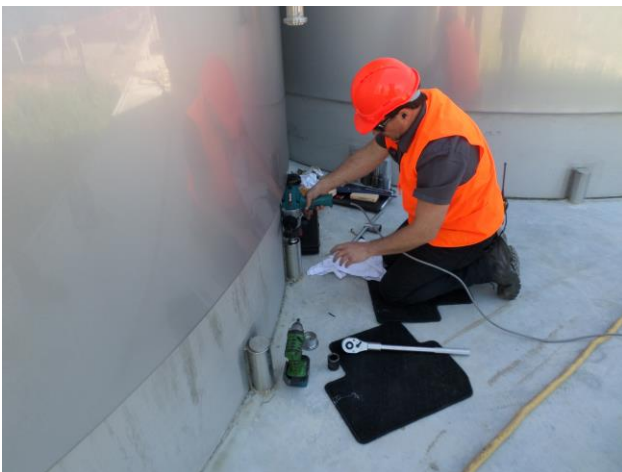
One such example that demonstrated good performance in the 2016 Kaikōura earthquake was a locally designed seismic anchorage system (Figure 9 and Figure 10). This is an anchor welded to the base of the tank and connected to the concrete slab foundation. The anchor contains a yielding mechanism, restrained against compression buckling, so is able to yield in tension and compression. All other components, including tank walls, skirt, connections and concrete adhesive anchorage are designed for the overstrength force of the anchors, so do not sustain damage as the anchor yields (Sarti, Palermo, & Pampanin, 2016). Following an earthquake, the yielding mechanism is easily replaced. Advantages of this system is that it limits damage to one defined replaceable component, so cost of repairs is very low compared with repairing damaged tank walls. The yielding mechanism is a stock component of a particular size, so can be directly replaced without the need for a drawn out assessment and repair design, and the replacement is quick and simple. The yielding mechanism replacement is carried out on site without the need for removing tanks, so can be done for tanks located anywhere in the winery. The disadvantage of this system is the higher cost compared to a simple tension-only anchor.

*Figure 9: Removing the yielding pin mechanism of the seismic anchorage system*

Finally, a capacity design approach will limit damage to a specified component (usually a yielding pin between the tank and concrete slab) which can be replaced following a seismic event. Tank walls are designed for the overstrength of the anchorage, which prevents buckling of the walls. Anchors designed for cyclic loading (yielding in tension and compression) were demonstrated to perform well in the earthquake, while tension-only anchors still allowed damage to tank walls as they introduced a ‘slackness’ on subsequent cycles following the initial yield. A similar capacity design approach could be applied to tanks supported on base frames.

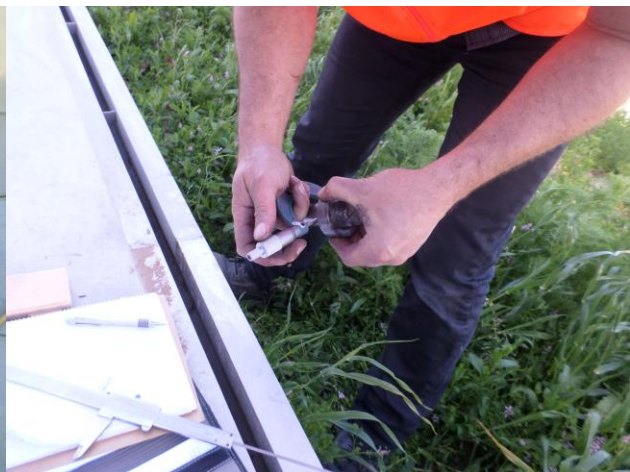
*Figure 10: Measuring the diameter to check yielding of the seismic anchorage system*
