PERFORMANCE OF ENGINEERED TIMBER STRUCTURES IN THE CANTERBURY EARTHQUAKES

Andrew Buchanan¹, David Carradine² and Justin Jordan³

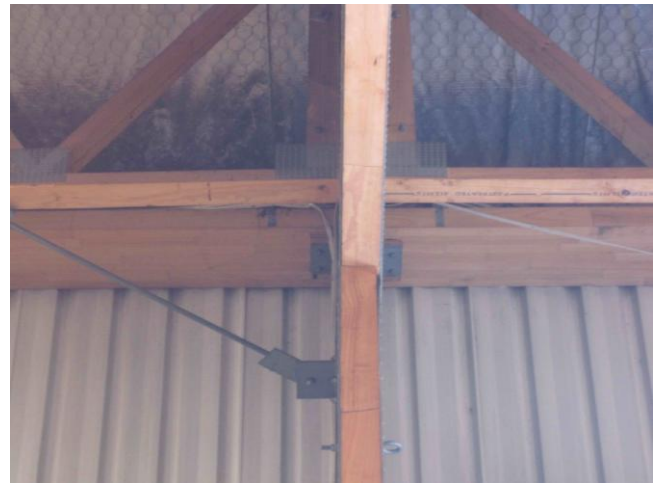
1(d). Investigations revealed that since the construction of the building nearly 30 years ago one bay of steel “X” bracing had been removed and could have affected the performance of the building, particularly the lateral displacement of the rafter at the knee joint shown in Figure 1(b), since repaired. The building had no restriction on use following the earthquake and repairs to the cracked columns will be executed using long fully threaded screws or epoxied steel rods.

(b) Local lateral displacement of rafter at knee joint.

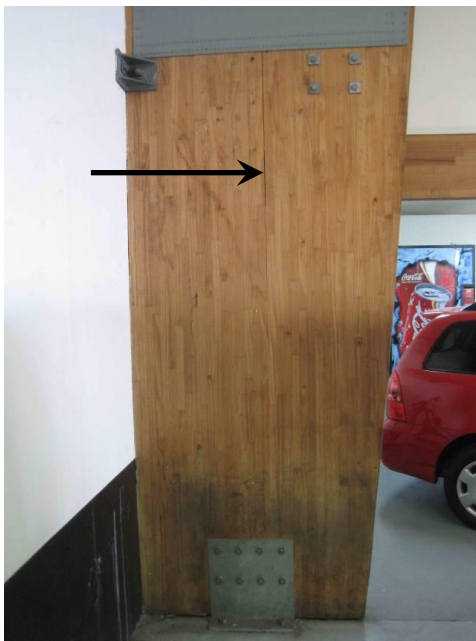
Figure 1(a) shows an industrial building constructed of glue laminated portal frames with nailed steel plates as moment resisting connections and deep timber trusses spanning between the frames. Some shear cracking was observed in columns of two of the frames, as seen in Figure 1(c) and

(c) Vertical shear crack in column (location shown by arrow).

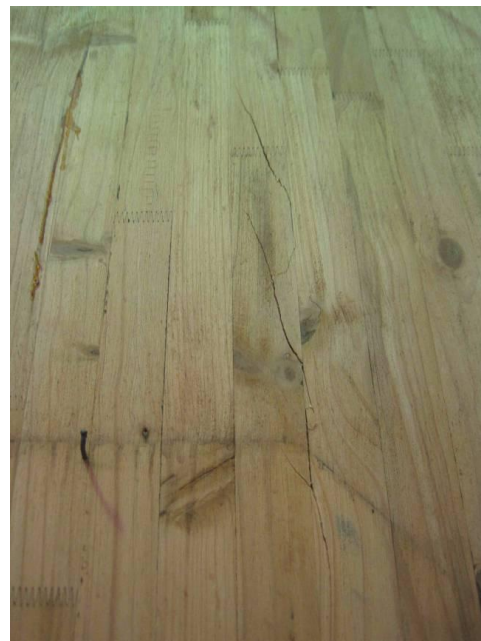
(d) Detail of shear cracks in another column of the same building.

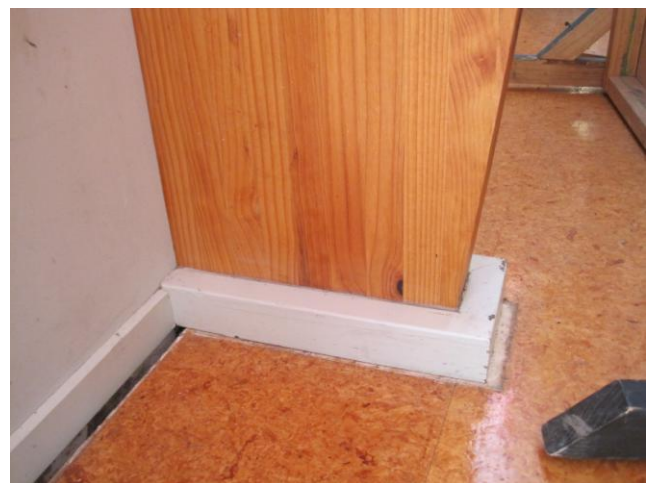
Many school halls in the Christchurch region have glulam portal frames. Most had no damage at all. The only damage observed during inspections of many of these buildings was caused by minor lateral movement of foundations, as shown in Figures 2 and 3. The damage in Figure 2 was caused by the 2010 earthquake. Figures 3(a), 3(b) and 3(c) are all the same school building, where the only damage was the minor foundation movement shown in Figure 3(c). A similar school hall suffered no structural damage despite the displacement of ceiling tiles shown in Figure 3(d).

(b) Minor lateral movement of foundations.

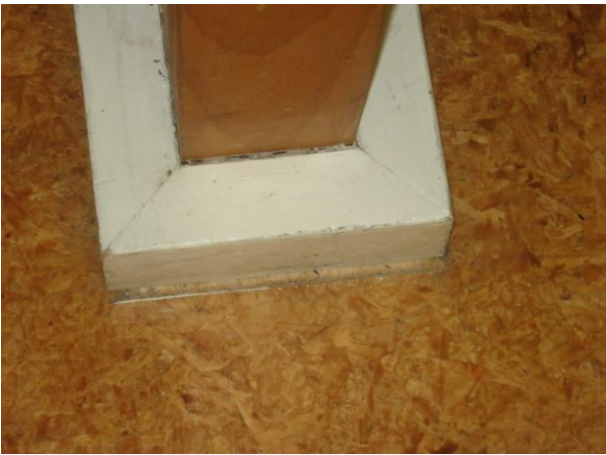
(c) Minor foundation movement visible at floor level.

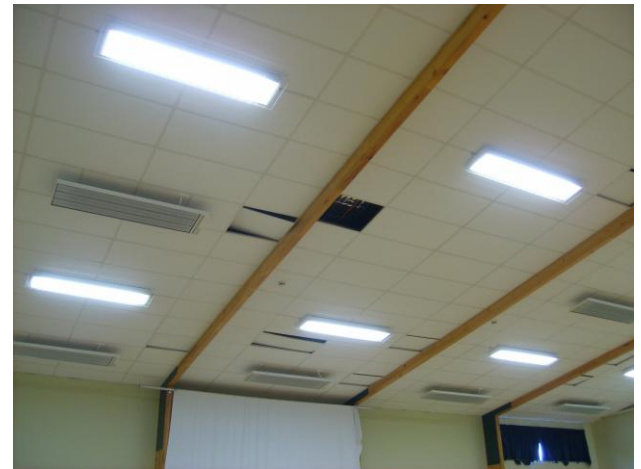
(d) No damage to portal frames despite ceiling tiles displaced by shaking.

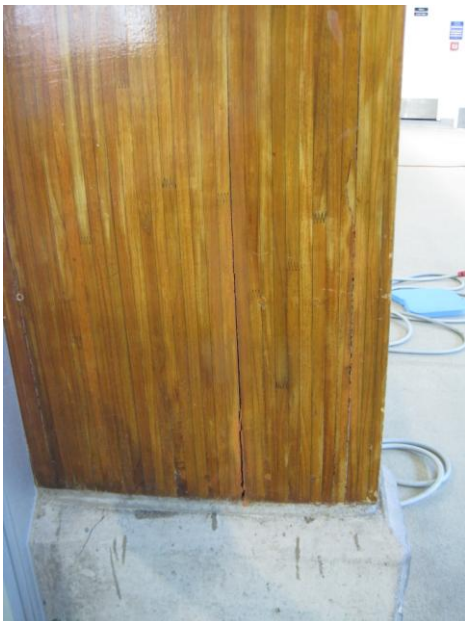
Several glulam swimming pool buildings were inspected. The only damage was very minor, such as shown in Figure 4(a) and 4(b). Based on current knowledge, none of these buildings have required repairs and they have continued to be occupied.

(a) Re-opening of old shrinkage crack at epoxy rod connection to foundation.

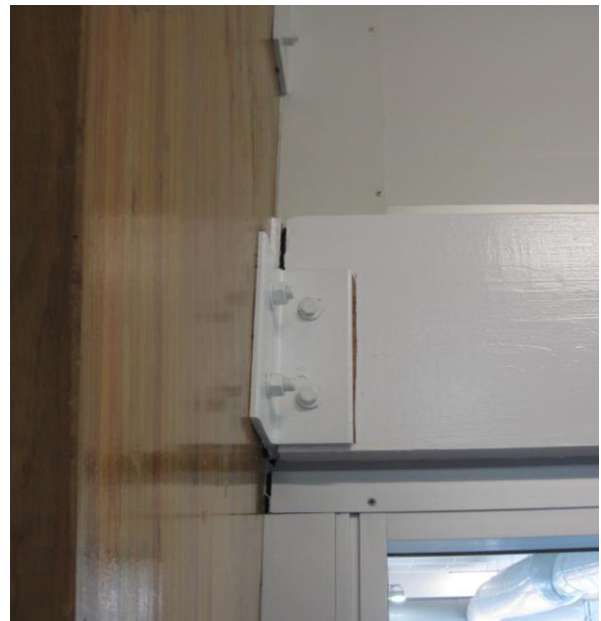
(b) Minor gap opening due to lateral movement.

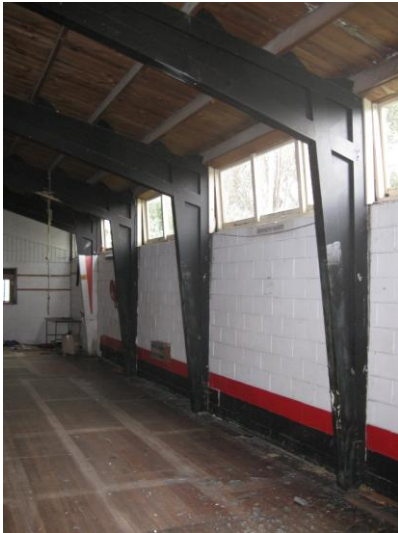
(a) Timber frames with damaged masonry infill walls.

Other portal frame structures are also part of the stock of single storey engineered timber structures around Christchurch and some of these were investigated and shown to have minimal damage, particularly to the timber portal frames. One example was an older building located in the Eastern suburb of Shirley and used for sports activities, which was comprised of a series of nail-laminated frames having a span of approximately 13m (Figure 5). This type of construction was described by Walford [6] and proved to be a robust and seismically resistant system. The building consisted of seven frames having masonry infill between them to provide lateral bracing. While the masonry walls were damaged the frames remained intact and were in no danger of failure.

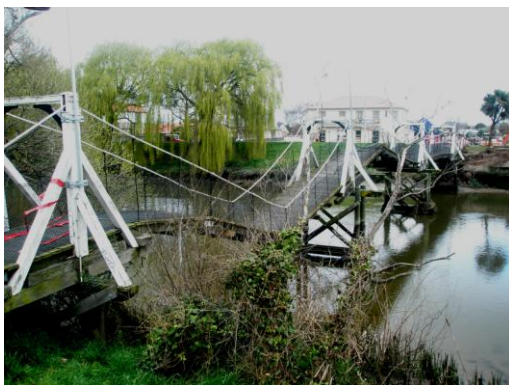
(a) Damage to Mandeville Bridge following 2010 earthquake.

Timber bridges were evaluated following the 2010 Earthquake [9] and were found to have been damaged primarily due to lateral spreading of embankment supports and some lateral movement of piers, as shown in Figure 9. Timber bridges assessed were pedestrian bridges and therefore designed to less rigorous standards than vehicle bridges. Many of these bridges have also been relatively quickly repaired (Figure 9(b)).

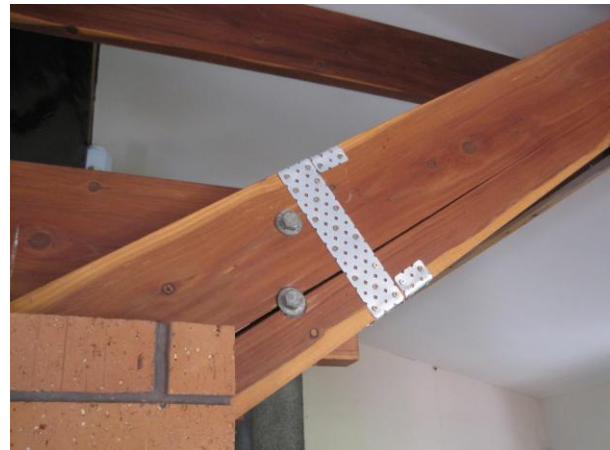
No damage was observed in any pressed metal plate trusses, as used in most residential houses. One case of damage to a bolted truss connection in an architecturally designed house is shown in Figure 8, after emergency repair with a screwed steel plate.

Figure 8: Emergency repair to a bolted rafter connection in a private house.

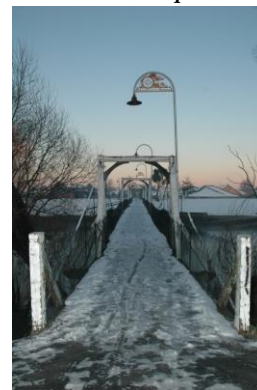
(b) Condition of repaired Mandeville Bridge as of July 2011.

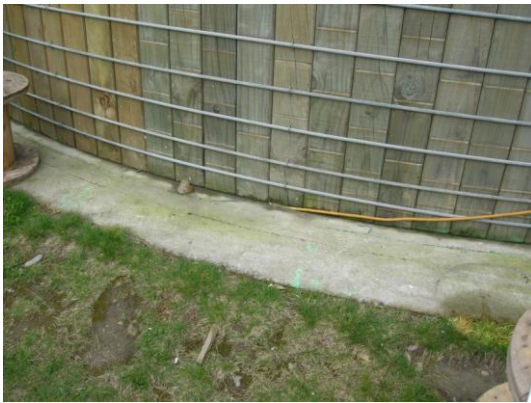
(a) Base Isolation sliding of 50 mm for 400 m³ tank in Kaiapoi. No damage to tank.

The 400 m³ tank at Kaiapoi, shown in Figure 10(a), moved to expose the pale concrete, and it has run over the orange power chord. This confirms that the tank moved backwards and forwards. The horizontal pale lines on the barrel staves in this photo are old cable marks as this tank was rebuilt and increased in size from 300 m³ to 400 m³ in 2009. As another typical example, the 180 m³ tank in Figure 10(b), located 10 km from Darfield, only moved 20 mm in the 2010 earthquake. Figure 10 shows the sliding of a 100 m³ tank in West Melton. The shaking pushed back the backfill 70 mm around the tank, and the tank rotated on its site by 170 mm.

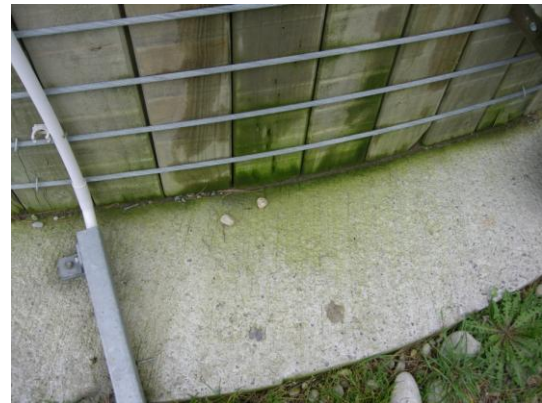
(b) Base isolation sliding of 20 mm for 180 m³ tank near Darfield. No damage to tank.

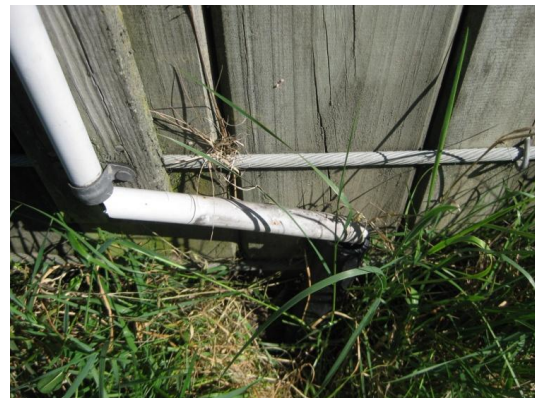
Figure 11: Pipe damage due to rotation of 100 m³ tank at West Melton. No damage to tank.

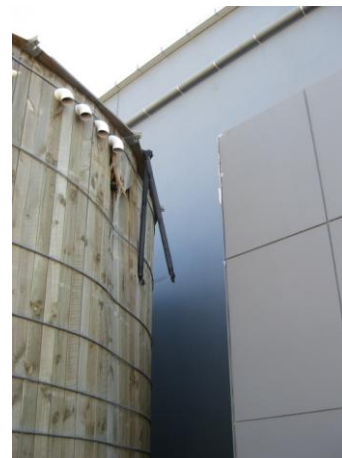
Figure 12: Damage to 210 m³, 7.75 m diameter tank in Hornby caused by a 3 sec slosh wave in the 2010 earthquake. The liner ruptured. The broken timbers have been replaced and the tank is working again now with a baffle system installed.

Of the seven tanks which lost content, four were laterally displaced by about 1 m, but remained structurally intact. Liners were ruptured and they lost water (7.8 m, 11.2 m, 11.2 m, and 11.5 m diameters). Two badly damaged tanks (6.9 m and 10.5 m diameters) were tied to heavy steel pipes and fences, and were backfilled with soil up to 500 mm deep, thus preventing base isolation. The combined effect of this base-fixity, exposed to the 2010 earthquake 3 second period slosh waves, rocked the tanks and led to failure initiated by liner hernia. One other damaged tank (9.45 m diameter) was significantly damaged by a slosh wave (Figure 12).

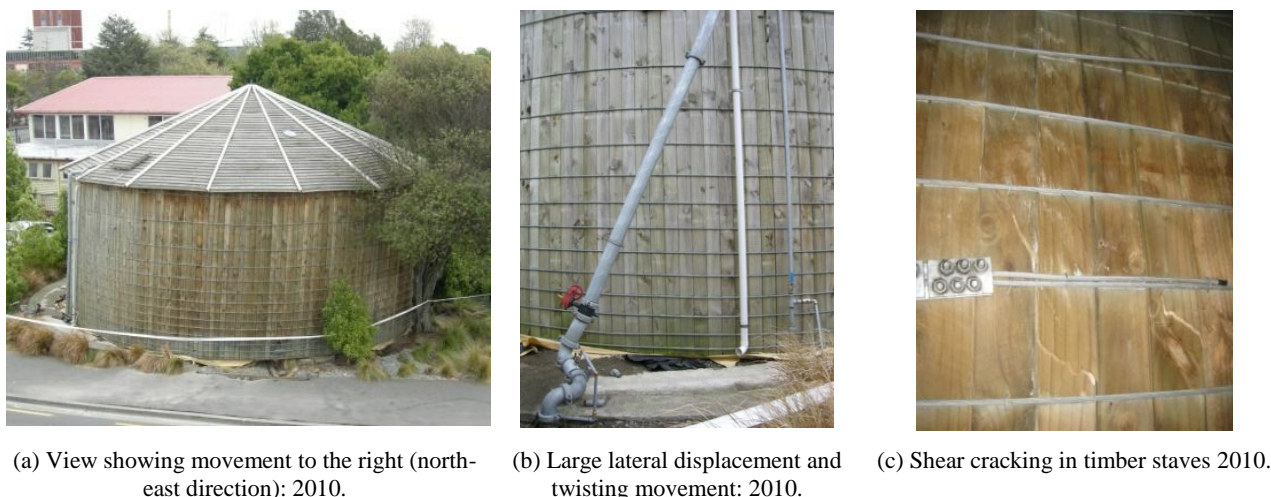
Figure 13: Damage to 400 m³ tank at Northland Mall.

Figure 13 shows extensive damage to the 400m³ sprinkler fire-fighting water supply tank at Northland Mall in Papanui in the 2010 earthquake. In the left photo (a), the tank has moved to the right (North-East). The centre photo (b) shows that the steel external inlet has moved 1.35 m from the tank wall and the tank has rotated 2.25 m to the right. The right photo (c) shows shear cracking in the timber staves over a 3 m wide area on the far side of the tank from the road. This tank was repaired in November 2010. The tank was craned back on to site. Stave shear, which assists energy dissipation, was corrected, and shear cracked timbers were cut out and replacement tongue and groove boards were butted in, with staggered end joints, and the cables were re-tensioned. Baffle foundations were installed, a new liner was installed, and the seismic baffle was fitted as shown in Figure 14.
