Shake table testing of scaled geogrid-reinforced adobe wall models

2010 NZSEE
Conference

J.F. Tipler¹, M.L. Worth¹, H.W. Morris & Q.T. Ma

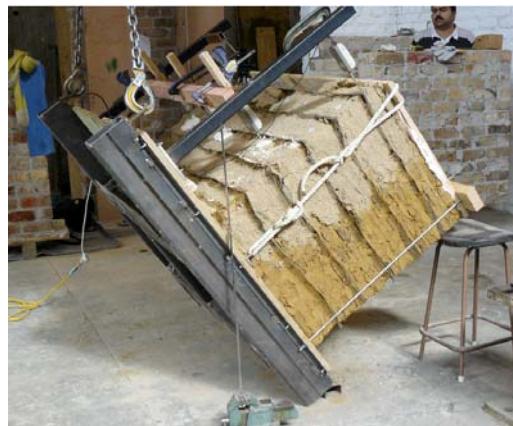
A static tilt test was performed in order to gain comparative displacement data from both walls under a known acceleration. The wall was tilted so that it experienced gravitational accelerations; the resultant displacements were read at mid height of the wall using displacement gauges and the gravitational accelerations experienced by the wall were calculated from the angle. Both walls were tilted from five degrees to fifty degrees in five degree increments. The wall was tilted using the gantry crane to lift one side of the base plate. An angle section was bolted to the floor to prevent sliding of the base plate. This test was performed following the dynamic testing, using the same models.

Figure 4.1 Tilt Test in Progress

The results from the tilt test enabled a comparison between the magnitudes of displacement occurring when both models were subject to the same equivalent acceleration. The tilt test used the damaged adobe models so the results are only relevant to post-cracked behaviour of the walls. The fully reinforced wall had smaller deformations than the partially reinforced model demonstrating that the geogrid provides additional stiffness to the post- cracked adobe wall (Fig. 5.11).

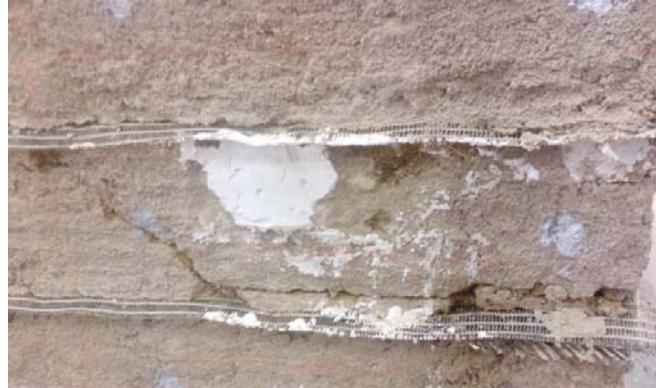
Figure 5.9 Crack running through geogrid layer on bottom right hand side of wall.

Figure 5.8 shows the final crack pattern in relation to the position of the geogrid, which is indicated by the dashed horizontal lines. At the base of the wall cracks tended to form in the geogrid layer but no sliding was observed, indicating that a plane of weakness had not formed. The photograph (Fig. 5.9). shows a crack that progressed through the geogrid layer and then passed through the top of the mortar layer and not along the plane of the geogrid .
