## Development of Typical NZ Ceiling System Seismic Fragilities

**ABSTRACT:** Seismic damage to ceilings can cause significant downtime and economic loss in addition to life safety risk. In order to understand this risk and develop mitigation strategies a small project on non-structural damage was recently funded by the FRST Natural Hazards Platform at the University of Canterbury. This particular project concentrates on two ceiling systems which are commonly used, or applicable, in NZ. This paper addresses the development of fragility functions for the ceiling systems based on component fragilities which are obtained from experimental testing of Armstrong<sup>(TM)</sup> ceiling components. The ceiling system fragility is obtained through Monte-Carlo analysis using in-plane finite element analysis. Demand parameters include absolute acceleration and displacement. The effect of rigid and flexible sprinklers is also investigated. The acceleration resistance is found to be dependent on the ceiling size. This information is being used directly to estimate both ceiling damage and its contribution to overall building loss.

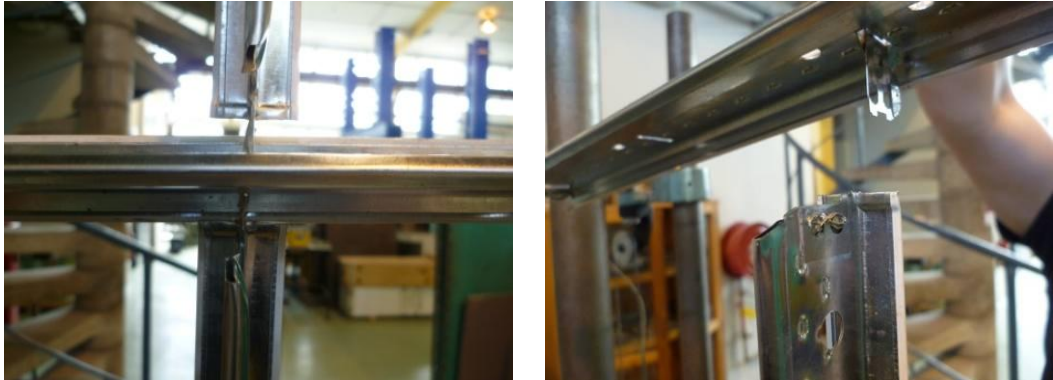
**Figure 5. Failure mode of connection in the tensile test (left); Failure mode of the riveted connection (right).**

For the purposes of tests, effort was made to use standard methods but a code with test procedures for all type of components is not available. The tensile tests for the members are standardized by AS/2785. However there is no standard suggesting methods to test the connections, which are likely to be the weakest part of the ceiling system. Also for compression, there is no specific test Standard, and the design of the experiment is very important because the results could be very different with a different configuration. Hence, a rig was constructed which not only maintains the joint position during the test, but also allows for the compressive action to take place without restraining the system too greatly, as this would potentially give higher values. Typical failure modes observed in the tension (member and connection) and compression tests are shown in Figures 4-6.

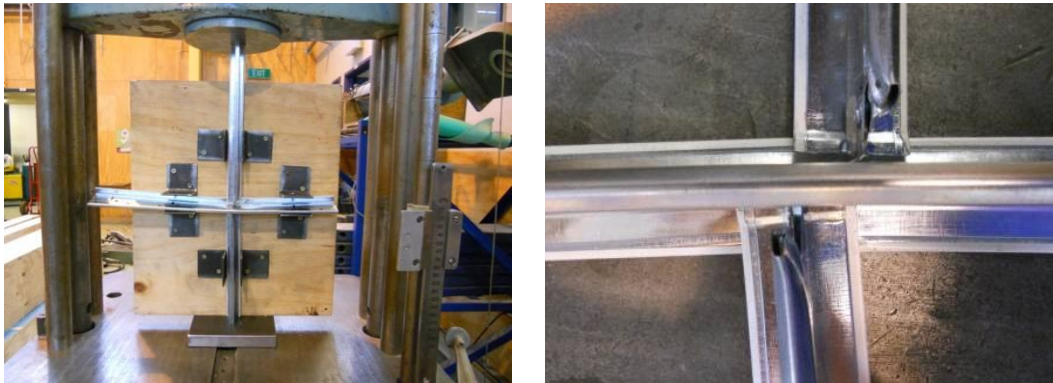
**Figure 6. Failure mode in a compression connection specimen**

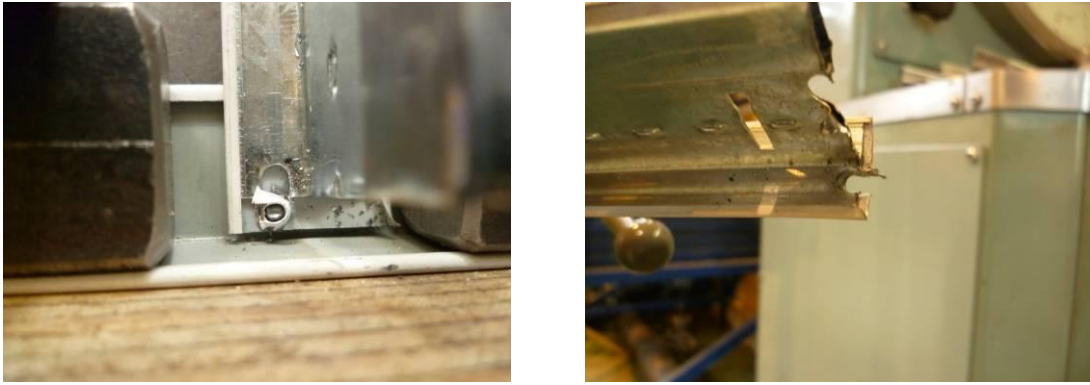
During an earthquake the ceiling moves and the rivet connecting the grid to the wall angle is stressed. Due to this it is possible that the acceleration fractures the rivet, as shown in Figure 7, leading to collapse of tiles. The breaking of connections can cause the downfall of many tiles, as witnessed in the library at the University of Canterbury during the September 4 Darfield earthquake.

**Figure 7. Failure mode in the rivet connection between the main beam and the wall angle**

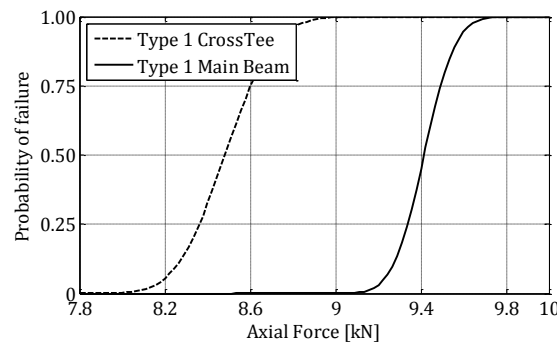
The lognormal distribution “median,  $\hat{x}$ ” and “dispersion  $\sigma (\ln x_i)$ ” are reasonable measures to describe failure rather than the “average” and “standard deviation”. Hence, results of the 10 tests were used to calculate the median and dispersion, which were used to obtain cumulative distribution function for the components, to be used in the analysis to follow. For instance, Figure 8 shows the fragility curves for the tension failure of the main beam and the cross tee based on the results of the tension tests. As can be seen in the figure, the median tensile capacity (i.e. 50% of the probability of failure) is 8.5 kN for the cross-tee and 9.4 kN for the Main Beam. Similarly, for all the tests it’s possible to plot a fragility curve like this.

**Figure 8. Member fragility curves obtained from the tensile tests**
