Retrofit Options for Residential House Foundations to Resist Earthquakes

G.C. Thomas and K. McGowan

School of Architecture, Victoria University of Wellington, Wellington, New Zealand.

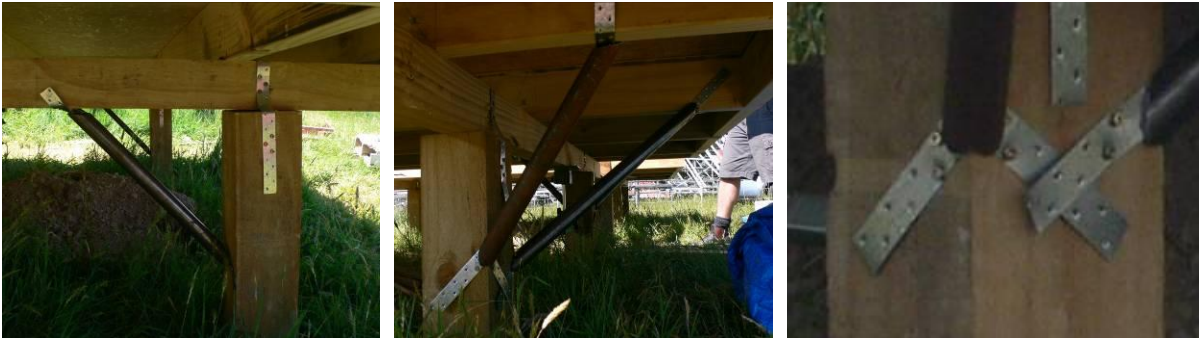
running two nail straps through a hollow steel pipe, to provide compression capacity. The two straps can then be splayed apart at the end of the pipe allowing nailing or screwing to timber members in a range of orientations as shown in Figure 2.

Figure 2. Steel pipe/nail plate connection, connected at 90° from pile to bearer (left) and at about 45° from pile to joists (centre) and close up of connection (right)

Specimens were mostly tested using 8 gauge screws as it is envisioned that these devices would mostly be used in confined subfloors where cordless drills were more practical than hand driven nails.

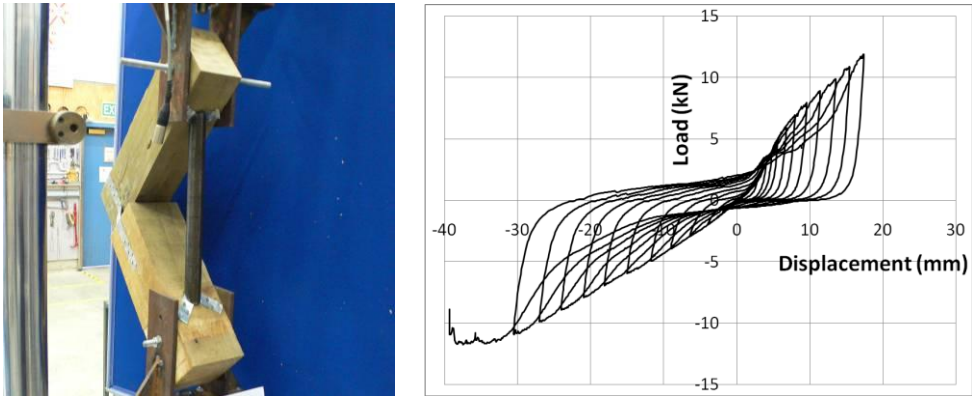
Initial tests were carried out in the “DARTEC” universal test machine at BRANZ. The model set-up is shown in Figure 3 (left), with the load displacement plot (right). This test specimen consists of a 33.7*4.0 steel tube and two 25*1.0mm Grade 300 Mitek straps, into a 125x125 pile and 140x90 Bearer, with two 8 gauge screws in each strap end.

Figure 3. Dartec test specimen (left). and Load vs. Displacement, note positive force and displacement is when the joint is closing, and the specimen is in compression.

The capacity is about 12 kN in tension and compression compared to a pile to bearer joint lateral shear capacity of 8.5 kN and a moment capacity of 3 kNm. Larger moment capacities can be achieved by using a longer brace, but this was not possible due to limitations of the test set-up. The system is ductile in both tension and compression but is stiffer in compression, where the tube ends push on the folded out strap and timber behind. In tension, the straps bend around the screw heads and straighten out resulting in more deformation.

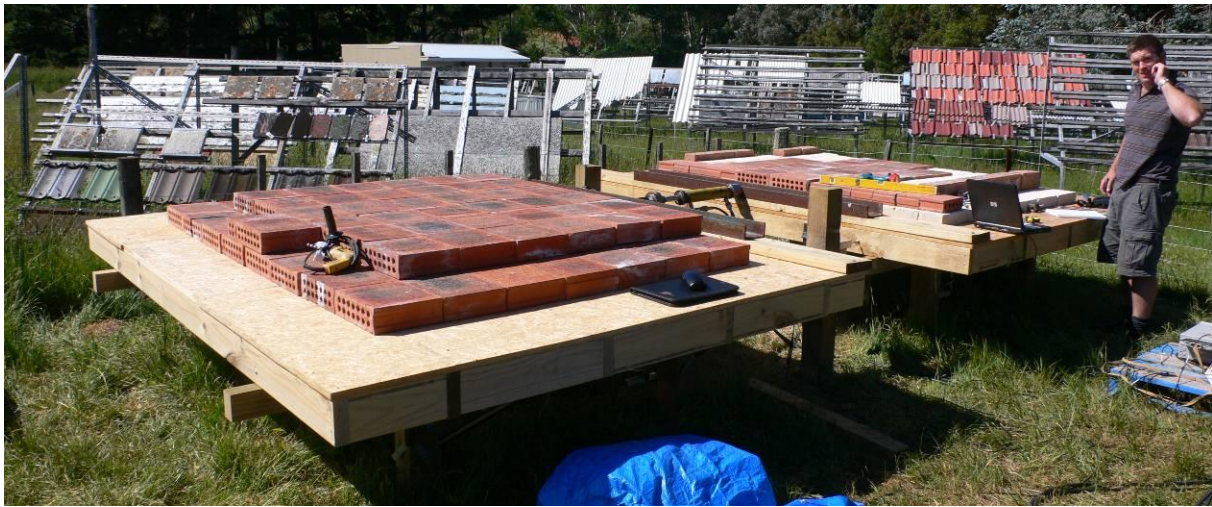
The general layout of the test specimens is shown in Figure 4. Framing and nailing were as per NZS3604:1999, including Amendment 1 & 2. Piles were pre-cut 125*125mm with 600 mm clearance between the bearer and the top of the concrete footing. Bearers were 90*75 mm spanning 1.35 m and joists were 190*45 mm spanning 2.0m. Joists to bearer connections were 2 no. 100*4 mm skew nails. Flooring is standard 20 mm flooring grade particle board fixed with 60*2.8 mm ring shanked flooring nails at 150 centres on sheet edges and 300 mm centres on intermediate supports. With overhangs, each piece of floor was 3.2 m long (along joists) and 2.5 m long (across joists). Each floor section was loaded with 400 kg of bricks and/or concrete pavers to simulate a factored live load and dead load of superstructure of 0.5 kPa. Footings were the minimum size permitted in NZS3604, of 200 mm square and 200 mm deep. The top of the concrete footing was a minimum of 50 mm below ground level, but varied from 50 to about 80 mm due to a slight slope in the site.

Figure 4. Large scale test set-up.

Three arrangements of braces were tested, as well as a control specimen with no braces. The pile-to-bearer connection consisted of 2 no. 100*4 mm skew nails and a 25*1 mm Grade 300 nail strap with 3 no. 8 gauge screws on each side of the pile and bearer in all tests including the one with no braces. One specimen had braces located between the piles and bearers with loading parallel to the bearers (Figure 2, left), and the other two specimens had braces running from the piles directly to joists, at 45 horizontally to the bearers and joists (Figure 2 ,right). In the last two specimens the direction of loading was along the joists in one, and along the bearers in the other.

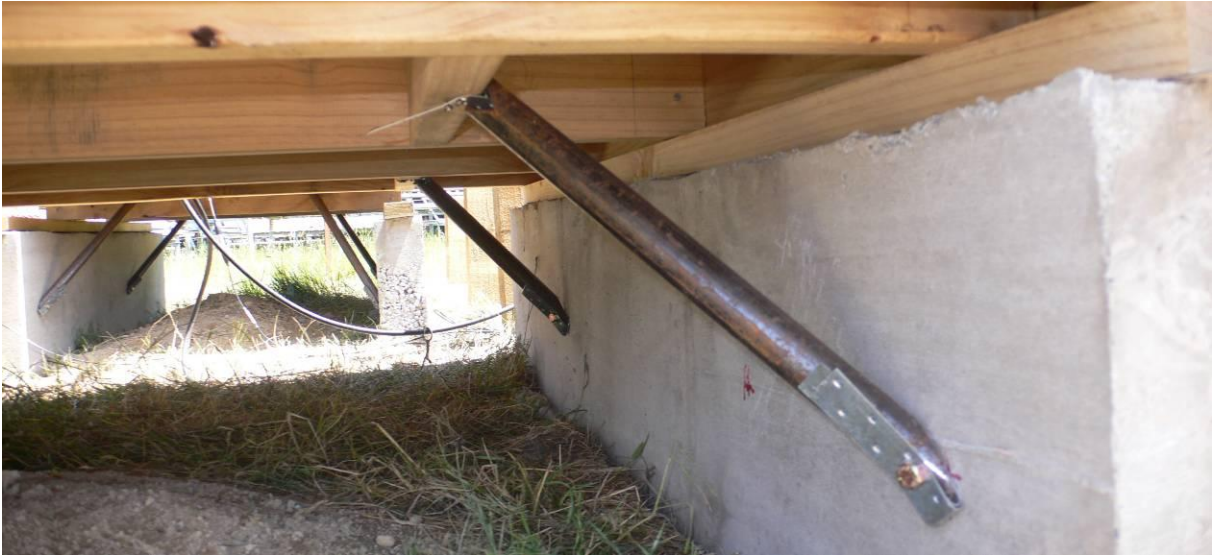
The straps at the other end of the brace can then be fixed to floor joists running parallel to the wall or blocking between joists running perpendicular to it. Sections of floor similar to those described previously were located on two pairs of parallel walls, ones set 1.35 m apart supporting bearers with loading perpendicular to the bearers and the other set 2.0 m apart supporting joists (Figure 6).

Figure 6. View of underside of wall specimens

The bearers for one pair of walls (rear of figure 6) rested on top of the wall. Although this is not the most common method of supporting bearers running perpendicular to a foundation wall, it has the least lateral load capacity compared with other methods such as inseting the bearer into a slot in the wall or supporting the bearer on a cast in-pier that sits lower than the top of the perimeter wall. This was shown dramatically in the test as the failure mode was roll-over of the bearer (Figure 7 (left)). The other wall specimen with joists supported by the walls and the braces fixed to blocking between joists performed more satisfactorily. The braces ran in opposite directions on each wall resulting in significant twisting of the specimen (Figure 7 right). Hysteresis loops are shown in Figure 8.

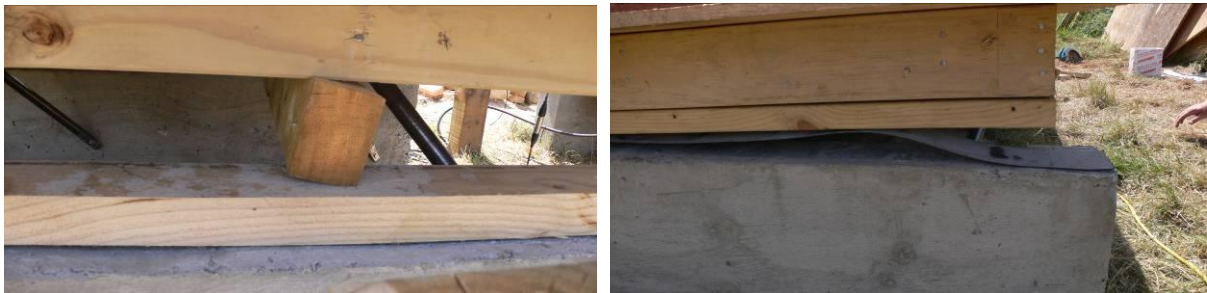
Figure 7. Left, failure of bearers in roll-over. Right twisting of other wall specimen
