Seismic assessment and strengthening of the Auckland International Airport Control Tower

E.S. Kunkel

2013 NZSEE
Conference

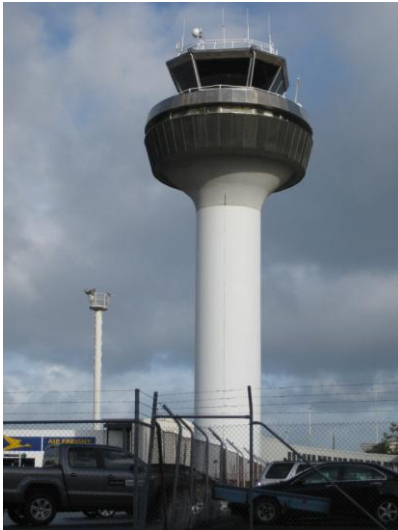
Figure 1: Control Tower elevation

Constructed in 1963, the Control Tower structure is located west of the south end of Fred Ladd Way at the Auckland International Airport. The Control Tower stands 29m high and is comprised of two elevated levels atop of a main reinforced concrete tower. The upper levels are constructed from reinforced concrete, structural steel, and timber. At an elevation of 22.4 metres above the foundation base, the lower of the two elevated levels functions as a service floor. At an elevation of 26 metres above the foundation base, the upper of the two levels functions as a control cab.

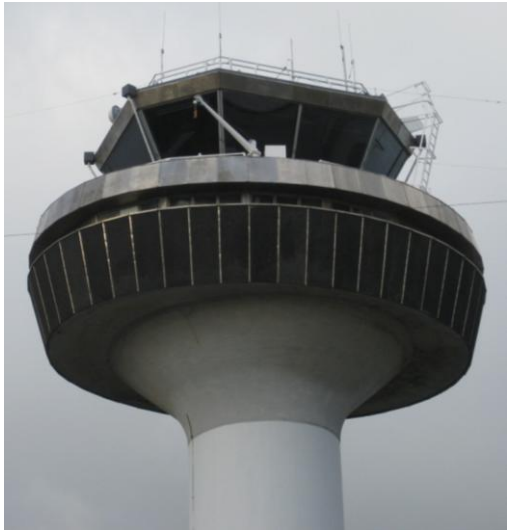
Figure 2: Close-up of service and cab levels

Atop of the main tower shaft is the elliptical-shaped service floor, the lower of the two elevated levels. The service floor major and minor axis dimensions are 12.8 metres and 10.4 metres, respectively. The service level floor slab is a 229mm thick concrete slab supported by the main tower shaft circular wall at the interior of the slab and by the main tower shaft's cone-shaped wall at the exterior of the slab.

Cantilevering up to 1.9 metres beyond the cone-shaped wall, the service level slab supports the service level exterior and interior timber framed walls, the service floor concrete roof, and the cab level concrete frame. As part of the exterior wall framing, horizontal steel angle trusses support the precast concrete panels at the lower half of the walls and vertical steel angle trusses support the stainless steel clad mansard parapets at the upper half of the walls. Vertical steel angles and horizontal channels support the parapet's vertical trusses and the precast panel horizontal trusses. Half of the service floor's concrete roof is supported by these angles and channels within the exterior walls of the service level. The other half of the concrete roof is supported by the cab's concrete frame.

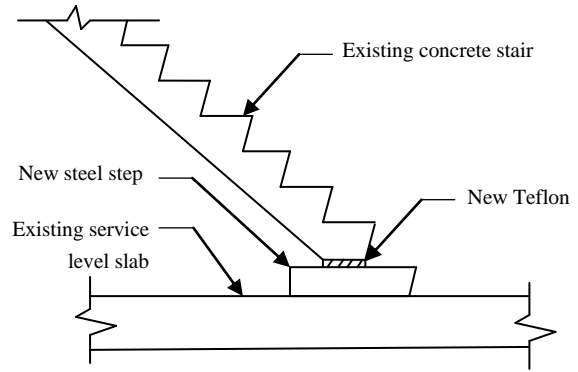
Figure 8: Cab access stair after remediation

The remediation methodology chosen for the cast in-situ concrete access stair was to disconnect the stair from the cab's lateral force resisting system (the cab's concrete moment frame) at the stair's base. This was accomplished by removing the bottom in-situ concrete step and replacing it with a new steel step. Only allowing for vertical support of the stair, the new steel step would be mechanically connected to the top of the service level slab. A Teflon pad would be placed between the bottom of the existing concrete stair and the top of the new steel step, effectively disconnecting the access stair from the cab's lateral force resisting system. Installing the Teflon pad allows for the access stair to slide across the top of the steel step during a seismic event. Because the Teflon pad disconnects the access stair from the cab's lateral force resisting system, the only forces present within the stair at all times are gravity forces. [Disconnecting the access stair also removed the lateral forces in the cab access stair support beam, eliminating the need to retrofit this cab structural element.](#)

Implementation of the cab access stair remediation required removal of the bottom step of the cast in-situ stair. Upon removal of the bottom concrete step, the new steel step was slid into place and attached to the service level concrete floor slab with post-installed mechanical anchors. Reference Figure 7 and Figure 8 below for cab access stair construction prior to and after remediation, respectively.

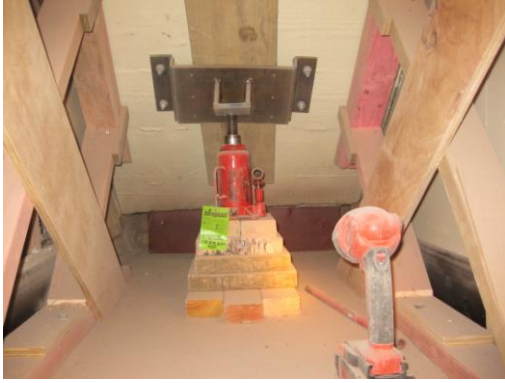
Figure 11: Cab access stair jacking

For the cab access stair, the engineer’s proposed implementation strategy involved propping the stairs, removing the bottom concrete step, sliding in the steel step, attaching the steel step to the service level floor slab and then, lastly, placing the Teflon pad between the steel step and the existing stair. The contractor proposed a modification to this implementation strategy, which involved jacking the existing stair roughly 5mm to allow for the installation of the steel step. This modification was reviewed by Opus and determined to be a feasible modification to the implementation strategy. Reference Figure 11 for the jacking setup. Reference Figure 12 for the installed steel step.

The second contractor related issue involving the implementation of the cab access stair remediation was related to the steel step being fabricated too tall. This forced the contractor to remove more of the underside of the existing stair and to increase the jacking amount to roughly 10mm.
