South Brighton Bridge: Lateral spread mitigation using jet grout lattice structures

C Keepa, G Saul, A Murashev

Opus International Consultants

2014 NZSEE
Conference

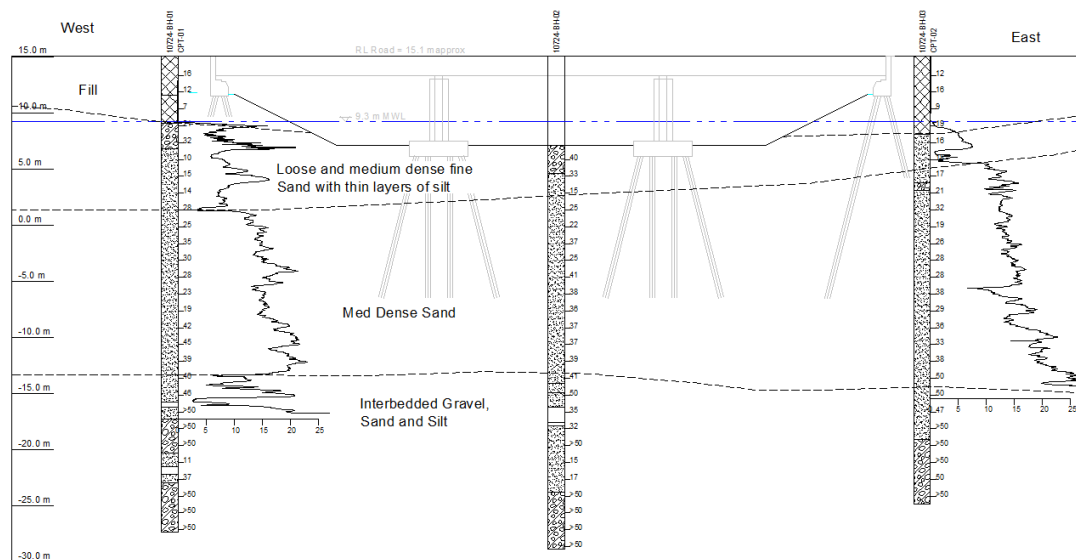
Figure 1. Ground profile

Figure 1 shows ground conditions along the centreline of the bridge inferred from borehole, CPT and seismic dilatometer testing carried out at the site. The site is located near the Heathcote – Avon River Eastury and is underlain by approximately 35 m of beach and alluvial sands which overlie dense alluvial gravels. The gravels extend several hundred meters deep and are interbedded with stiff silts and clays. The sands are typically fine and loose up to a depth of 6 m to 10 m and fine to medium coarse and medium dense to dense from the base of the loose sands to a depth of 35 m. Occasional thin layers of firm to stiff silt are interbedded within the sands, particularly in the upper 6 m to 10 m of the ground profile and below 23 m depth. The road embankments that form the approaches to each end of the bridge are constructed of sand and silty sand and are up to 4 m high.

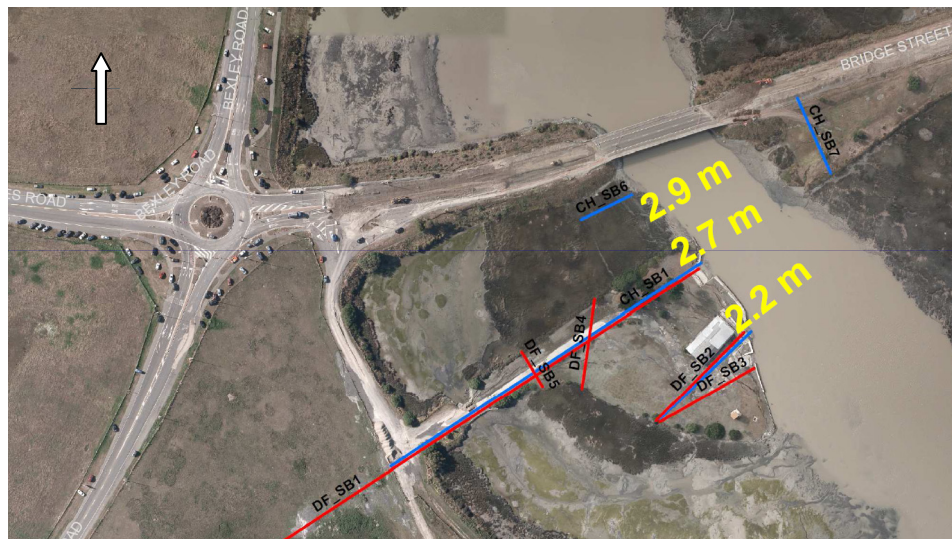
Figure 3. Lateral spread displacements (Cubrinovski 2012)

Peak ground accelerations of 0.23g and 0.59 g were recorded at the nearby Pages Road strong ground motion station during the respective September 4 2010 and February 22nd 2011 earthquakes (Geonet, 2013). Substantial lateral spreading of the river banks and approach embankments occurred at this site in both events. Approximately 100 m south of the bridge site, lateral spreading displacements between 0.79 and 1.05 m were measured after the September 4, 2010, earthquake (Cubrinovski et al, 2014). Lateral ground displacements of 2.9 m were measured approximately 23 m to the south of the bridge's west abutment following the February 22, 2011 earthquake. Figure 3 shows lateral spread

displacements measured following the 22nd February 2011 earthquake.

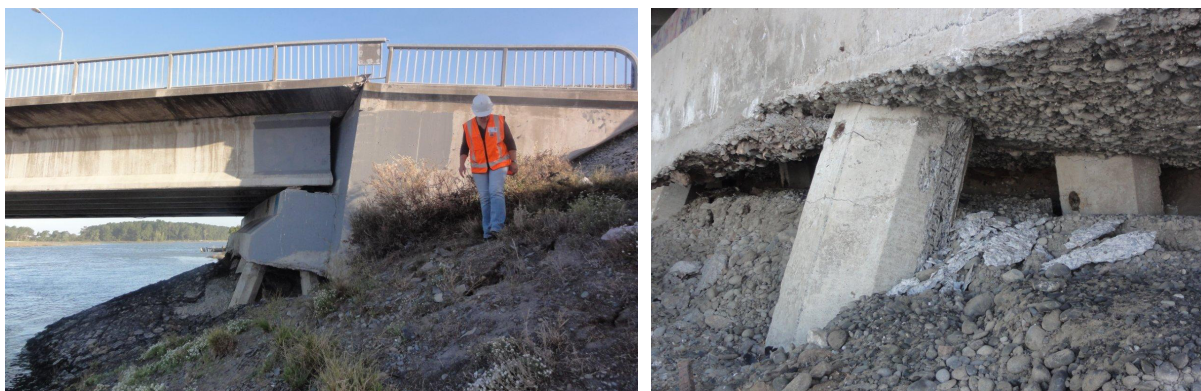
Figure 4. Abutment damage

Pinning by the bridge piles and propping between the abutments by the stiff superstructure constrained lateral spreading at the abutments. The abutment piles were not able to fully resist spreading of the banks and the abutment blocks and backwalls rotated back about the lower flange of the bridge beams by approximately 7° - 8°. Lateral displacement of the tops of the piles was in the order of 200 mm (Cubrinovski et al, 2014). Tensile cracking was evident on the river side of the piles along with spalling on the landward side from the combined translation and rotation of the piles heads. Figure 4 depicts spreading-induced damage to the South Brighton Bridge.

Because of the skew and stiffness of the bridge, the direction of lateral spreading of the approach embankments was biased toward the south at the western abutment and towards the north at the eastern abutment. Differential subsidence between the piled abutments and the approach embankments was in the order of a few hundred millimetres.

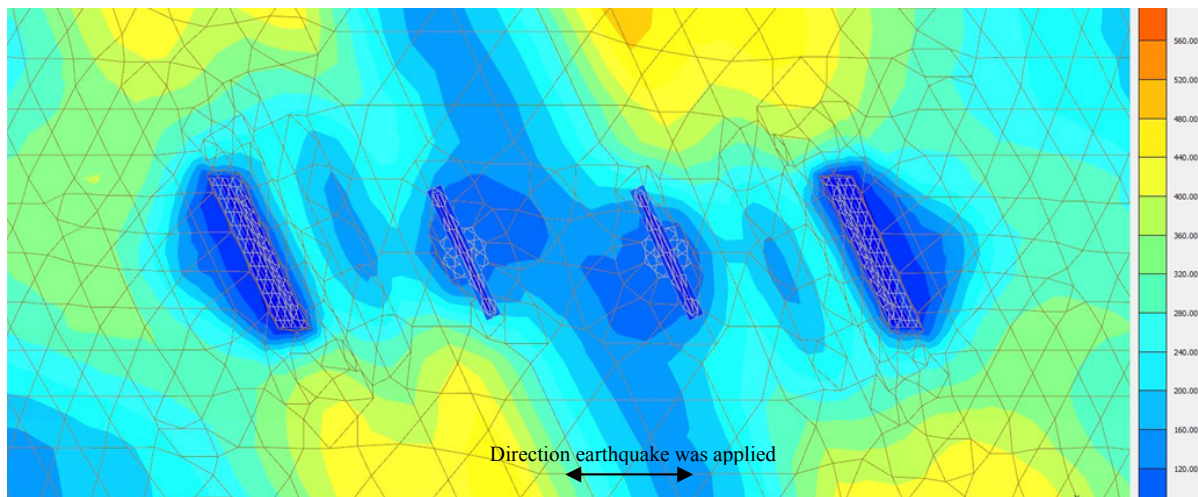
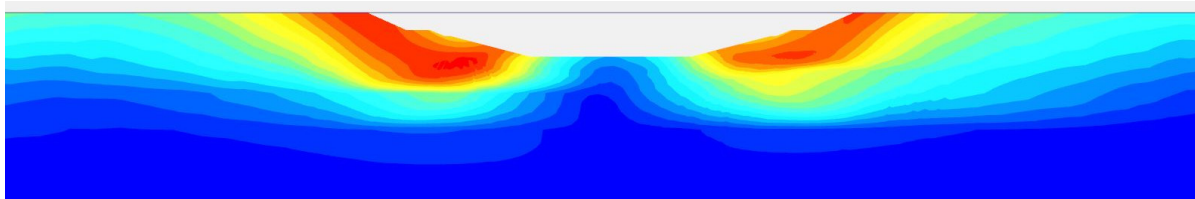
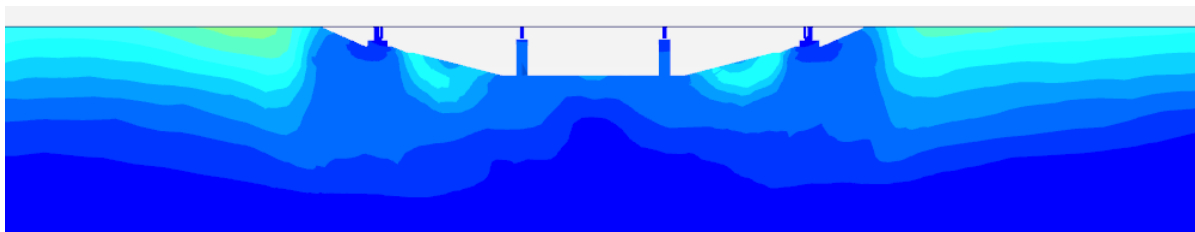
Figure 8. Typical displacement contours along the bridge centreline

The reduction in lateral spreading at the bridge from the ground improvement and the bridge itself is depicted in Figure 8 which shows typical displacement contours calculated in the 3D FE model following a time history analysis. The effects of the skew of the bridge on the ground displacements is evident in Figure 8a. Although the overall response appears reasonable, with the constraints of having a continuous mesh restricting the potential for the ‘flow’ of soil around the blocks and numerical problems with large strains, the calculated displacements should be viewed with some skepticism.

a) Plan: surface displacement contours (Contour interval = 40 mm, dark blue = 0 mm disp)

b) Section: Free field displacement contours (without the ground improvement or bridge), peak displacement is 670 mm (red shaded area 640 mm to 680 mm)

c) Section: Displacement contours along bridge centreline

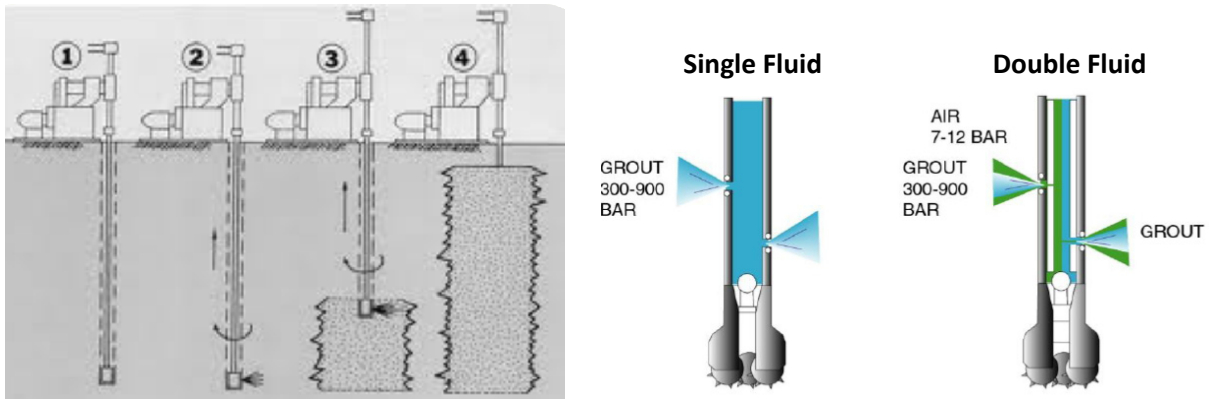
Figure 10. Jet grouting Process

Jet grouting is a relatively new technology to New Zealand and equipment including grout mixes, high pressure pumps and an injection rig were brought from the USA for construction of the jet grout columns at South Brighton Bridge. Construction of jet grout columns involves drilling to the base of the column then mixing a cement slurry into the soil insitu with rotating high pressure jets that are located just above the drill head as the drill string is brought to the surface, the process is illustrated in Figure 10. Both single fluid (grout jets only) and double fluid (air and grout jets) have been used at South Brighton Bridge. The double fluid process is capable of producing larger diameter but generally weaker columns compared to the single fluid process.

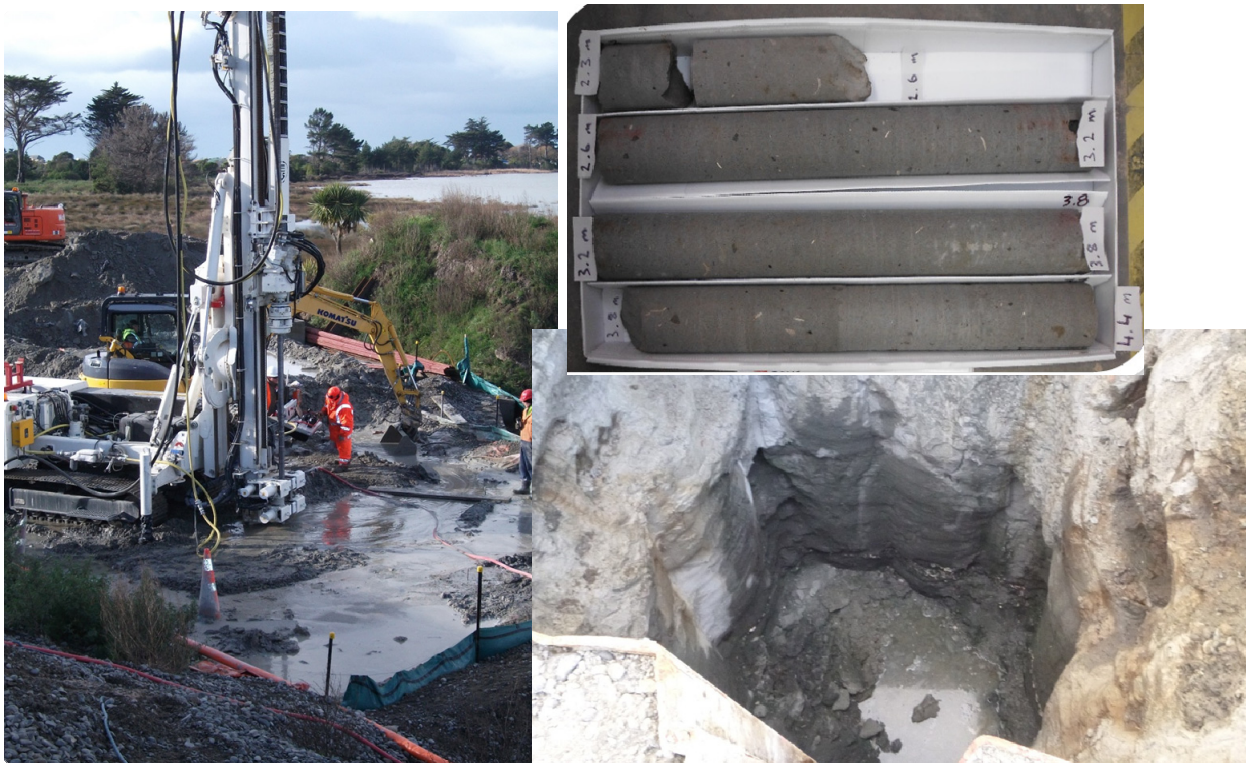
Figure 11. Trial column construction

Before commencing the ground improvement works at the bridge abutments, a trial was carried out to determine additive dosage rates, fluid pressures, jet rotation speeds and step times to create thoroughly mixed, sufficiently strong and columns of sufficient diameter. The upper parts of the walls created in the trial were excavated and examined. Figure 11 shows the rig installing the trial columns and the columns exposed after the first trial. A number of boreholes were drilled in the trial sections to assess the diameter of the columns the amount of overlap, the strength of the grout and consistency of the mixing at depth. Sonic cross-hole testing was also undertaken on one of the columns to assess mixing consistency and the structural integrity of the columns.

Getting a suitable column diameter and overlap in the medium dense to dense sands in the lower parts of the walls proved challenging. Pre-cutting using bentonite was employed for lower parts of the columns to get a larger diameter and improve overlap between columns in the medium dense to dense sands. Column strengths were higher than expected with 28 day unconfined compressive strengths ranging between 3.5 MPa and 77 MPa with an average strength of 20.0 MPa.
