# Lessons from liquefaction damage to bridges in Christchurch and strategies for future design

P. Brabhakaran

**2014 NZSEE  
Conference**

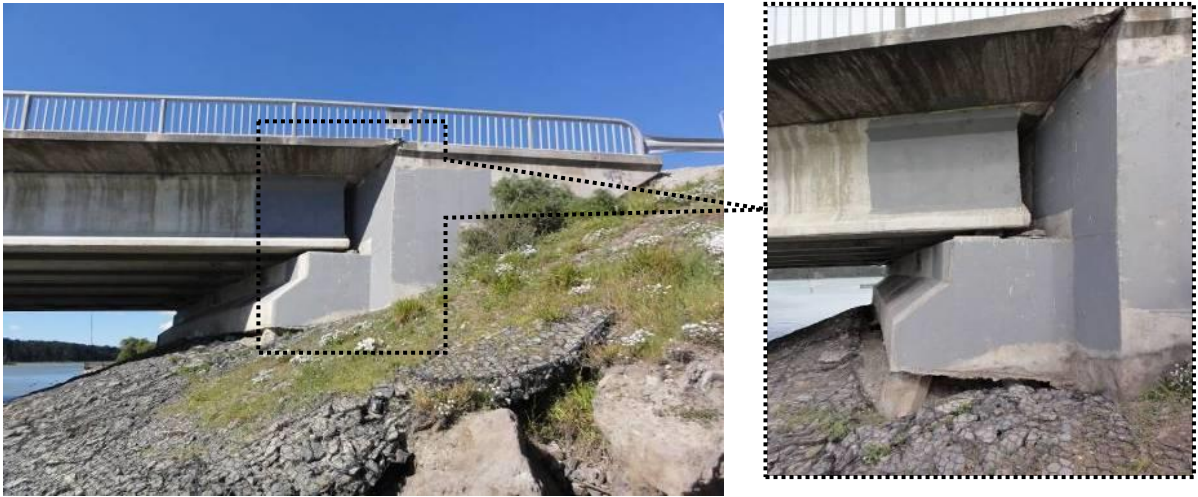
Figure 2 shows the South Brighton Bridge across the Avon River, which experienced severe damage to its abutments due to liquefaction and lateral spreading. This was constructed and opened in 1981.

**Figure 2. Damage to bridge abutment at South Brighton Bridge in the Darfield Earthquake of 4<sup>th</sup> Sep 2010**

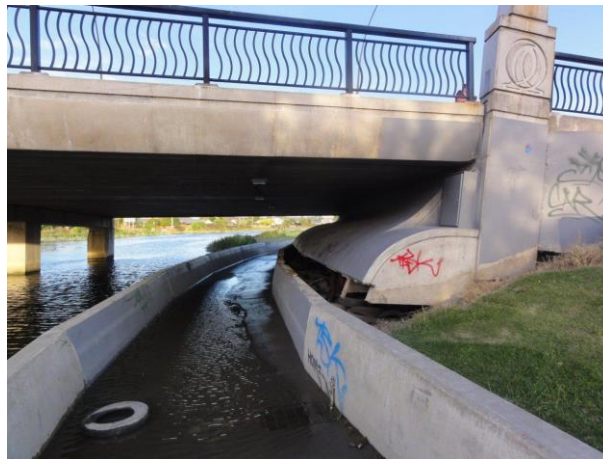
Figure 3 shows the State Highway 74 ANZAC Bridge which was constructed in 2000, and suffered severe damage as a result of liquefaction and associated lateral spreading. This caused damage to the abutments as well as to the piers that were relatively close to the river banks.

**Figure 3. Damage to SH74 ANZAC Bridge in the Canterbury Earthquakes**

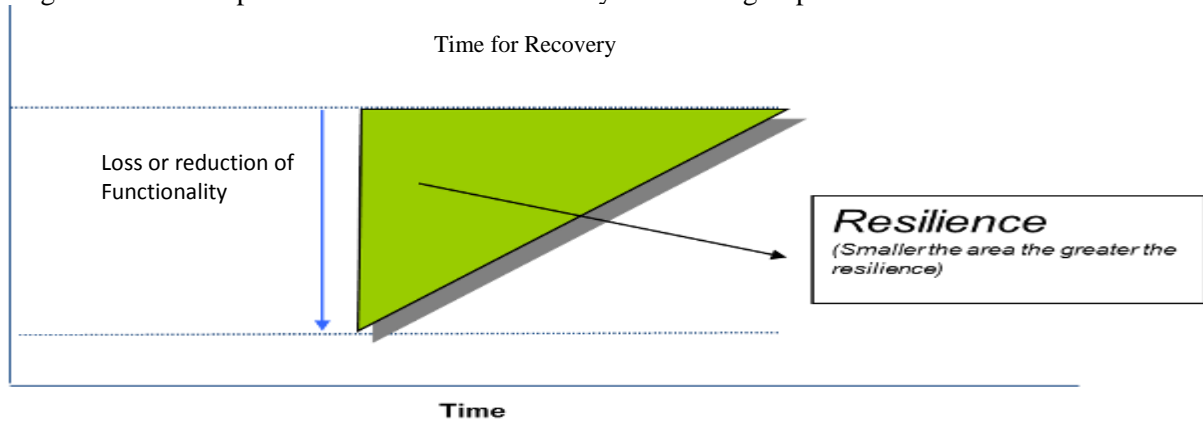
Resilience can be defined as the ability to recover quickly to provide a level of service prior to the event, as illustrated by Brabhakaran (2006). This is illustrated conceptually in Figure 4.

**Figure 4. Conceptual Definition of Resilience (after Brabhaharan, 2006)**

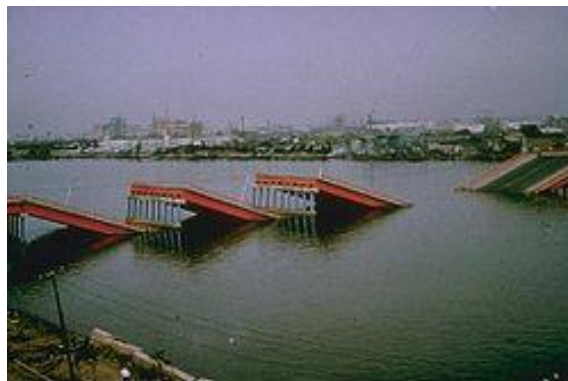
The phenomenon of liquefaction has been better understood in the last 50 years. The 1964 Niigata Earthquake was a landmark earthquake where the effects of liquefaction caused widespread damage to buildings and infrastructure, including the collapse of bridges, see Figure 5.

**Figure 5. Collapse of Bridge in the Niigata Earthquake attributed to Liquefaction and Lateral Spreading**
