# Time history analysis correlation between observed and predicted response of typical industrial buildings with steel portal frame and concrete tilt panel cladding during Christchurch earthquake

2014 NZSEE  
Conference

W. Batchelar, M. Mashal & D. Southwick

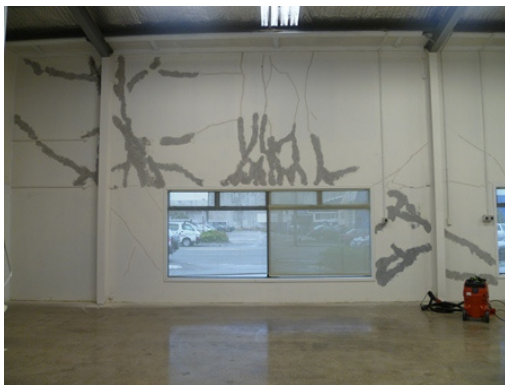
**Photo 1: Upper half of the panel is spanning horizontally resulting (for this case) in widespread vertical cracking.**

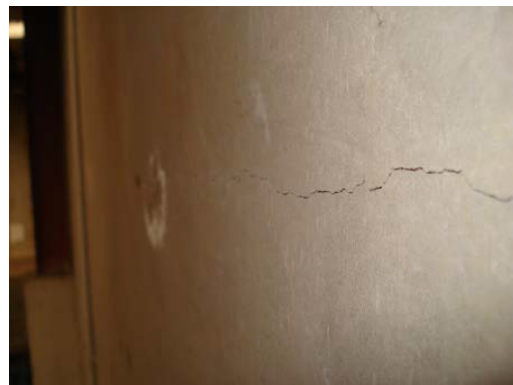
**Photo 2: Example of typical residual crack in a panel.**

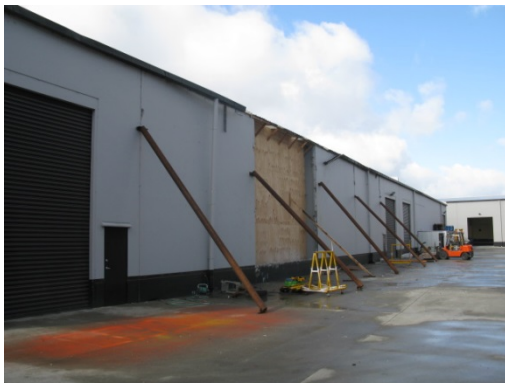
**Photo 3: Instances of panel collapse and stability concerns occurred.**

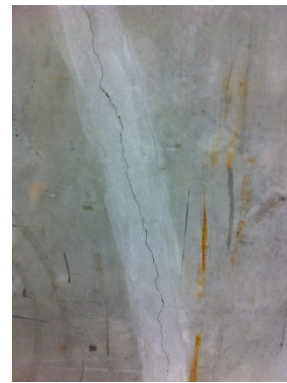
**Photo 4: Concrete crack (1.0-1.5mm) ready to receive repair by epoxy injection.**
