Experimental investigation of wall-to-floor connections in post-tensioned timber buildings

D. Moroder, F. Sarti, A. Palermo, S. Pampanin & A.H. Buchanan

2014 NZSEE
Conference

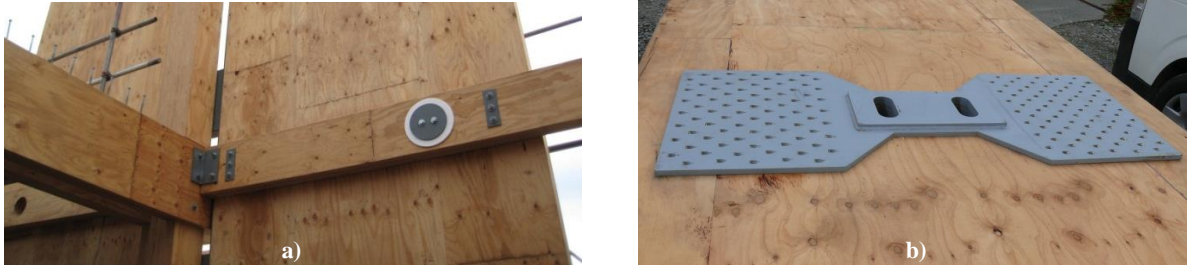
Figure 2. Connection of collector beams to walls. a) NMIT Building in Nelson with a large diameter pin (Devereux et al. 2011); b) Trimble Building in Christchurch with a steel-to-steel connection (Brown et al. 2012)

Another solution was chosen in the design of the *NMIT Arts and Media Building* in Nelson designed by Aurecon (Devereux et al. 2011) where the collector beams have been connected to the coupled walls by 200 mm steel pins, located slightly offset from the centre of the wall to avoid the central post-

tensioning cables. The non-continuity of the collector beam and the distance between the pins create little restraint in case of wall uplift. Furthermore, the pin acts as a hinge so that no rotation will be imposed on the beam. A connection design which is supposed to eliminate any displacement incompatibilities has been built in the *Trimble Building* in Christchurch designed by Opus International Consultants (Brown et al. 2012). A steel plate with a vertically slotted hole has been attached to the timber wall; similarly a steel plate with a round hole was attached to the collector beam, so that a simple steel pin can transfer horizontal forces while allowing for uplift and rotation. In the currently under construction *Kaikoura District Council Building* designed by Nelson Timber Solutions Ltd, each timber-to-timber connection between the collector beam and the wall is a group of bolts arranged in a circular pattern. Because of the confined connection geometry, rotation is allowed, uplift of the beam however needs to be accounted for by checking the bending strength and stiffness of the collector beams.

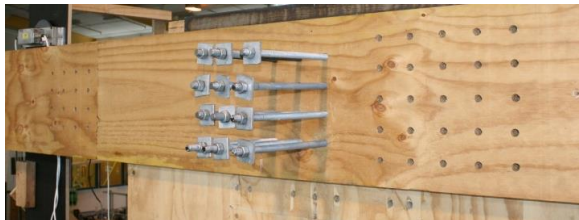
1) 12 centred 16mm bolts

Connection type 1 - centred group of 12 bolts:

This connection had a relatively small rotational stiffness and forced the beam to rotate slightly. Because of the centred position and the high linear stiffness, the beam followed the wall uplift closely. The stiffness of the system was increased slightly when compared to the wall tested without beams.

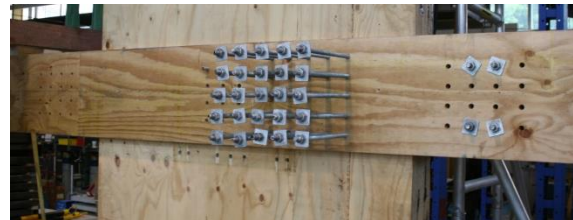
2) 25 eccentric 16mm bolts

Connection type 2 - eccentric group of 25 bolts:

Because of the eccentric connection, the uplift of the beam was noticeably higher when the wall was pushed. Similarly the strength of the system had a big increase in the same direction, as the beam had to be bend closer to the support. Even with a higher rotational stiffness, the beam did not rotate more than with connection type 1.

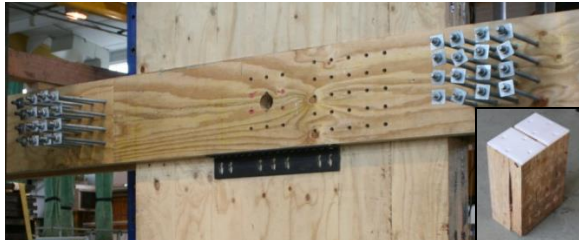
3) timber blocks pushing against the wall

Connection type 3 - external blocks with dowels:

Although the rotation of the beam is similar to the bolted connections (type 1 and type 2), the uplift of the beam was bigger, as the timber blocks were pushed up by the wall due to friction, even though care was taken to reduce the friction. The beams therefore had a vertical displacement close to the wall edge uplift, which is higher than the one at the wall centre. There was also a noticeable increase of strength in this system.

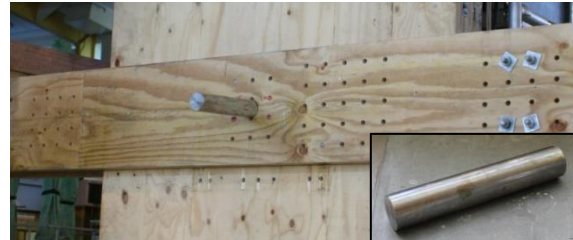
4) centred 65mm diameter pin

Connection type 4 - large diameter pin:

As expected, no rotations were transferred to the beam and the uplift of the beam followed closely the

wall uplift. There was almost no interaction of the beams with the wall in terms of strength increase.

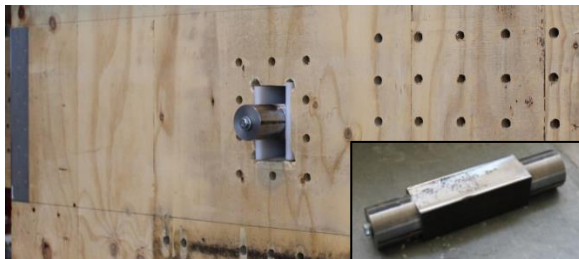
5) centred 65 mm diameter pin with slot in wall

Connection type 5 - large diameter pin with slotted hole:

This connection was supposed to provide better results than connection type 4, as uplift should be prevented by the slotted hole in the wall. Because of the high friction however, the expected sliding did not occur. In terms of rotation and strength increase the two connections type 4 and type 5 were relatively close and differences can be attributed to construction tolerances.

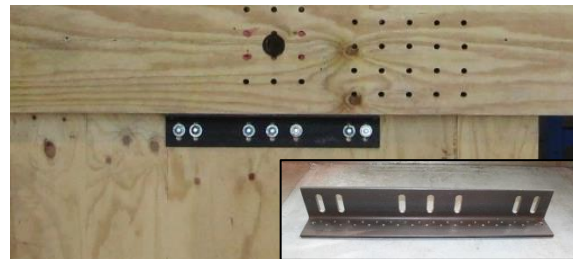
6) steel comb with slotted holes

Connection type 6 - steel comb with slotted holes:

Because of the high friction between the external bolts and the steel element, no sliding occurred on the slotted holes. Due to the length of the steel comb, high rotations were imposed on the beam. This was also reflected in the increase of stiffness of the system compared with no beams.
