External reinforced concrete beam-column subassemblages in fire

2014 NZSEE
Conference

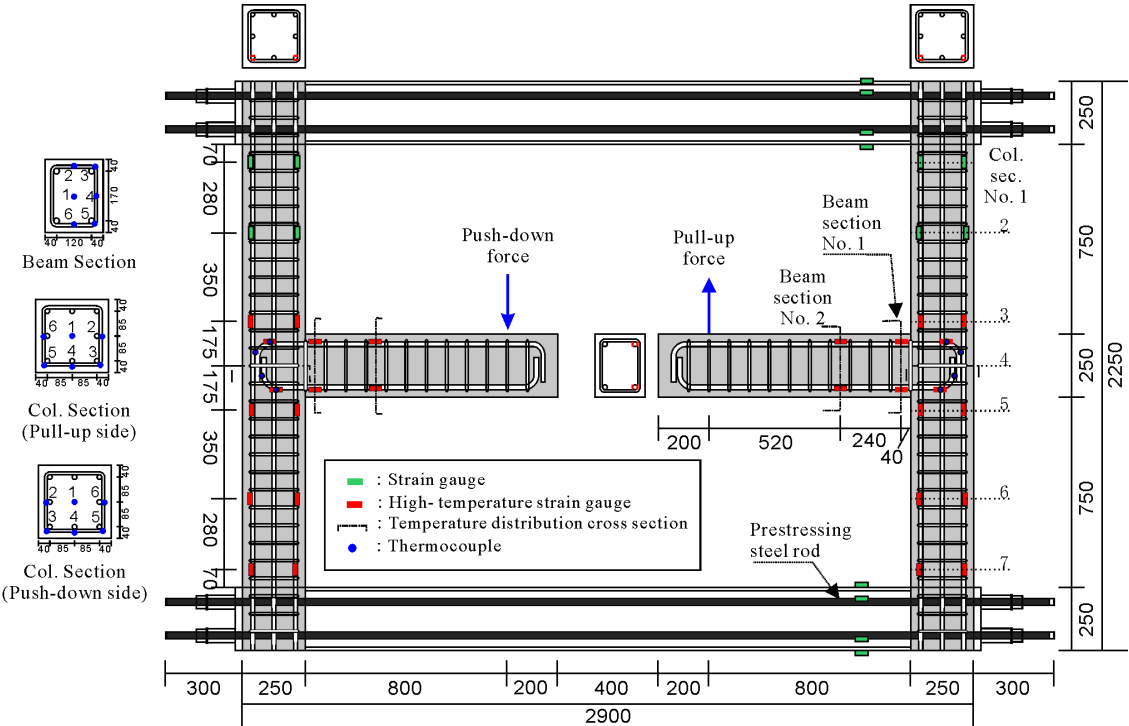
Figure 1: Specimens geometry & arrangement of strain gauges and thermocouples (unit: mm)

As it is shown in Figure 1, two RC beam-column sub-assemblages were constructed in scale of 1/3. The cross-sections of beams and columns were 200×250mm and 250×250mm, respectively. The two columns' bases and heads were linked together via two H-shape steel beams (250×250×9×14). Four prestressing steel rods (ϕ 26mm, SBPR 1080/1230) were used to connect the H-beams to the columns bases and heads tightly by post-tensioning. The prestressing load for each prestressing steel rod was 141 kN. The details of reinforcement and materials are shown in Table 1 and 2, respectively. Two

Figure 1 shows the arrangement of thermocouples and strain gauges. Cross-sections 4 to 7 of each column and 1 and 2 of each beam were instrumented with six thermocouples per a cross-section. Four thermocouples were also installed inside the beam-column joint. However, in this paper the temperature distributions of cross-sections 1 and 2 of beams and 4 of columns are presented. Figure 2a illustrates the arrangement of displacement gauges. In order to measure the deflection of each beam, two displacement transducers (DT), DT1 and DT3, were installed at a section 80mm from the column face (80mm-section) and another two, DT2 and DT4, at 800mm-section, respectively. The relative

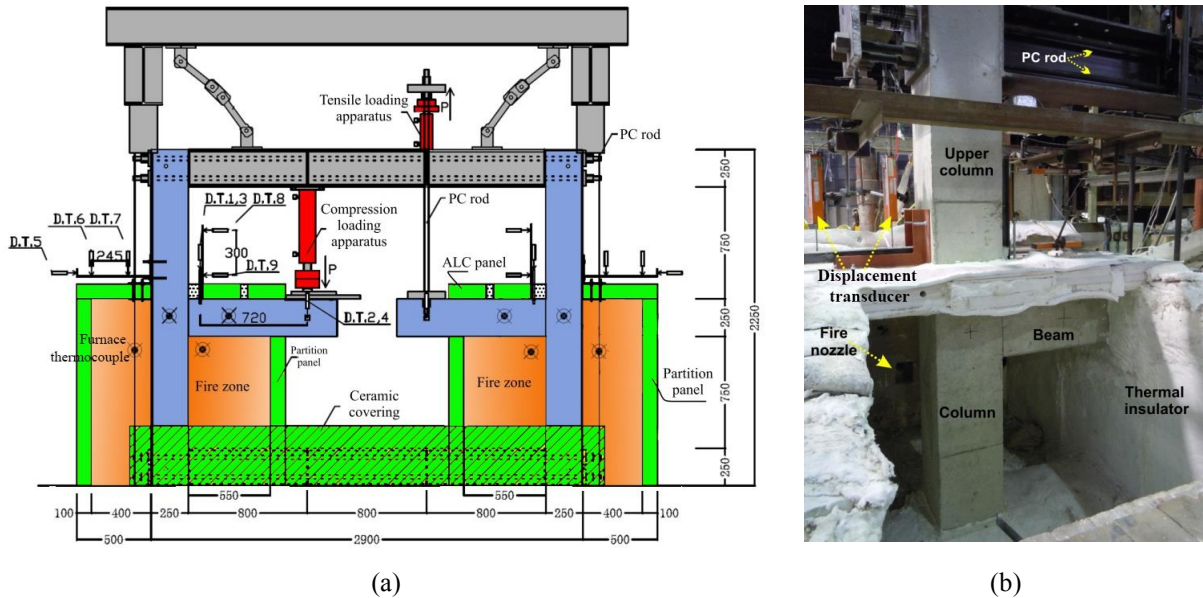
Figure 2: Loading apparatus, furnace, and displacement transducers arrangement (unit: mm)

Arrangement of loading apparatuses and furnace are shown in Figure 2a and 2b, respectively. The test was consisted of two phases; in the first phase two equal vertical 17.3kN forces were applied at the left beam end and the right beam end downward and upward, respectively. The loading point in each specimen was at a section which was 800mm from the column face. When the specimens were under the load, the widths of newly formed hairline cracks were measured (less than 0.10mm wide).

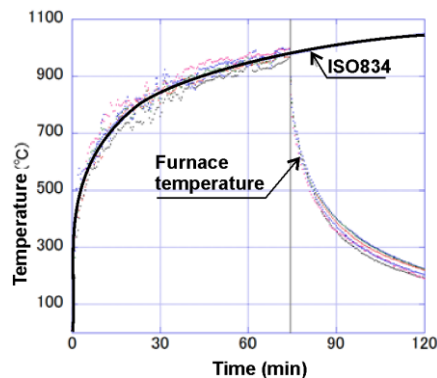
Figure 3: Standard fire ISO834 and furnace temperatures

In the second phase, the heating process started according to the standard fire ISO834 which is shown in Figure 3. Eight thermocouples were measuring the furnace temperatures. The fire zone in each specimen was covering the beam (except for its top face) and the lower column. To keep the load cells out of the furnace, the fire-exposed length of each beam was limited to 550mm from the column face. The lower steel H-beam was thermally insulated with several sheets of insulator and gypsum paste.

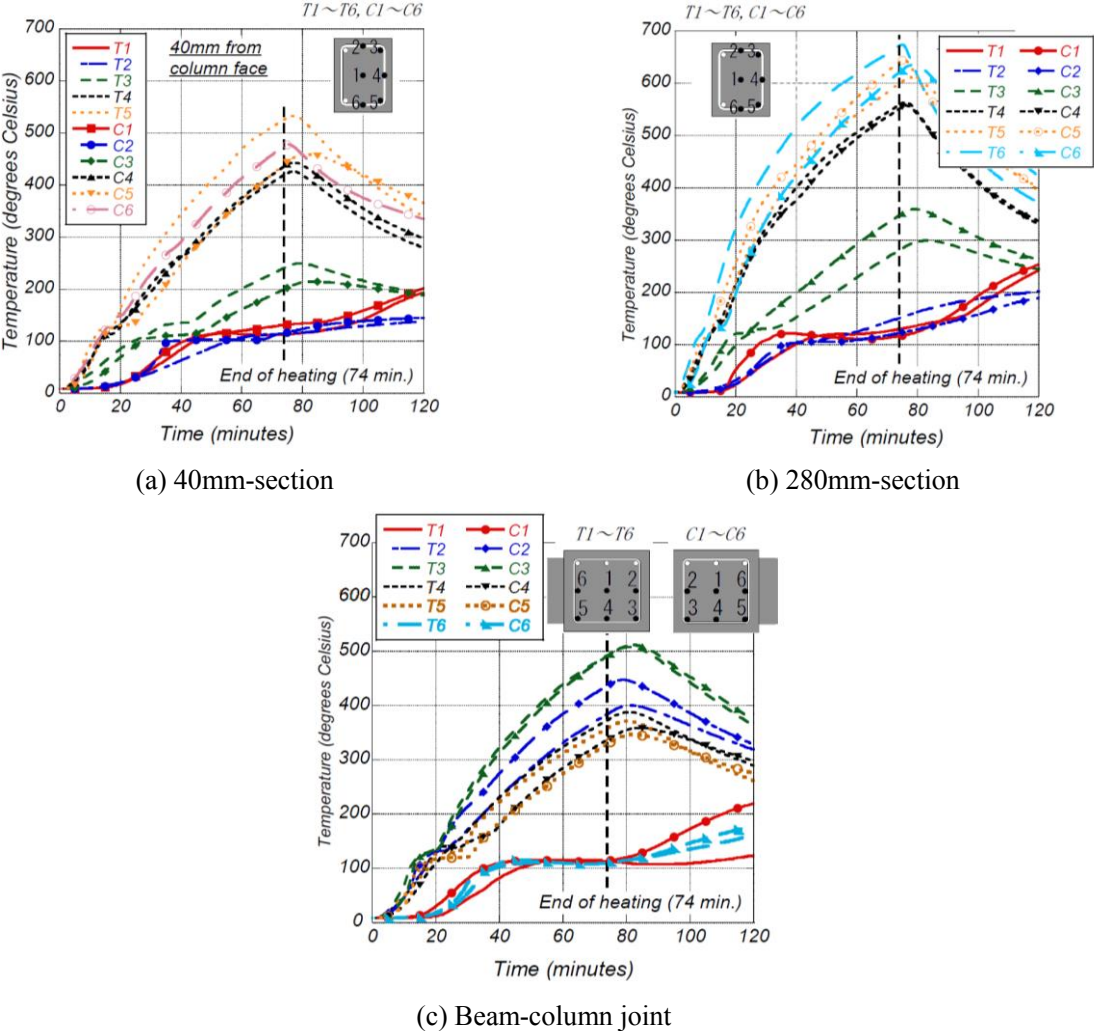
Figure 4: Internal temperature distribution at different sections

In order to investigate the temperature distributions inside the beam-column sub-assemblies, each of the three sections was instrumented with six thermocouples. T1~T6 belonged to the pull-up side and C1~C6 belonged to the push-down side. The beam cross-sections in each side were located 40mm (40mm-section) and 280mm (280mm-section) from the column face. The column cross-section was aligned to the beam horizontal centroid axis. As can be seen in Figure 4, thermocouple No.1 measured the central temperature of each cross-section, No.2, 4, and 6 measured the hoops temperatures, and No. 3 and 5 recorded the temperatures of the longitudinal reinforcements.

As can be seen in Figure 4a, the bottom longitudinal reinforcement of the beam at the pull-up side reached the temperature 350°C 15min sooner, when the reinforcing steel strength degradation started. This was probably because of the cracks that had formed under the load and widened and extended at elevated temperatures. The effect of crack on fire-exposed reinforced concrete members is under investigation by the authors. At the end of the test the bottom longitudinal reinforcement in the pull-up

beam was 90°C hotter than the push-down side. However, the temperature measured at the top longitudinal reinforcement (No.3) in the pull-up side was 40°C lower than that of the push-down side at the end of the tests. Thermocouples No.2 and No.4 (hoops), regardless to the loading direction and the location of cross-section, roughly recorded the same temperatures. However, thermocouple No. 6 of 280mm-section of the pull-up side recorded temperature approximately 100°C higher than that of the push-down side (Fig. 4b). Thermocouple No.6 in the 40mm-section of the pull-up side failed to record any temperature. The 40mm-section absorbed less heat than 280mm-section. This showed a heat flow (heat conduction) from the hotter regions (cross-sections far from the column) to the less hot regions (cross-sections close to the column face).

Figure 4c shows the internal temperature distributions within the beam-column cross-section. This section was aligned to the centroid axis of the cantilever beam. Thermocouple No.1 was at the centre of the section and No.2 ~ No.6 were attached to the column longitudinal reinforcements. Even though thermocouple No.6 was close to the cracked zone, it measured considerably low temperatures. However, this lower temperature was in compliance with the heat transition from the 40mm-section to the column. Unlike the beams, there were no significant internal thermal differences when the loading direction changed. At the end of the fire test, thermocouples No.4 and 5 and thermocouple No.2 in the push-down side were 40°C and 50°C less hot in the pull-up side, respectively.

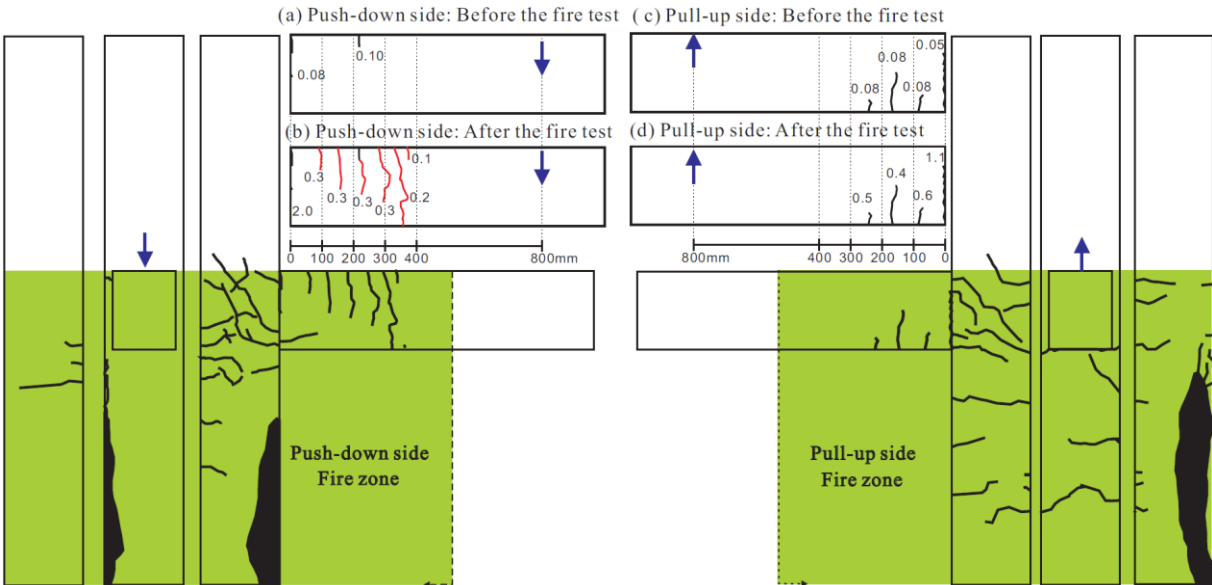
Figure 5: Crack pattern after the fire test (The black zone is the explosive spalling of concrete and the red lines are representing the extension of initial cracks)

After the fire test, an in-place visual inspection for the specimen was carried out. The color of the cooled specimens apparently had turned buff and mild pink. Except for intricate networks of superficial thermally-induced crackings all over the fire-exposed surfaces, several major medium and wide crackings were spotted as shown schematically in Figure 5.

After the initial loading, some hairline flexural cracks appeared in the beams. For example, at the beam-column intersection face in the push-down and the pull-up sides, 0.08mm and 0.05mm wide cracks formed, respectively. These cracks widened and extended in fire condition and other new ones appeared in the beams, beam-column joints, and columns. The maximum crack widths at the end of the test in the push-down and the pull-up sides were 2.0mm and 1.1mm, respectively. In the pull-up side, after 15 minutes, explosive spalling of concrete caused large cracks at the base of the column and as a result, some reinforcing steels of the column were directly exposed to the fire. The explosive spalling of concrete in the column of the push-down side also occurred but the exact time of happening was not detected.

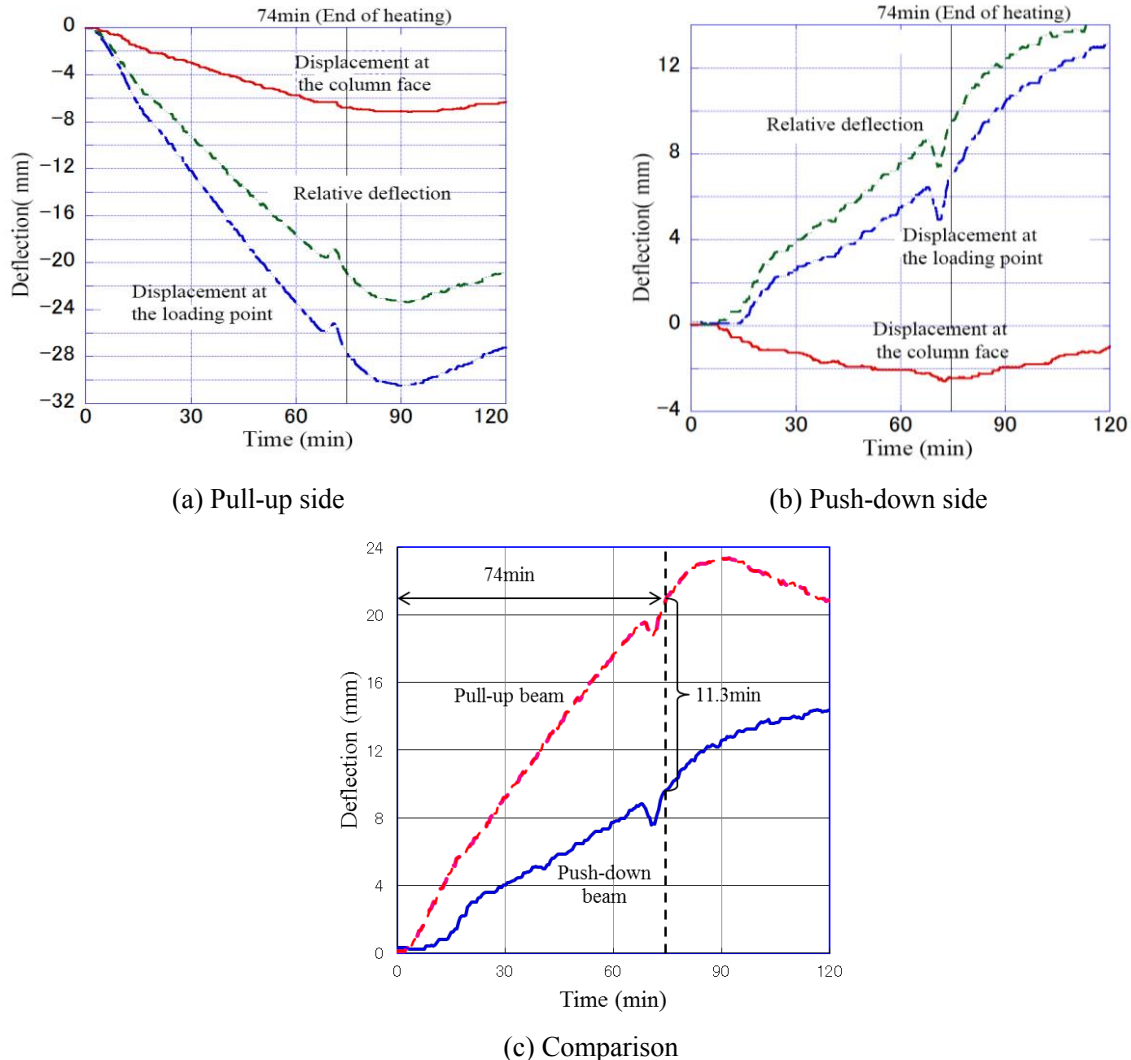
Figure 6: Relative vertical deflection of each beam

The relative vertical deflection of each beam was the difference of the vertical displacements of two locations on each beam; one roughly at the fixed end (80mm from the column face) and one at the loading point (800mm from the column face). Figure 6a and 6b show the relative vertical deflections of the pull-up and the push-down side beams against time, respectively.

Figure 6c is the comparison between the relative deflections of the beams. The positive direction is the downward deflection. As can be seen in the figure, at the end of the test the relative deflection of the pulled up beam was 11.3mm larger than that of the push-down side. That is because of a 326°C thermal difference in the tensile reinforcements (199°C at C3 in push-down side and 525°C at T5 in pull-up side) and caused large degradation in stiffness and strength of the longitudinal reinforcements of the pulled-up beam. 15 minutes after starting the test in the compression side, almost no deflection was recorded. That was because of an upward bending deformation (opposite direction) due to the thermal differences between the top layers (thermally insulated) and the heated bottom layers of the beam. However, in the pull-up side the thermal upward bending and loading led to larger deflections.

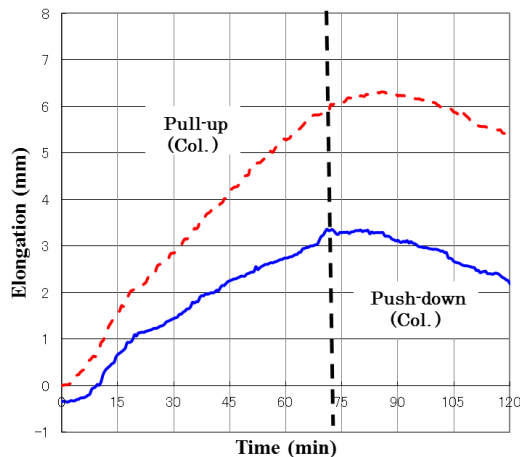
Figure 7: Columns' vertical elongation

During the fire test, specimens gradually expanded due to the thermal expansion. Figure 7 illustrates the columns' average elongations which were recorded by displacement transducers 1, 3, 6, and 7. As can be seen in the figure, the column of the push-down side had smaller vertical elongation at elevated temperatures than the pull-up side due to the subjected downward compression force. In the pull-up

side, however, the same directions of vertical elongation and force led to larger vertical expansion in the column.

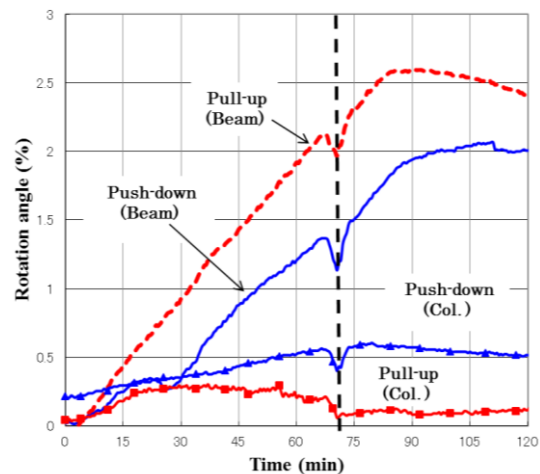
Figure 8: Column and beam rotation

Figure 8 shows the rotation angles of the beams and columns in fire condition, respectively. As for the beams, the explanations discussed in section 3.4 are applicable here as well. The rotation angle of each column was measured in a section belonged to the upper column and close to the beam.
