# External reinforced concrete beam-column subassemblages in fire

2014 NZSEE  
Conference

**ABSTRACT:** Structural behaviour of reinforced concrete (RC) beam-column subassemblages under fire conditions have always been a place of interest for engineers. However, due to the difficulties associated with conducting fire tests on the RC beam-column subassemblages subjected to service loads, empirical data has been limited. In order to investigate the fire resistant behaviour of the aforementioned subassemblages, a frame consisting of two cantilever beams was constructed. Equal upward and downward service loads were applied at the end of each beam, respectively. Several thermocouples, strain and displacement gauges were installed at different sections. The top faces of the cantilever beams and the upper columns were thermally insulated. The formation of flexural and thermal cracks and the loss of bond strength at elevated temperatures led to a significant drop in fire-resistant behaviour compared to the ambient temperature.

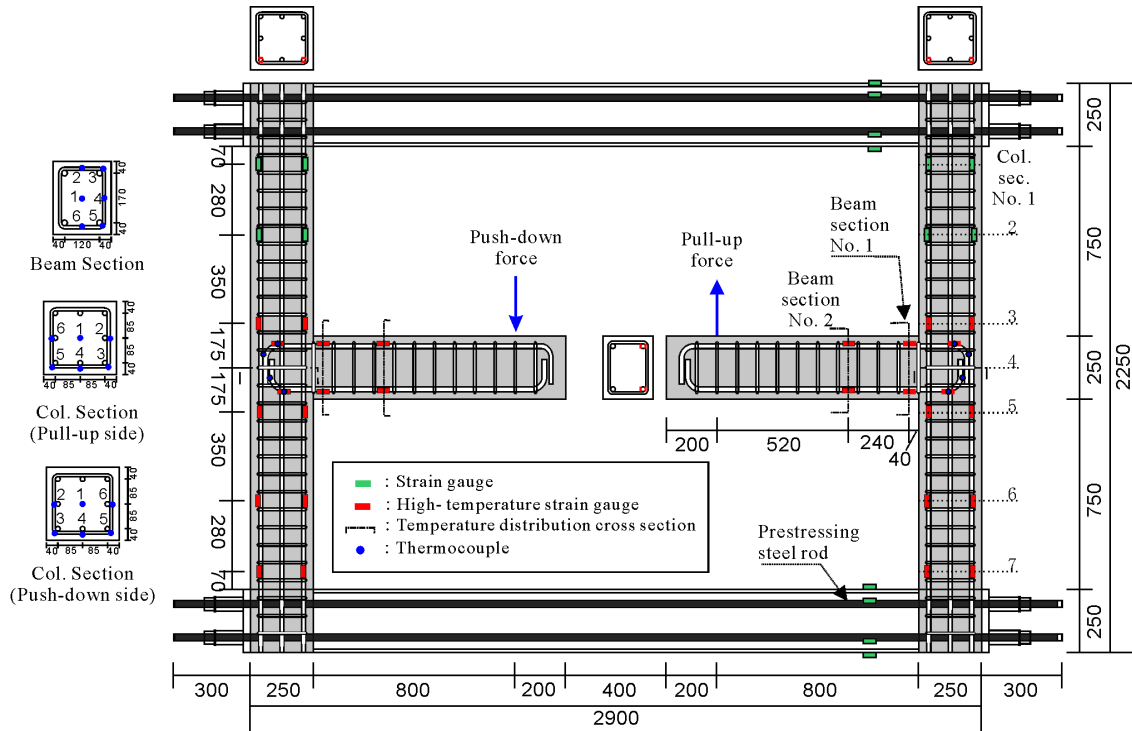
**Figure 1:** Specimens geometry & arrangement of strain gauges and thermocouples (unit: mm)

As it is shown in Figure 1, two RC beam-column sub-assemblages were constructed in scale of 1/3. The cross-sections of beams and columns were 200×250mm and 250×250mm, respectively. The two columns' bases and heads were linked together via two H-shape steel beams (250×250×9×14). Four prestressing steel rods ( $\phi 26$ mm, SBPR 1080/1230) were used to connect the H-beams to the columns bases and heads tightly by post-tensioning. The prestressing load for each prestressing steel rod was 141 kN. The details of reinforcement and materials are shown in Table 1 and 2, respectively. Two

Figure 1 shows the arrangement of thermocouples and strain gauges. Cross-sections 4 to 7 of each column and 1 and 2 of each beam were instrumented with six thermocouples per a cross-section. Four thermocouples were also installed inside the beam-column joint. However, in this paper the temperature distributions of cross-sections 1 and 2 of beams and 4 of columns are presented. Figure 2a illustrates the arrangement of displacement gauges. In order to measure the deflection of each beam, two displacement transducers (DT), DT1 and DT3, were installed at a section 80mm from the column face (80mm-section) and another two, DT2 and DT4, at 800mm-section, respectively. The relative

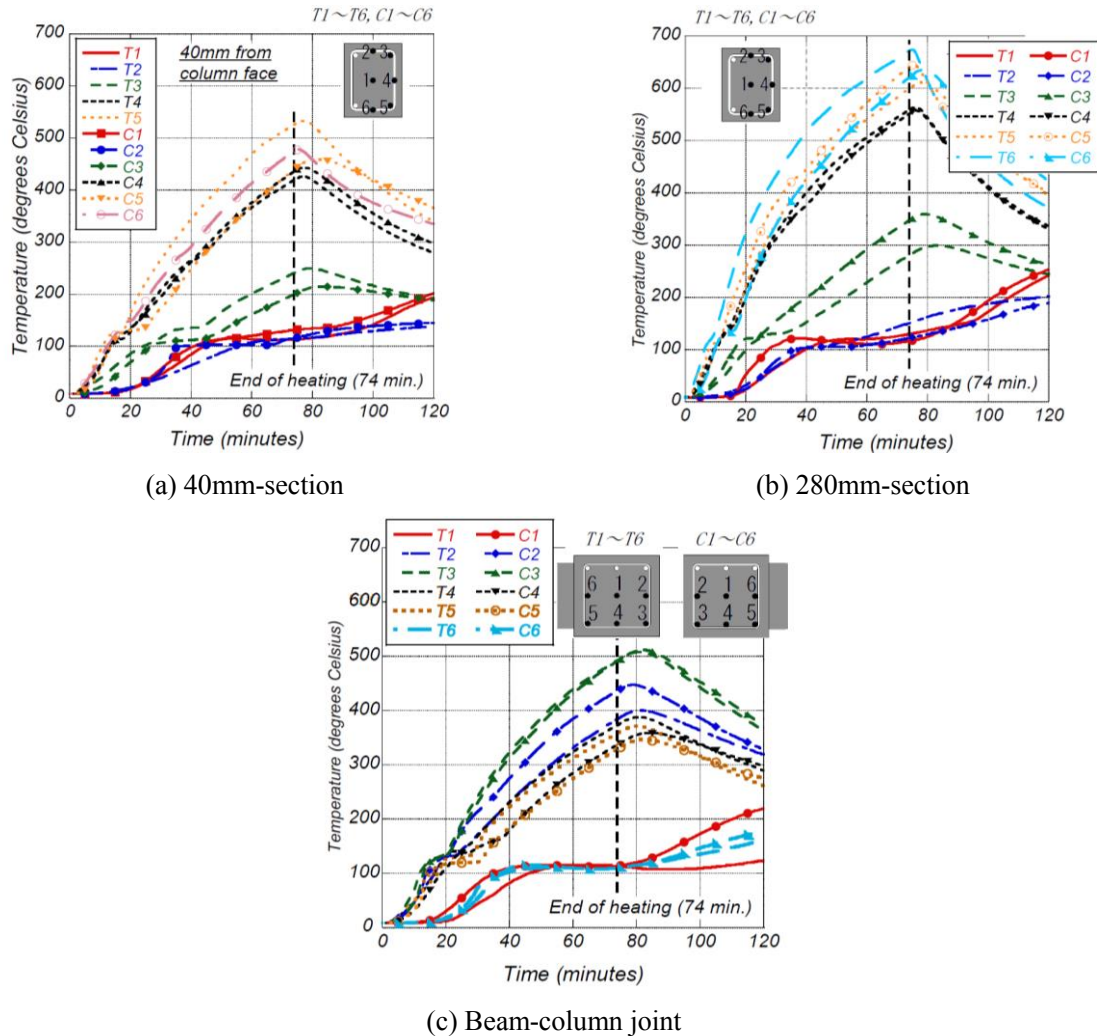
**Figure 4:** Internal temperature distribution at different sections

In order to investigate the temperature distributions inside the beam-column sub-assemblies, each of the three sections was instrumented with six thermocouples. T1~T6 belonged to the pull-up side and C1~C6 belonged to the push-down side. The beam cross-sections in each side were located 40mm (40mm-section) and 280mm (280mm-section) from the column face. The column cross-section was aligned to the beam horizontal centroid axis. As can be seen in Figure 4, thermocouple No.1 measured the central temperature of each cross-section, No.2, 4, and 6 measured the hoops temperatures, and No. 3 and 5 recorded the temperatures of the longitudinal reinforcements.

As can be seen in Figure 4a, the bottom longitudinal reinforcement of the beam at the pull-up side reached the temperature 350°C 15min sooner, when the reinforcing steel strength degradation started. This was probably because of the cracks that had formed under the load and widened and extended at elevated temperatures. The effect of crack on fire-exposed reinforced concrete members is under investigation by the authors. At the end of the test the bottom longitudinal reinforcement in the pull-up

beam was 90°C hotter than the push-down side. However, the temperature measured at the top longitudinal reinforcement (No.3) in the pull-up side was 40°C lower than that of the push-down side at the end of the tests. Thermocouples No.2 and No.4 (hoops), regardless to the loading direction and the location of cross-section, roughly recorded the same temperatures. However, thermocouple No. 6 of 280mm-section of the pull-up side recorded temperature approximately 100°C higher than that of the push-down side (Fig. 4b). Thermocouple No.6 in the 40mm-section of the pull-up side failed to record any temperature. The 40mm-section absorbed less heat than 280mm-section. This showed a heat flow (heat conduction) from the hotter regions (cross-sections far from the column) to the less hot regions (cross-sections close to the column face).

Figure 4c shows the internal temperature distributions within the beam-column cross-section. This section was aligned to the centroid axis of the cantilever beam. Thermocouple No.1 was at the centre of the section and No.2 ~ No.6 were attached to the column longitudinal reinforcements. Even though thermocouple No.6 was close to the cracked zone, it measured considerably low temperatures. However, this lower temperature was in compliance with the heat transition from the 40mm-section to the column. Unlike the beams, there were no significant internal thermal differences when the loading direction changed. At the end of the fire test, thermocouples No.4 and 5 and thermocouple No.2 in the push-down side were 40°C and 50°C less hot in the pull-up side, respectively.

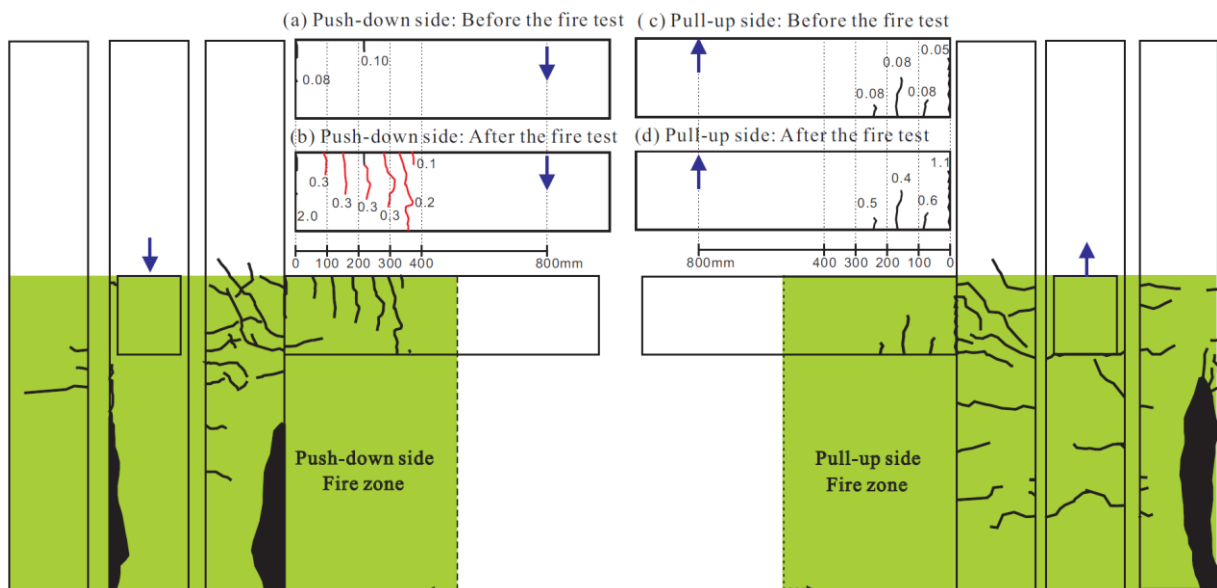
**Figure 5:** Crack pattern after the fire test (The black zone is the explosive spalling of concrete and the red lines are representing the extension of initial cracks)

After the fire test, an in-place visual inspection for the specimen was carried out. The color of the cooled specimens apparently had turned buff and mild pink. Except for intricate networks of superficial thermally-induced crackings all over the fire-exposed surfaces, several major medium and wide crackings were spotted as shown schematically in Figure 5.

After the initial loading, some hairline flexural cracks appeared in the beams. For example, at the beam-column intersection face in the push-down and the pull-up sides, 0.08mm and 0.05mm wide cracks formed, respectively. These cracks widened and extended in fire condition and other new ones appeared in the beams, beam-column joints, and columns. The maximum crack widths at the end of the test in the push-down and the pull-up sides were 2.0mm and 1.1mm, respectively. In the pull-up side, after 15 minutes, explosive spalling of concrete caused large cracks at the base of the column and as a result, some reinforcing steels of the column were directly exposed to the fire. The explosive spalling of concrete in the column of the push-down side also occurred but the exact time of happening was not detected.

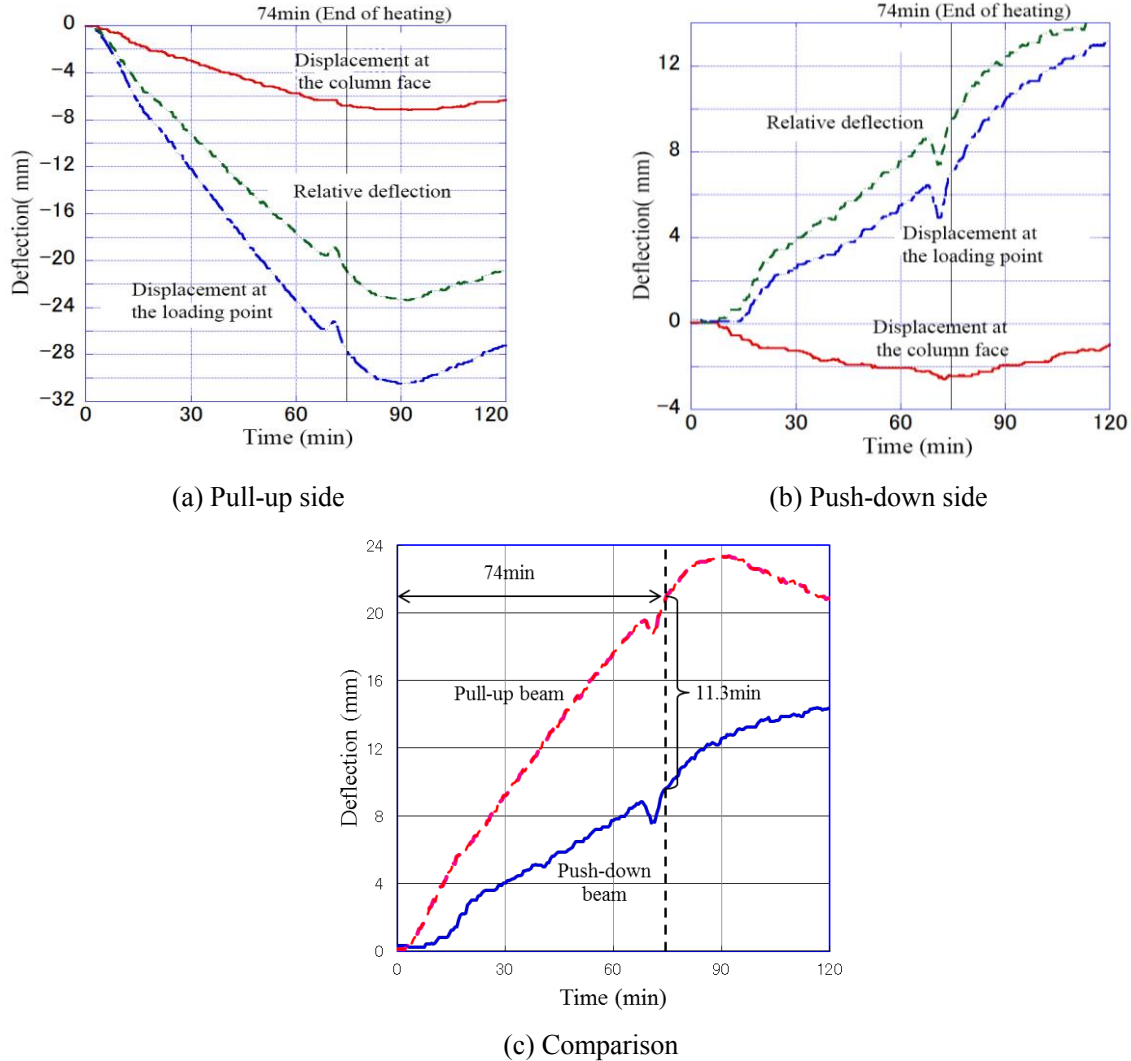
**Figure 6:** Relative vertical deflection of each beam

The relative vertical deflection of each beam was the difference of the vertical displacements of two locations on each beam; one roughly at the fixed end (80mm from the column face) and one at the loading point (800mm from the column face). Figure 6a and 6b show the relative vertical deflections of the pull-up and the push-down side beams against time, respectively.

Figure 6c is the comparison between the relative deflections of the beams. The positive direction is the downward deflection. As can be seen in the figure, at the end of the test the relative deflection of the pulled up beam was 11.3mm larger than that of the push-down side. That is because of a 326°C thermal difference in the tensile reinforcements (199°C at C3 in push-down side and 525°C at T5 in pull-up side) and caused large degradation in stiffness and strength of the longitudinal reinforcements of the pulled-up beam. 15 minutes after starting the test in the compression side, almost no deflection was recorded. That was because of an upward bending deformation (opposite direction) due to the thermal differences between the top layers (thermally insulated) and the heated bottom layers of the beam. However, in the pull-up side the thermal upward bending and loading led to larger deflections.

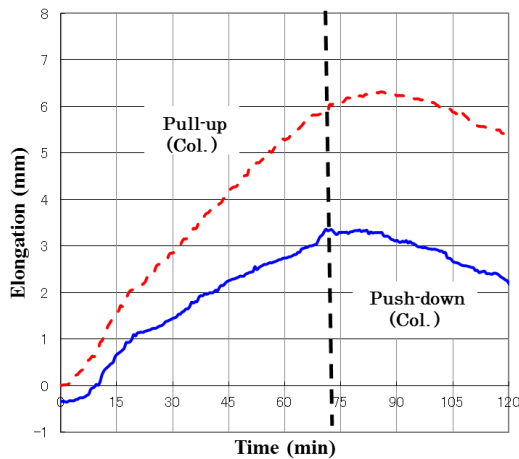
**Figure 7:** Columns' vertical elongation

During the fire test, specimens gradually expanded due to the thermal expansion. Figure 7 illustrates the columns' average elongations which were recorded by displacement transducers 1, 3, 6, and 7. As can be seen in the figure, the column of the push-down side had smaller vertical elongation at elevated temperatures than the pull-up side due to the subjected downward compression force. In the pull-up

side, however, the same directions of vertical elongation and force led to larger vertical expansion in the column.

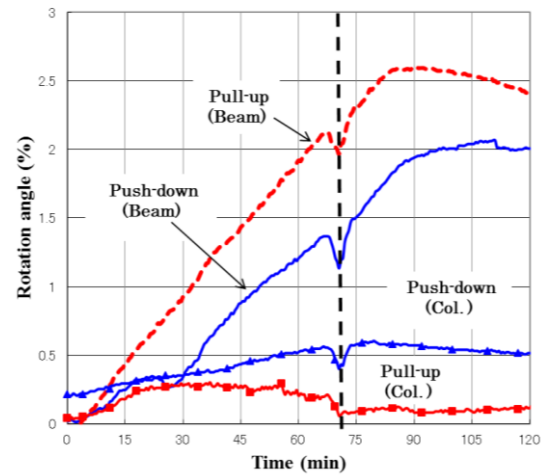
**Figure 8:** Column and beam rotation

Figure 8 shows the rotation angles of the beams and columns in fire condition, respectively. As for the beams, the explanations discussed in section 3.4 are applicable here as well. The rotation angle of each column was measured in a section belonged to the upper column and close to the beam.
