# Progressive Collapse analysis of a heritage building using Applied Element Method –Hotel St George, Wellington

I. Prionas & M. Seifi

*Harrison Grierson Consultants Ltd*

2015 NZSEE  
Conference

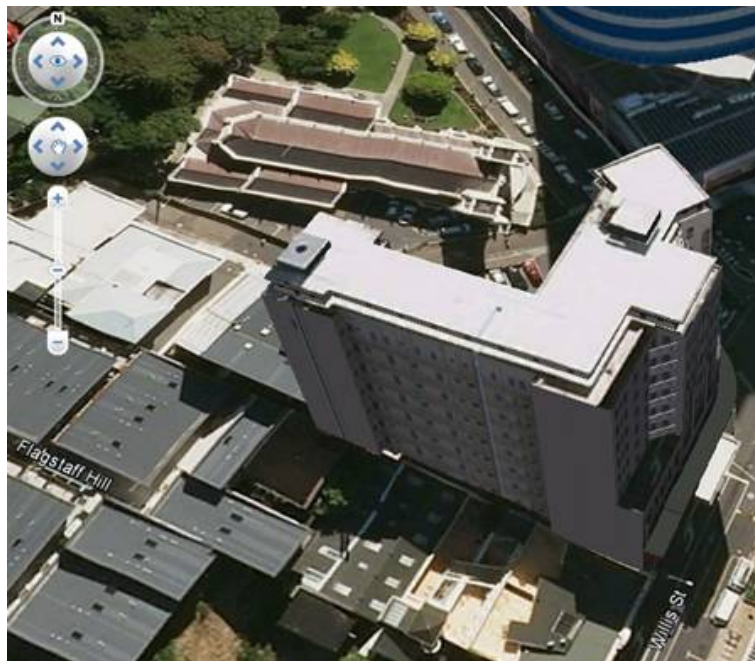
The Building at 124 Willis St, Wellington, is a 7-storey concrete encased steel frame structure constructed in 1929-1930 (Figure 1) with an irregular L-shape configuration. It was designated for retail use on the ground floor and hotel accommodation for the upper storeys.

**Figure 1. Aerial View of the building.**

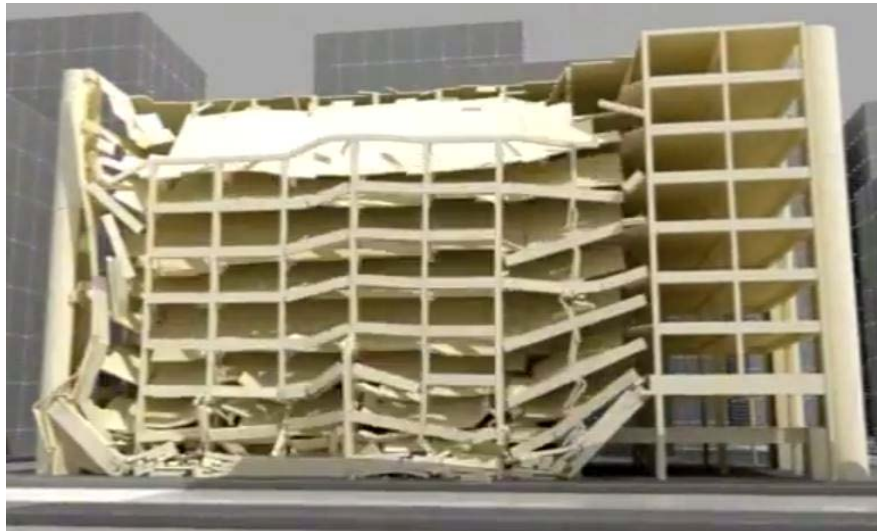
Progressive collapse (aka: Disproportionate Collapse) occurs when a local failure spreads throughout a structure from element to element, eventually resulting in the collapse of either the entire structure or a disproportionately large part of it. Progressive collapse is caused by an abnormal or extreme loading event, typically due to earthquake, accidental impact, faulty construction, foundational failure, or violent changes in air pressure (i.e. Blast). Infamous examples of progressive collapse can be seen in such history events as the terrorist attacks on the A.P. Murrah Building (Figure 3) and the Twin Towers of the World Trade Centre on September 11, 2001 or the Roman Point building (1968).

Figure 3. AP Murrah Building Progressive Collapse.
