# Full scale snapback testing of reinforced concrete bridge piers

L.S. Hogan, L.M. Wotherspoon, M.J. Pender, S. Beskhyroun & C. Lambert

2015 NZSEE  
Conference

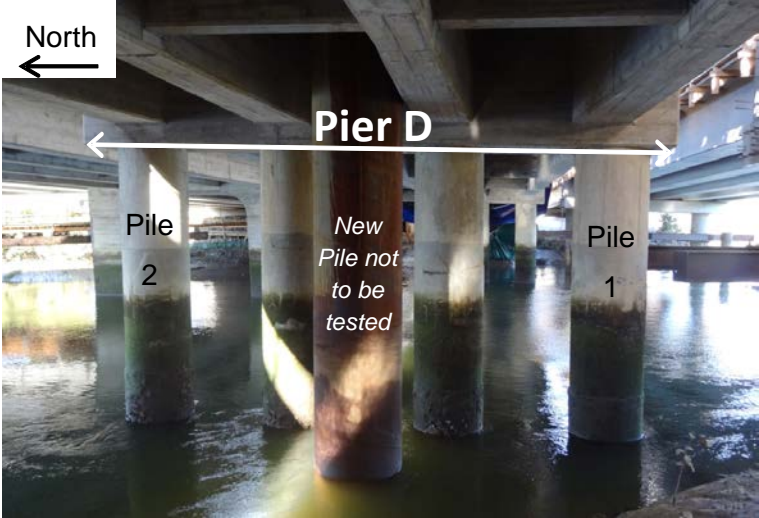
Figure 2. Elevation of Pier D as viewed from Abutment F (Photo taken 20th May 2014).

Pile 1 and Pile 2 from Pier D shown in Figure 2 were tested. As a pile foundation for the new bridge was installed prior to testing, and there was less than a few diameters from the middle two piles, these were not tested. The top of the pile cap of Pier D was 6.55 m above ground level, based on measurements taken the day of testing.

Prior to testing, the bridge deck and beams were removed from the entire bridge. To isolate the test piles at Pier D from each other, the pier cap was sawn between the piles. The removal of the pier cap was part of the scheduled demolition works and left a clear gap of approximately 1.0 m between the top of each pile in the pier. The pier cap at Pier C, which was used as a reaction during testing as outlined in the next section, was not altered prior to testing, and all four piles remained connected.

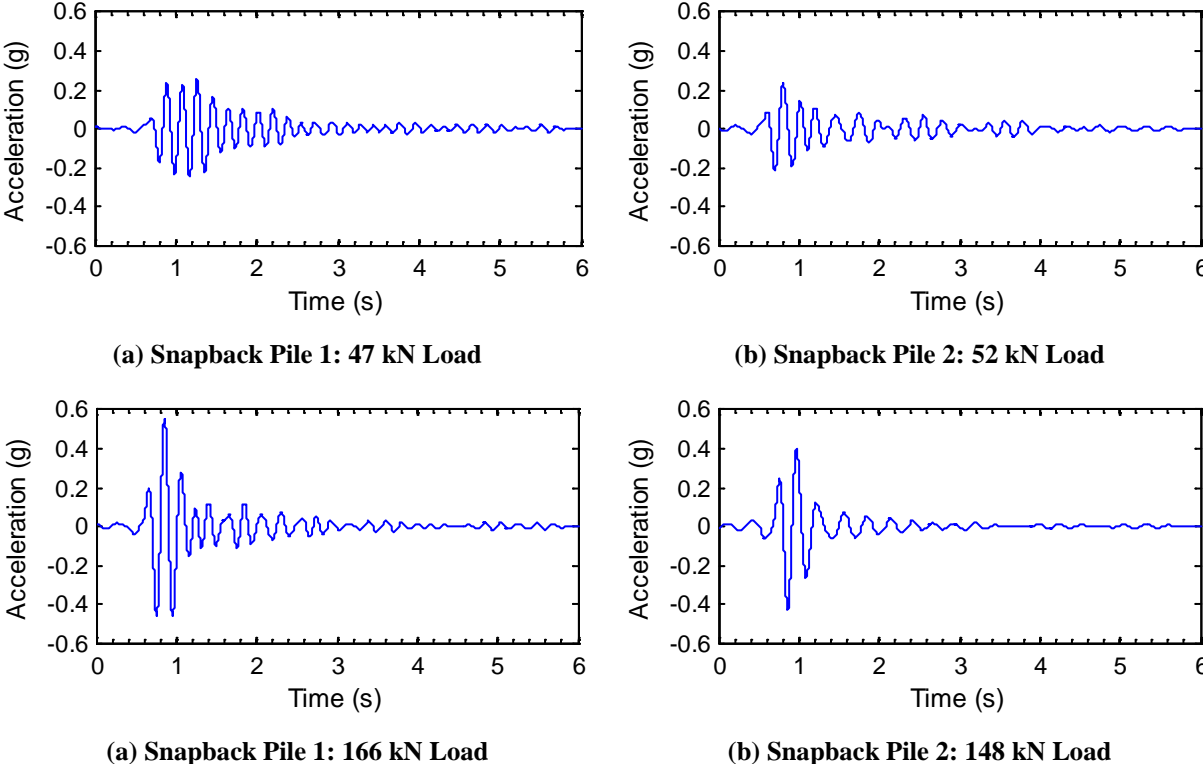
**Figure 8. Selected free vibration responses from Pile 1 and Pile 2 snapbacks.**

The free vibration response from selected snapback tests is presented in Figure 8. Snapbacks with release loads of approximately 50 kN were found to have a slow amplitude decay while snapbacks with release loads above 100 kN exhibited a large initial amplitude reduction and then a slow low amplitude decay similar to the lower release load tests. There is also a slight increase in natural period between the initial high decay portion of the free vibration response and the low amplitude decay. The initial amplitude reduction and period shifts can be attributed to the nonlinear response of the soil-pile

system dissipating energy through compressive nonlinearity of the soil and the creation of gaps on either side of the pile. Following this initial response, the pile responds in an elastic manner as a lightly damped cantilever and oscillates at similar amplitudes to that of the 50 kN snapbacks.

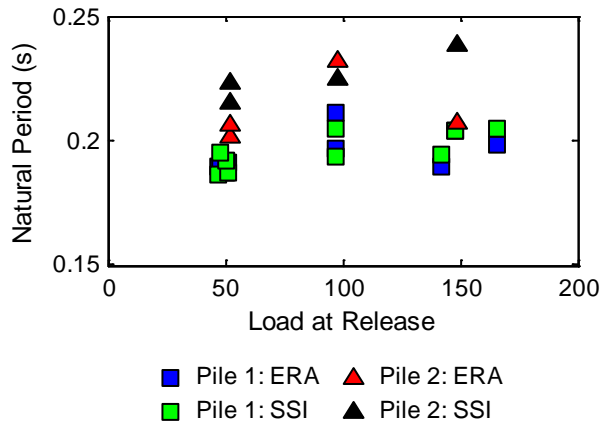
Figure 9. Natural period of test piles with respect to release load.

Two system identification techniques were used to characterise the entire free vibration response and to determine the indicative natural frequency and equivalent viscous damping of each snapback test. These techniques were the Eigen Realisation Algorithm (ERA) (Juang and Pappa 1985) and Stochastic Subspace Identification (SSI) (van Overschee and De Moor 1996). The natural period and damping ratios identified by these techniques are shown in Figure 9 and Figure 10, respectively. The natural period of Pile 1 ranges from 0.19 to 0.21 s as the load increases. Pile 2 had a significantly larger variation of natural period from 0.2 to 0.27 s. The large natural period variation in Pile 2 occurs after in the tests following Test 4 and likely results from the crushing of the loading block, affecting the clean release of the load during snapback. The lack of a clean release suggests that there was an interaction between the test pile, the loading rig, and the reaction pier during the initial portion of the free vibration response. Acknowledging this issue with the snapback data, the natural periods and damping ratios for Pile 2 have only been included for Tests 1-4 in Figure 9 and Figure 10. The damping of Pile 1 exhibits a clear trend of 3-4% at 50 kN load increasing to 10% above 150 kN. Similar to the natural period of Pile 2, the damping ratios identified for Pile 2 are highly variable, but there is a trend of 10% to 15% equivalent viscous damping ratios for Tests 1-4. Similar loading levels exhibit similar damping ratios and appear to be relatively unaffected by the loading history of the soil-pile system.
