Integrating Foundation Design for a Low-Damage Superstructure

N. Barounis, A. Brown & G. Saul

Opus International Consultants, Christchurch

2015 NZSEE
Conference

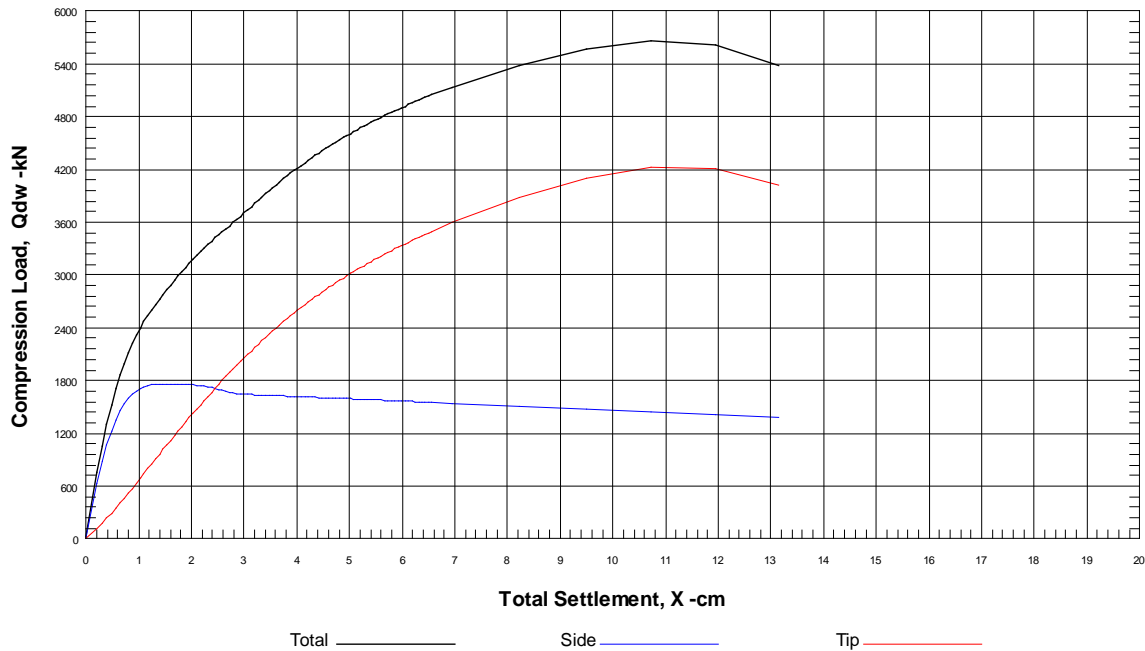
Figure 2. Load-settlement graph from Allpile for D=900mm and L=25m.

The load-settlement graph obtained from Allpile is shown in Figure 2. This result is considered a lower bound estimation for the pile capacity. A 900mm diameter pile requires sufficient PDA testing to enable a strength reduction factor Φ_r of 0.55 to be adopted as per AS 2159.

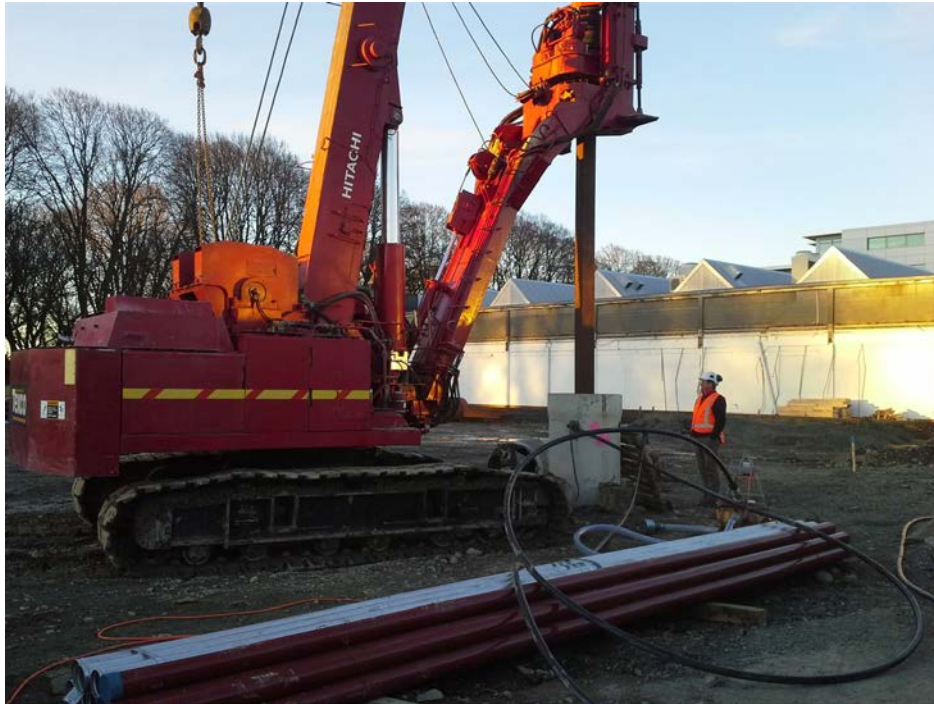
Figure 3. Excavation of typical pile.

The piles were constructed by first installing the 12m long open hole casing by means of vibration applied at the top of the casing. Excavation commenced from within the casing installed to its full depth with an open hole and then with the support of polymers. The excavation continued for the length between 12m and the final pile depth being uncased but under the support of the piling fluid. Excavation was by rotary bucket excavator with a self-closing gate (refer Fig. 3).
