Speights brewery seismic strengthening, Dunedin

2015 NZSEE
Conference

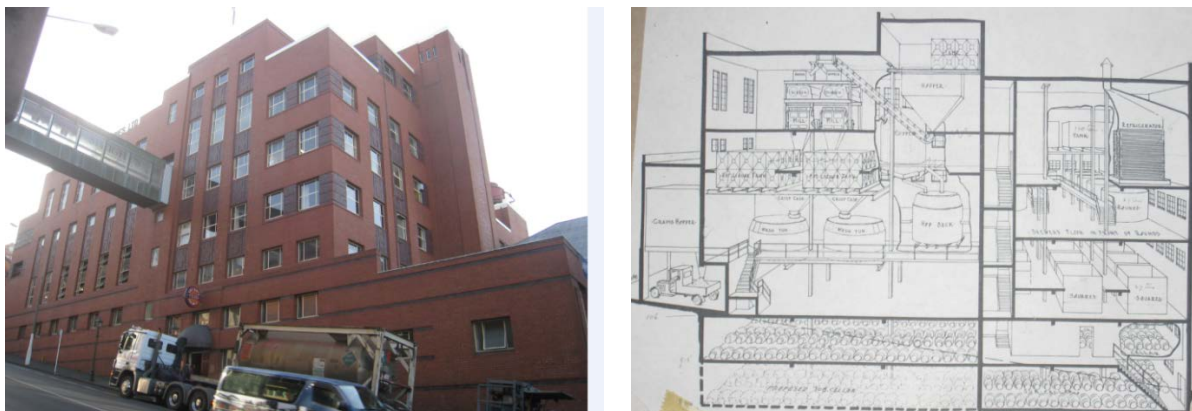
Figure 3. Brewhouse Building Rattray Street (left); Historic section through Brewhouse (right).

Built circa 1939, the brewhouse building functions as a working brewery as well as a heritage tour and museum open to the public. The building is an 8 storey structure approximately 36m x 39m in plan and approximately 25m in height. It is located on a relatively steep slope, with the bottom 2 storeys cut into the slope to form a partial basement.

The gravity load resisting system comprises a steel gravity frame with full concrete encasement. The floors are reinforced concrete slabs, typically either 130mm or 150mm thick. The building sits on shallow pad foundations, generally on basalt rock.

The building is clad with masonry walls, comprising a 110mm thick inner skin (single brick), and a 230mm thick outer skin (double brick). The 2 skins are separated with a 50mm cavity. The internal walls are a mix of masonry and reinforced concrete. Both the internal walls and the perimeter walls provide the lateral load resistance for the building.

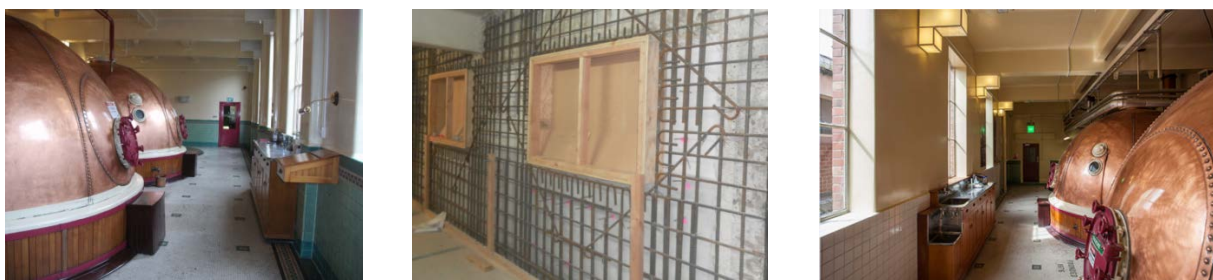
Figure 4. Shotcrete lining before (left), during (centre), and after (right).

Two of the key drivers for developing the seismic strengthening scheme were to provide a solution that would allow the continued operation of the brewery within the building, while limiting the impact to the heritage value of the street frontages. To achieve this, a reinforced shotcrete lining was applied to the internal face of selected masonry walls to form a framework of shear walls and spandrels that will provide the lateral load resistance for the building. The aim being to improve the seismic capacity of the building to a minimum of 70%NBS.

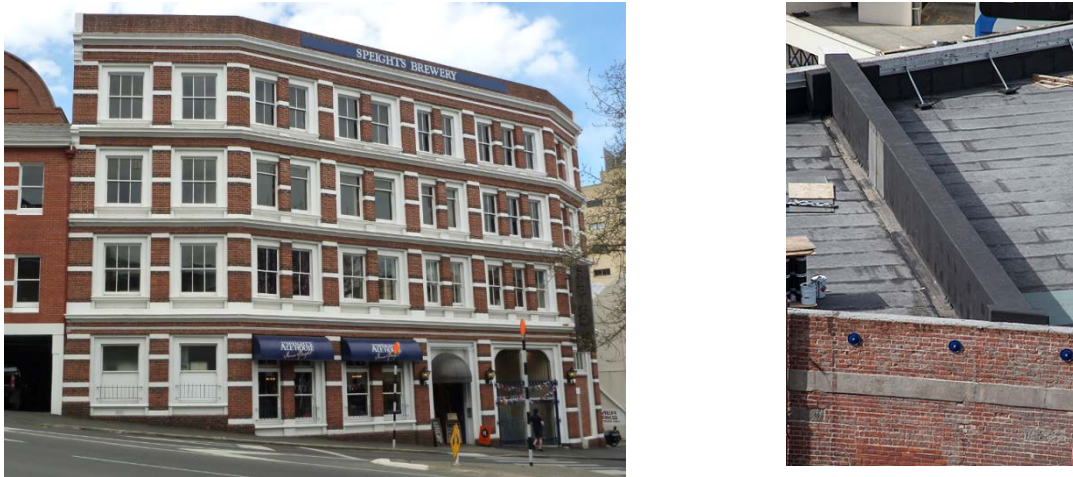
Figure 7. Shamrock Building Elevation (left); Roof level beam element (right).

- A reinforced concrete beam element extending the full width of the building at roof level, projecting both above the roof and below the ceiling level of the third floor connected the wall to the new column, thereby forming a large propped cantilever shear wall system, with the new wall and beam forming a moment connection at roof level.
