Bridge-Utility Systems: Learnings from the Canterbury Earthquakes (2010-11)

A. Rais, S. Giovinazzi, A. Palermo & P. Lee

2015 NZSEE
Conference

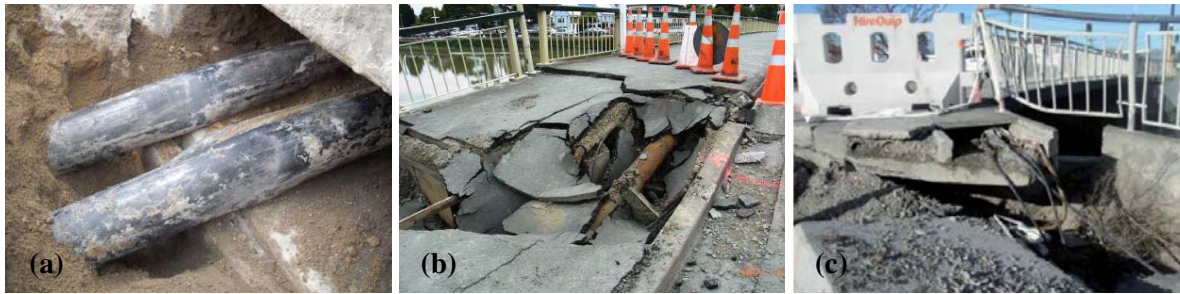
Figure 1. Utility failures at bridge crossings, after the CES; a) Partial failure of 66KV lines at Dallington Bridge (Eidinger and Tang, 2012); b) Damage to pipelines crossing over Avon River (Cubrinovski et al. 2011); c) Damage to lifelines at Gayhurst Road Bridge (Palermo et al. 2012).

The Canterbury Earthquake Sequence 2010-2011 (CES) triggered significant impact at these bridge-utility linkages. Several impacts to bridge-crossing utilities were, in fact, reported (Table 1), even though the structural performance of bridges proved to be good, with very low count of moderate to extensive damage occurrences (Palermo et al. 2010, 2011). These impacts on bridge-crossing utilities included: leakages in potable water and waste water pipes due to connection failures with the bridge deck; failure of power cables (Fig. 1) due to insufficient rotational ductility capacity at the bridge ground transitions (Eidinger and Tang 2012); and other observed damage mechanisms, as defined in the following section.

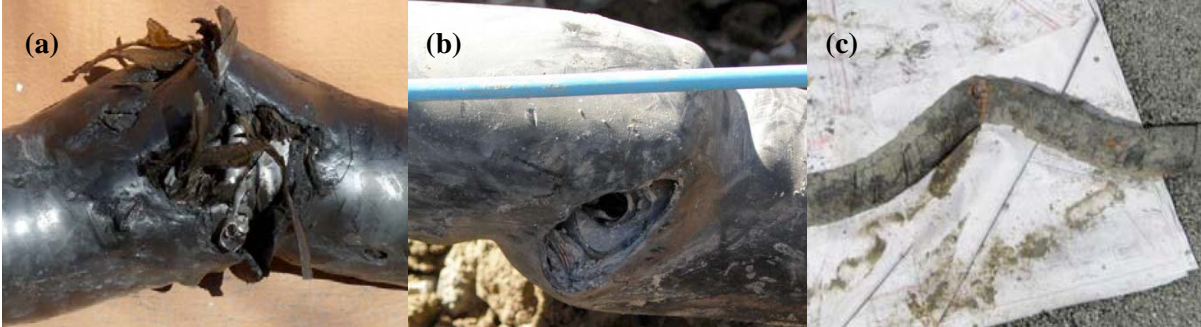
Figure 5. Damages to cables during the CES; a) Failure of 66 kV oil filled cable (Eidinger 2012); b) Failure of 66 kV XLPE cable (Eidinger2012); c) Failure of 11 kV cable (Eidinger and Tang 2012).

Impact induced by the CES was severe on all levels of transmission networks, mainly due to liquefaction. 50% of the 66 kV cables were damaged, leading to power outages in the area, while 15% cables with more than 1000 faults were identified in the 11 kV cables (Kongar et al. 2014 Eidinger and Tang 2012, Giovinazzi et al. 2011). The physical failure mechanism in cables was attributed to the development of bending stresses (from shear waves and ground deformations) in the weak concrete backfill. This resulted in backfill failure due to tensile bending stresses; at the same time inducing high compressive bending stresses in the cables, leading to buckling in the cable, with double curvatures. (Figure 5) (Eidinger 2012).

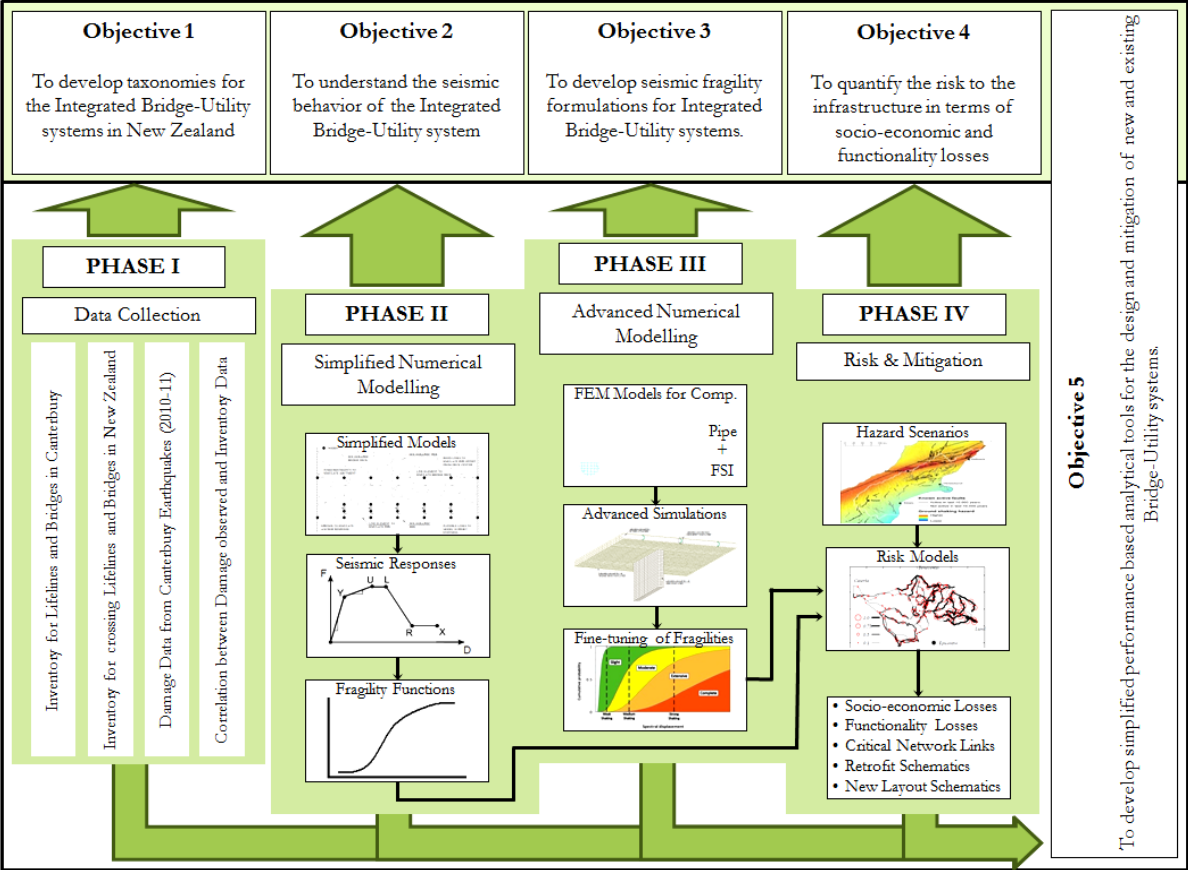
Figure 7. Schematic overview of the framework and objectives.

A framework is herein proposed (Fig. 7), consists of four phases, each providing a unique output. The four objectives are inter-related and contribute to provide the final objective, namely Objective 5 'To develop simplified performance based analytical tools for the design and mitigation of new and existing Bridge-Utility systems'. The first phase is to collect and collate exhaustive data on bridge-utility integrated systems in the Canterbury region, and detailed damage reports from the Canterbury Earthquakes 2010-11. The second phase involves simplified numerical analysis of the integrated BUS, developing the understanding of the basic seismic response of the system and the underlying uncertainties associated with it. The third phase focuses on detailed numerical analysis of the system, by incorporating results from FEM modelling of components integrated with Fluid Structure Interaction (FSI) effects into the global model of the integrated BUS, to develop fragility functions;
