Wine industry implementation of the NZSEE guidance on the seismic design of liquid storage tanks

E.V. Au, A.F. Walker & W.J. Lomax

Structex, Consulting Engineers

2015 NZSEE
Conference

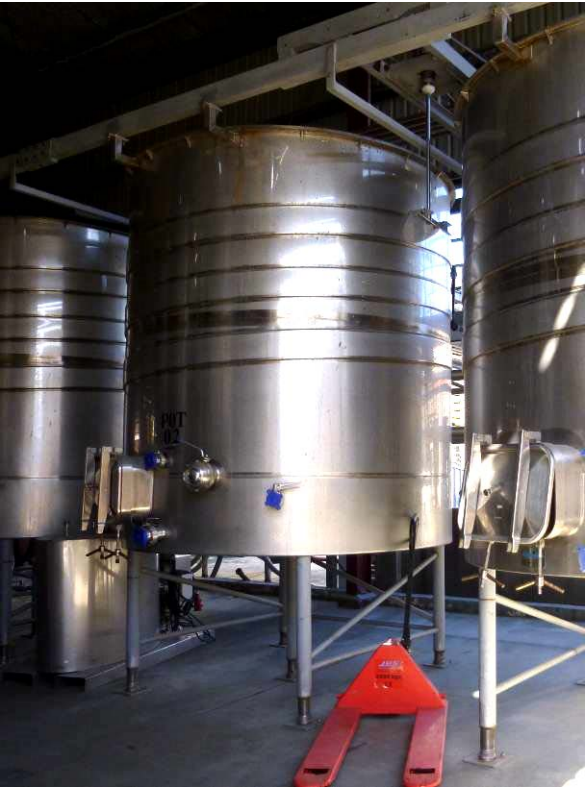
(a) Diagonally-braced base-frame

Figure 1. Examples of base-frame mounted tanks.

Tanks used for wine storage in New Zealand form a much smaller subset. Wine tanks are generally sealed vertical cylindrical tanks, with height to radius ratios on the order of 3-5, and constructed from 2-6mm thick stainless steel. Smaller 5,000-60,000 litre tanks are typically supported on mild steel base-frames, with or without diagonal bracing (Figure 1), and with the frame feet either fixed to the slab or left unbolted. Larger 40,000-270,000 litre tanks are typically mounted on concrete plinths, and usually anchored to the slab. Methods used to anchor plinth-mounted tanks are wide ranging, and include shear bolts anchored into the plinth through the tank skirt (Figure 2a), or necked and un-necked tension bolts epoxied into the slab that are connected to the tank via brackets/chairs, which themselves vary in configuration (Figure 2b-f).

Where frames are braced, additional flexural actions in the legs created by eccentricities in the alignment of braces (such as that in Figure 1a) should be considered. From the author's assessment of some existing frames, it is apparent this has not been done.

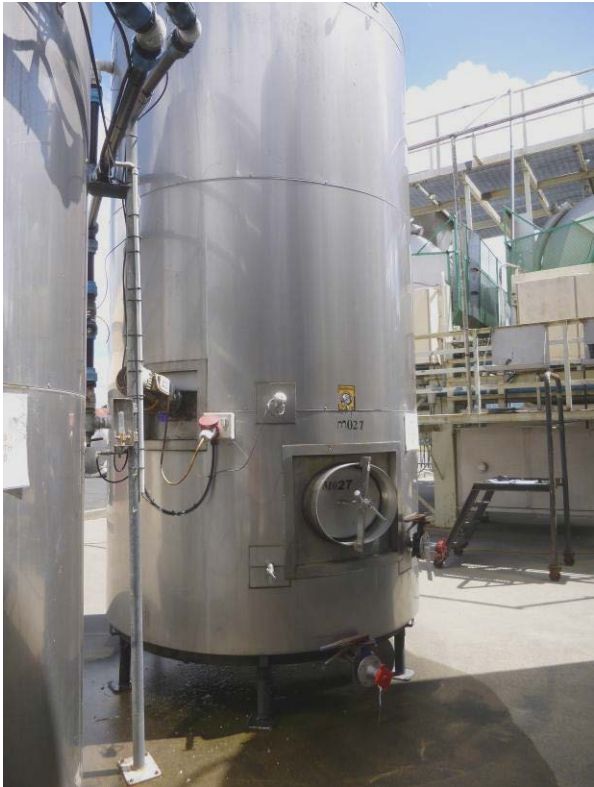
(b) Un-braced base-frame

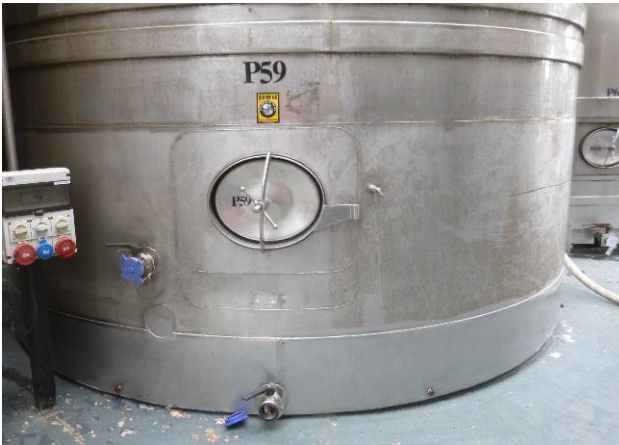
(a) Shear bolt anchors

Figure 2. Examples of plinth-mounted tank anchorages.

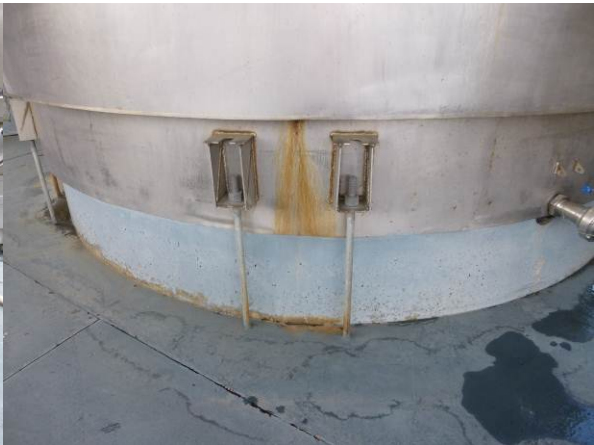
(b) Chair mounted un-necked tension anchors

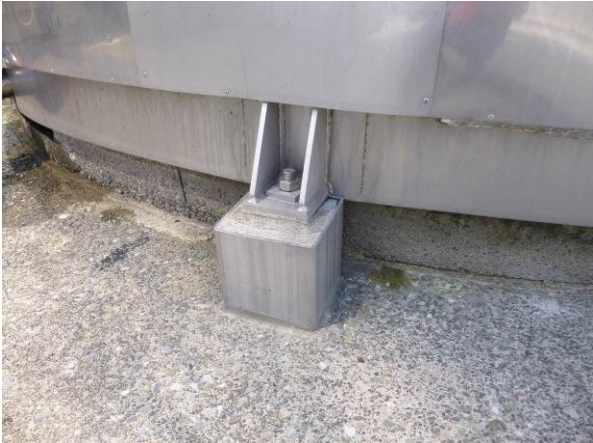
(c) Chair mounted un-necked tension anchor

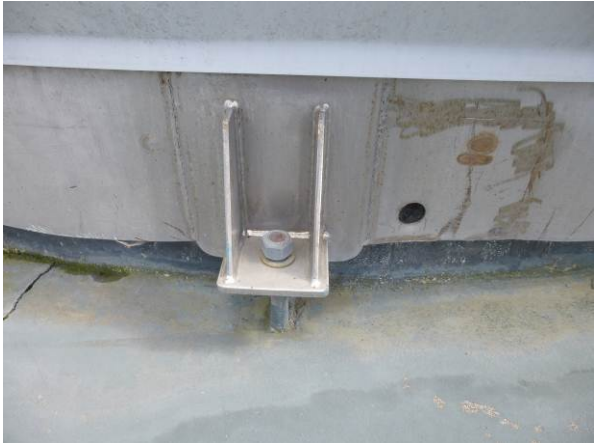
(d) Chair mounted un-necked tension anchor

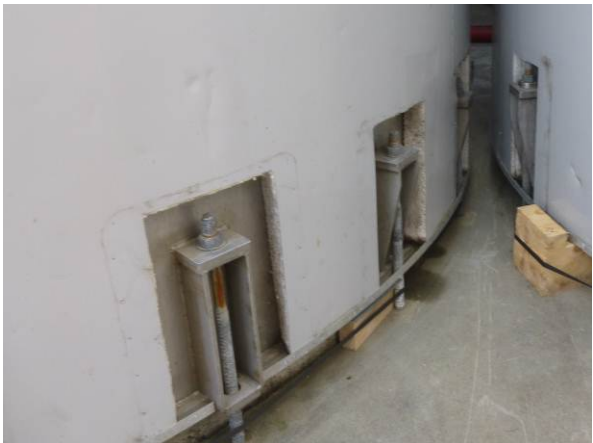
(e) Chair mounted necked tension anchors

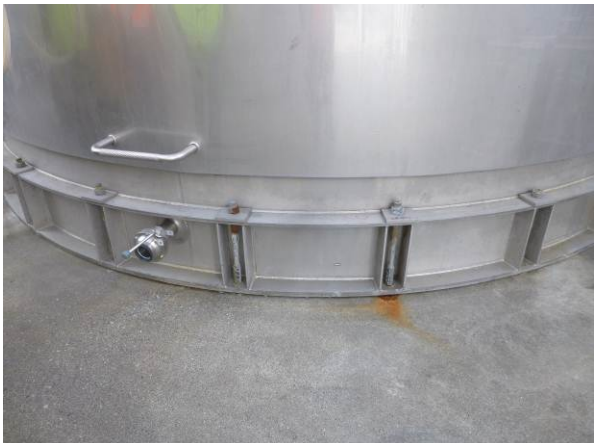
(f) Chair mounted necked tension anchors

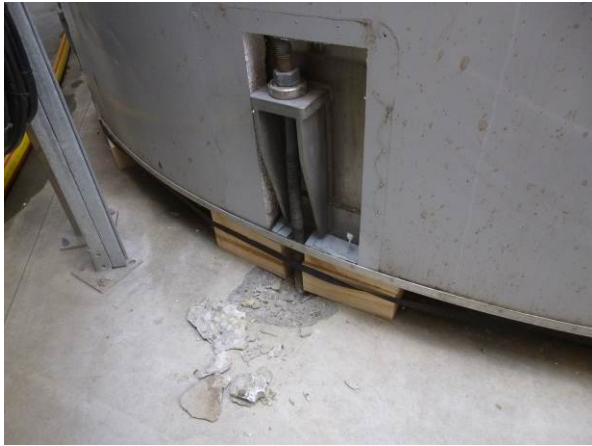
(a) Combined concrete cone-pull-out failure

Figure 3. Examples of damage observed to plinth-mounted tanks (Source of figures d-f: Morris et al. 2013).

- Tensile anchor bolt failure, whether by steel fracture, pull-out through the epoxy, or concrete cone failure (Figure 3a). Concrete failure modes occur when the anchorage has insufficient capacity to develop the overstrength of the steel cross section. Steel fracture occurs when the material has insufficient ductility for the displacement demand, which may occur with tension-only anchors when an event larger than the chosen design level occurs (described later in section 5).

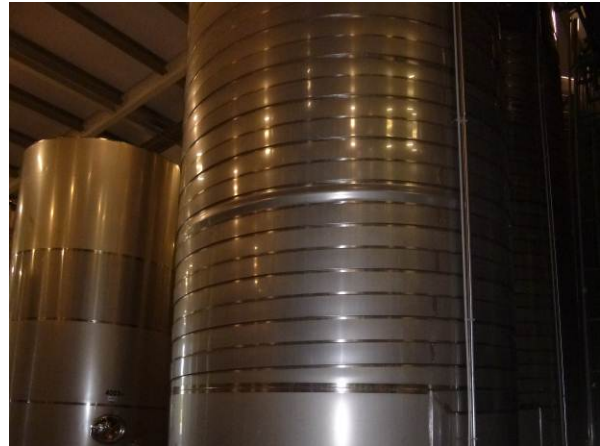
(b) Buckling of tank wall

- Diamond-shaped or elephant foot’s wall buckling (Figure 3b), which occurs due to insufficient wall thickness to resist axial wall stresses.
- Local skirt damage. In the case of Figure 3f, the skirt did not extend to the slab and the loadpath for the compression reaction was via the hold-down chair. The skirt had insufficient thickness or support to resist the concentration of stresses, resulting in local buckling around the chair.

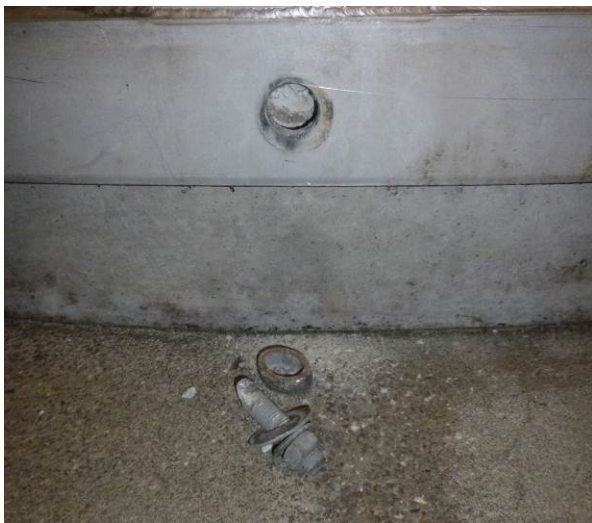
(c) Steel shear bolt failure

- Shear failure of shear bolts (Figure 3c).
- Lateral sliding of the tank on top of the plinth, leading to bending of hold-down anchors (Figure 3d). For older wine tanks, there can be a 20-80mm gap between the tank skirt and concrete plinth to provide tolerance for the construction method used. As such, the only available shear mechanism between the tank and plinth is friction between the tank floor and plinth. When this is exceeded, sliding occurs.

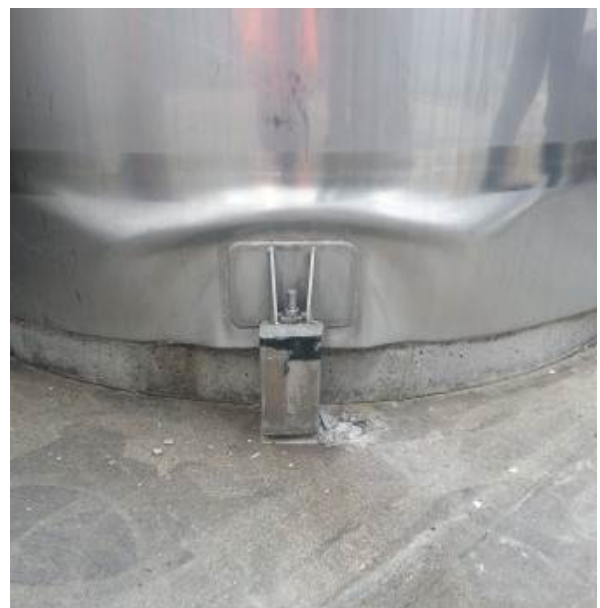
(f) Local buckling of skirt

If the loadpath is provided by continuing the tank skirt down to the slab, the skirt and concrete bearing must be appropriately checked to prevent buckling of the skirt or bearing failure of the concrete slab. If chairs are being relied upon to transfer some of this reaction, local buckling above the chair should also be considered to avoid that seen in Figure 3f.

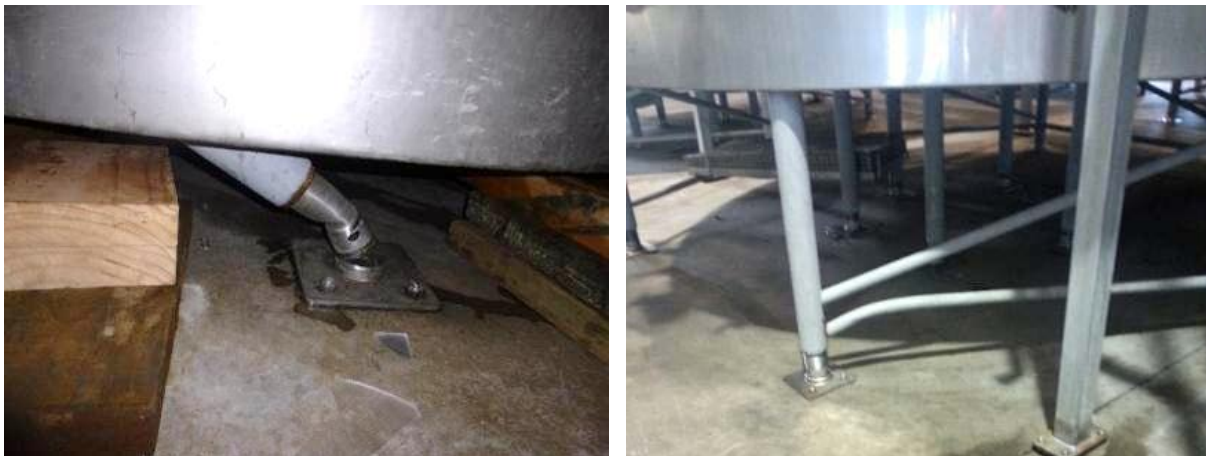
(a) Bending of un-braced leg

(b) Buckling of braces

Figure 4. Examples of damage observed to base frame mounted tanks (Source: Morris et al. 2013).

- Bending of legs for un-braced frames (Figure 4a). Where frames are un-braced, they are required to act as moment-resisting frames to resist lateral loads. However, often beam to leg joints were not detailed to act as fully-rigid connections.

- Buckling of braces for braced base frames. In these cases, braces were too slender to resist the applied loads (Figure 4b).
- Bending of adjustable feet (Figure 4a). Winery floors are often sloped to provide drainage. To accommodate this, base frame-mounted tanks often have threaded adjustable feet. These connections were observed to act as weak points leading to failure.
