# An Experimental Study on the Asymmetric Friction Connection (AFC) Optimum Installed Bolt Tension

2017 NZSEE  
Conference

**ABSTRACT:** The Asymmetric Friction Connection (AFC) is an energy dissipating component, consisting of five steel plies all clamped by the fully tensioned High Strength Friction Grip (HSFG) bolts according to the current New Zealand practice. The AFC was originally proposed through the developments of the Sliding Hinge Joint (SHJ) connection, a damage resistant alternative for the seismic Moment Resisting Steel Frames (MRSFs). The AFC can also be used in other types of the seismic resisting systems such as braces and rocking shear walls and columns. However, a concern with the AFC is its post sliding elastic strength reduction. The main reason of this is the reduction of the AFC clamping force generated by the high strength bolts that is caused during the sliding. One of the main reasons behind this post earthquake bolt tension loss is the interaction of tensile force, bending moment, and shear force in the bolts during the stable sliding state, which can plastify the bolts material and result in bolt tension loss.

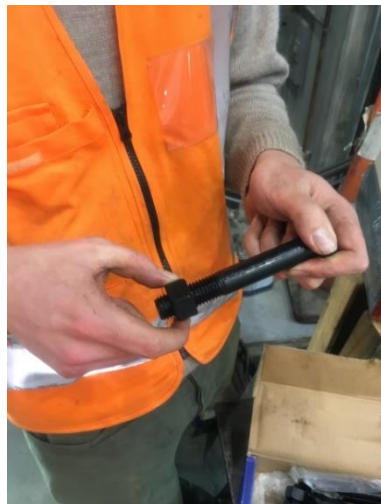
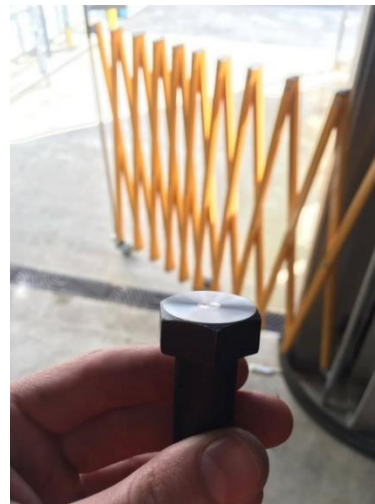
Figure 5. a) Free-turn of nut check b) Bolt prepared using lathe

Each individual bolt was prepared by adhering to the recommendations of (Ramhormozian, Clifton et al. 2016). The first stage of this process was to conduct a “Free-turn of nut” check to identify any bolts with poor thread and finish quality (Figure 5a). Failed bolts were removed from testing as they have a tendency to develop plastic strain during installation as a result of their imperfections. Following this, the tips and heads of the accepted bolts were made smooth using a lathe (Figure 5b) in order to improve the reliability of elongation measurements using the ultrasonic bolt meter. Prior to installation, the bolt threads were applied with a molybdenum disulphide paste (GA 50 Molybond) to act as a lubricant.

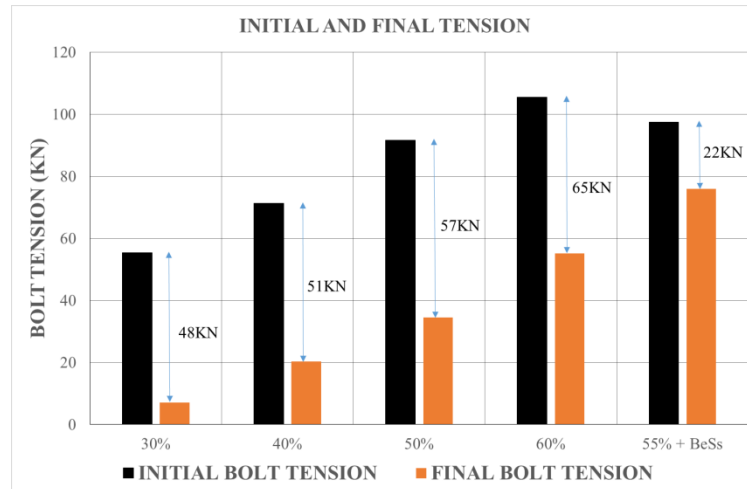
Figure 7. Comparison between initial and final AFC average bolt tension (% represents the installed bolt tension as the percentage of the bolt proof load)

As previously mentioned, the first two tests conducted with an installed tension equal to 30% of the bolt proof load (55kN) performed poorly suggesting that this was not the ideal level of tension. The methodology for test 3 was altered to limit the amount of relative rotation between the nut and bolt. Although installed with the same initial tension, the imposed provisions resulted in an improvement with around 10kN being restored by each bolt. It can be concluded that 30% is not the optimum level of installed bolt tension and this is strongly supported by the fact that 87% of the installed tension was lost during testing (Figure 7).

Tests 4 and 5 were carried out with an installation tension of 40% (70kN) of the bolt proof load which provided a marginal improvement to that exhibited by the 30 % group. The remaining post-sliding tension was found to be 12kN and once again, this was a small fraction of the original applied force. Overall, the percentage of tension loss was 72% (Figure 7) and, thus, 40% (70kN) of the bolt proof load was also considered to be not the optimum level of tension.

Whilst still remaining with the elastic range, tests were carried out at 50% (90kN) and 60% (105kN) of the bolt proof load. The results of which showed a substantial improvement to the previously analysed tensions groups. At 50%, the bolt tension diminishes to within the range of 30kN and 38kN. Similarly, the final tension for the 60% test reduced to a value just less than 40kN. Figure 7 compares the lost bolt tension in terms of percentage, reinforcing the notion that there is marginal separation between the two outcomes as both values are around 62%. Thus, it can be concluded that optimum level of installed bolt tension is a range between 50% and 60% of the bolt proof load. A noteworthy trend that is established by the plot is that it appears to taper-off (plateau) with increasing tension groups. The behaviour of the bolts when installed to a tension higher than that of the investigated quantities is known to cause plastic deformation. This response causes a major loss in tension as bolts are forced into double curvature, further reinforcing the finding that 50% - 60% is optimum level of installed bolt tension.

The change produced a significant improvement in terms of the amount of tension which was lost during sliding. Figure 7 reflects this impact with the test involving BeSs proving far superior to any of the other tests carried out without the device. In the end, the post-sliding tension was determined to be around 80% of the original tension. This finding provides strong evidence that the SHJ has the ability to undergo seismic events and not require any post-earthquake maintenance.
