South British House – seismic upgrade of a building founded on liquefiable soils

C. Lavin, H. Wahab, K. de Graaf & H. Maragkos

Beca Ltd, Tauranga, New Zealand

2017 NZSEE
Conference

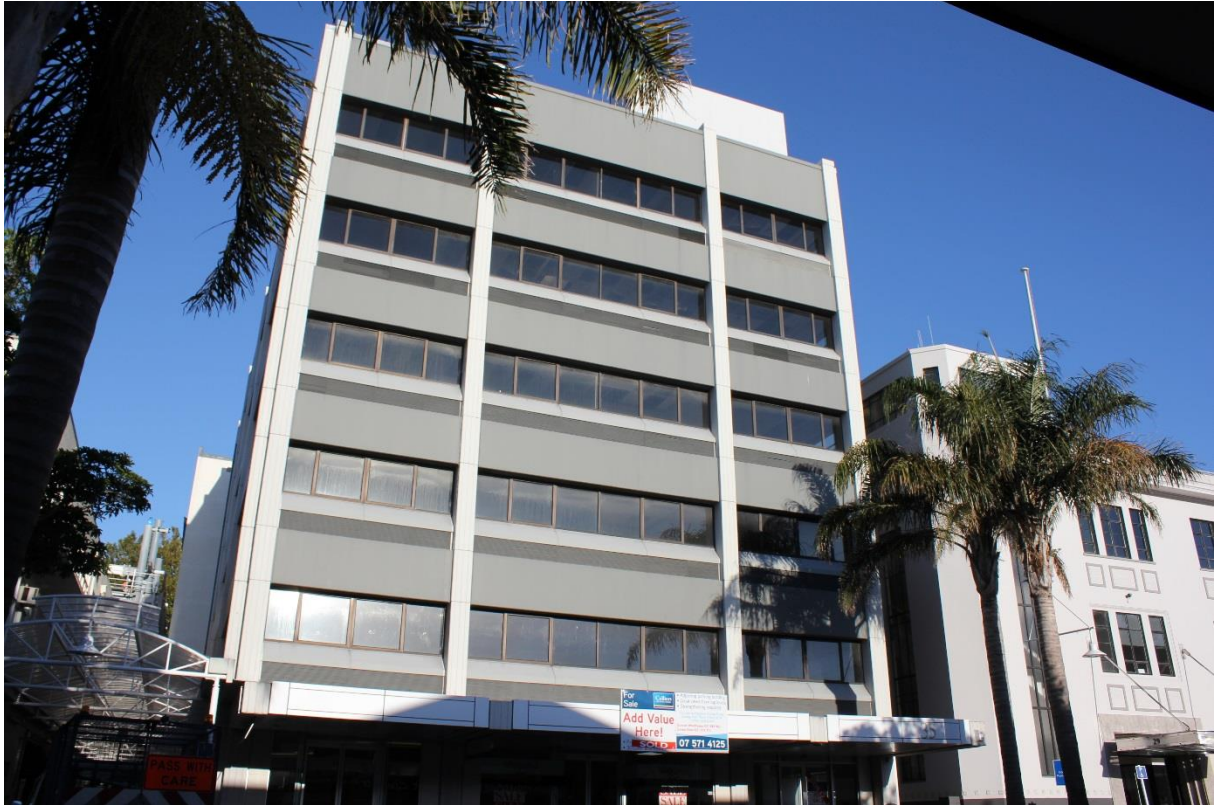
Figure 1 shows the existing building frontage on Grey Street.

Figure 1 Existing building street frontage (eastern side)

- Uncertainty surrounding the actual pile depths (there were no as-built records), although limited testing indicated there was variability in the lengths
- An asymmetric structural system
- The building is located within a constrained site (see Figure 1) and the majority of any foundation works would need to be carried out from within the building, i.e. with limited headroom
- The presence of a significant underground service (11kV cable) running under the rear of the building which presented a significant constraint to investigation, design and construction
- The Client's preference was that the existing tenants at the front of the building on the ground floor should be able to remain during the works

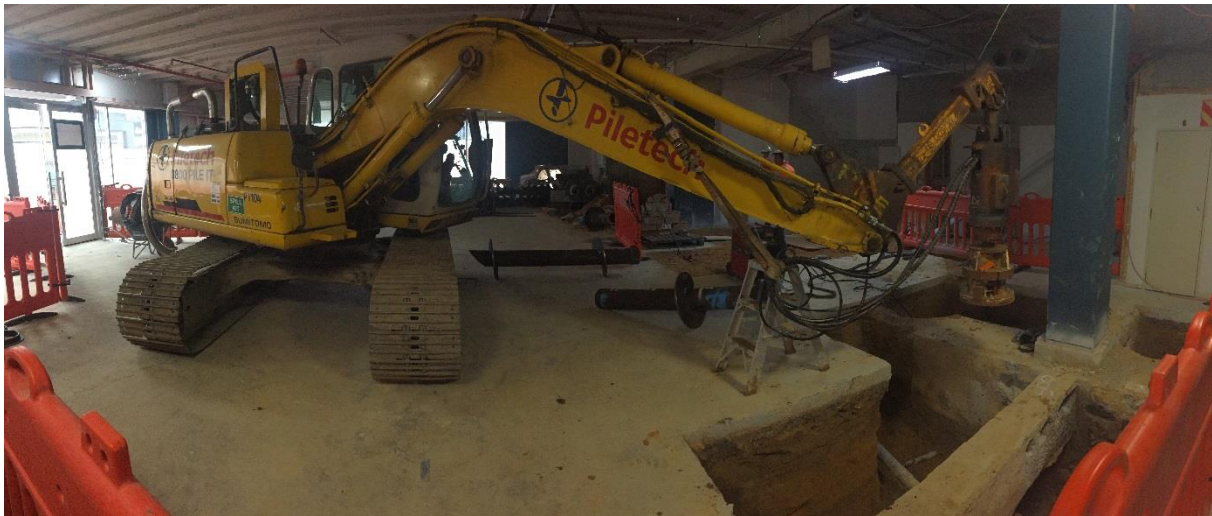
Screw piles were adopted as the most suitable solution for the site challenges presented. As well as being a cost effective solution compared to the alternatives, screw piles had the added benefit of reducing the construction noise and vibration effects, and potential for disruption to the existing tenants (refer Figure 5).

Figure 5 Screw pile installation
