# Monitoring of seismic isolated buildings: state of the art and results under high and low energy inputs

2017 NZSEE  
Conference

**ABSTRACT:** The experimental response of base isolated structures under seismic loading is shown and discussed in this paper. Actually, the good performance of isolation systems has been demonstrated during strong earthquakes occurred in Japan, United States and China where the reduction of the seismic accelerations from the basement to the top has been recorded. The behaviour under low intensity earthquake could be different as in the case of some base isolated buildings subject to the recent Central Italy earthquakes in Italy. These experiences pointed out the importance of the non-linear analysis, able to point out the different behaviour under different input energy.

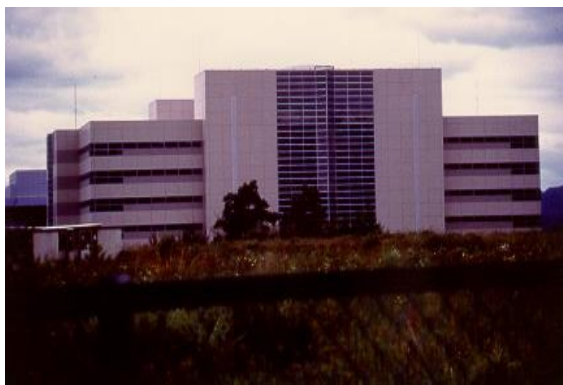
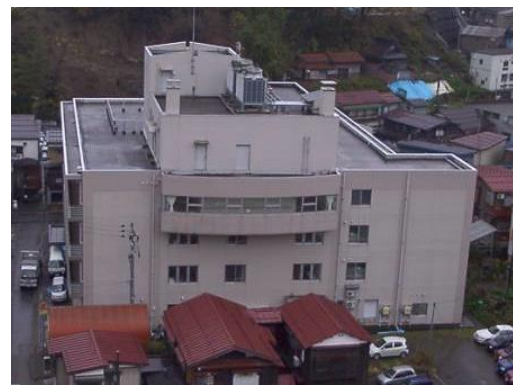
Fig. 1 – (a) The communication minister in Sanda City and (b) the reinforced concrete building in Ojiya City, Japan.

This happened in Japan, which is without doubt the leader in the application of base isolation. As a matter of fact, the number of seismic isolated buildings in Japan increased very much after the 1995 *Hyogo-ken Nanbu* earthquake ( $M = 7.3$ ), when two isolated buildings in the epicentre area, near Kobe, reported no damage during the quake. One of these was the communication minister in Sanda City (Fig. 1a), which was about 30 km far from the epicentre. It had been isolated by means of low damping rubber bearings and elasto-plastic energy dissipators. The monitoring systems allowed to state that the ratio between the acceleration peak at the top and that on the basement was about 1/9, so with a significant reduction of the seismic action. Also during the severe earthquakes occurred after 1995 all seismic isolated buildings behaved very well and the increase of number of applications in Japan is continuing. The reinforced concrete building in Ojiya City (Fig. 1b), Japan, completed in 1994 and isolated by means of rubber bearings and sliders, supported very well the 2004 Mid Niigata earthquake ( $M = 6.8$ ); the peak acceleration was 0.725 g at the base and 0.194 g at the top, with a reduction ratio of about 1/4.

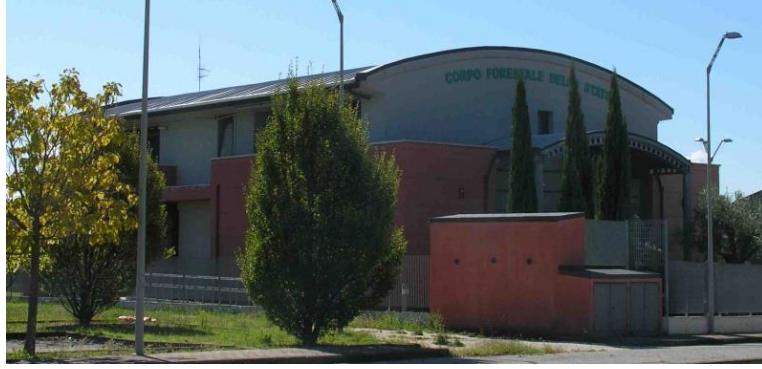
Fig. 4 – The Forestry Building in the Civil Protection Centre of Umbria Region at Foligno, Italy

In the following two cases are shown in which the previously described behaviours were exhibited during the recent Central Italy earthquake of October 30<sup>th</sup>, 2016. The Forestry Building in the Civil Protection Centre of Umbria Region in Foligno (Fig. 4) has been instrumented by means of twelve accelerometers, deployed in the building as follows (Fig. 5):

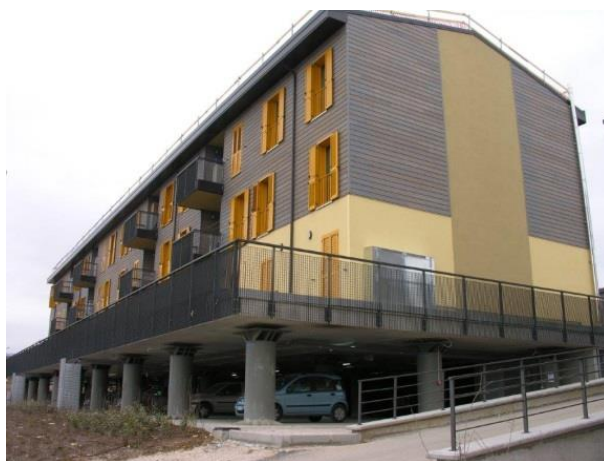
Fig. 9 – Typical isolated platform of the C.A.S.E. project in L'Aquila

The use of seismic isolation increased rapidly after L'Aquila earthquake of April 6<sup>th</sup>, 2009, as a consequence of the large damage caused by this event to conventionally founded structures and to cultural heritage structures, but also thanks to the use of such protection system to buildings for temporarily hosting about 17,000 homeless residents (C.A.S.E. project). These consisted in 184 wooden, reinforced concrete or steel pre-fabricated houses, each of them placed on a large isolated reinforced concrete slab supported by means of curve surface sliders (CSS), manufactured in Italy, installed at the top of circular columns (Fig. 9).
