Timber strong-backs as cost-effective seismic retrofit method for URM buildings

M. Giaretton, J.M. Ingham & D. Dizhur

2017 NZSEE
Conference

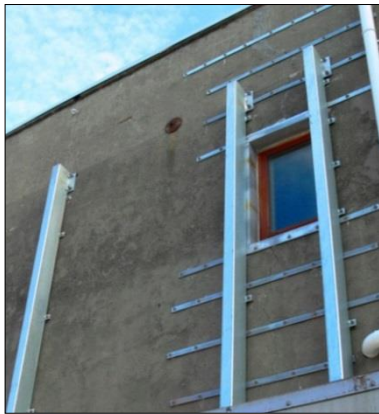
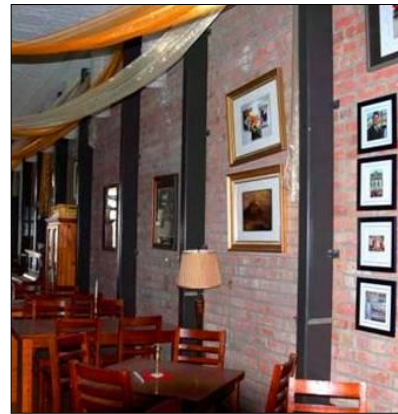
(a) External vertical steel strong-backs

(b) Internal vertical steel strong-backs

Figure 1. Examples of steel members used as strong-backs for out-of-plane retrofit of URM walls

One method for the out-of-plane seismic retrofit of URM walls is to connect a series of vertical members (termed herein as strong-backs) to the interior surface of the wall (see **Figure 1**) at sufficient spacing to ensure that the width of wall between supports is capable of resisting the out-of-plane forces. Strong-backs act in flexure in order to transfer wall loads to the adjacent floor diaphragms, breaking up a large planar wall into a number of buttressed segments. A similar approach was proposed by (King 2009) using strong-backs as a retrofit strategy to protect masonry cladding structures from blast loading. Strong-back members are connected to the URM material via adhesive anchors or through-plate anchors, which allows a high level of reversibility should the need to remove the retrofit system arise. Design considerations when using strong-backs include height to thickness of

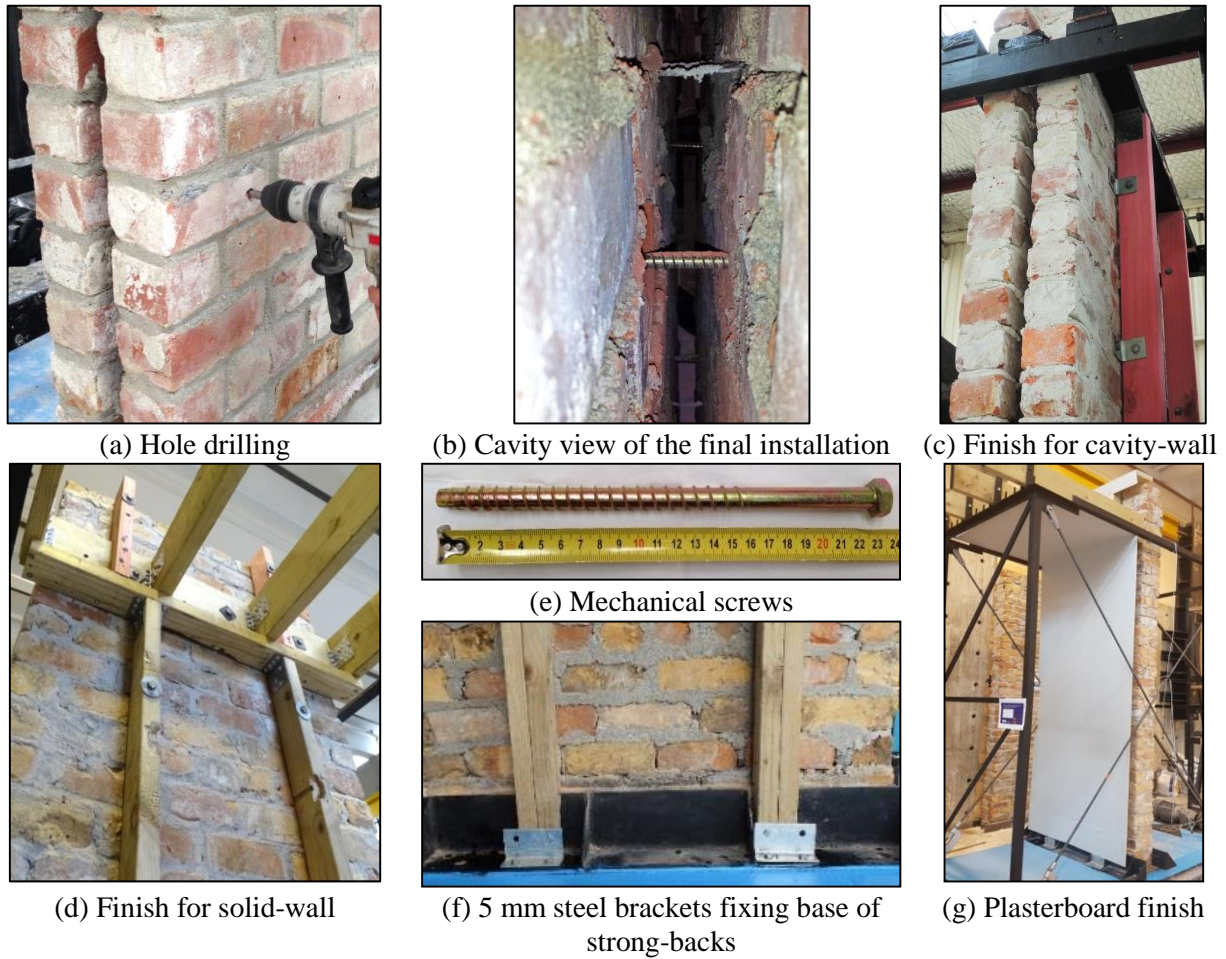
Figure 2. Installation process for timber strong-back retrofit

The vertical strong-backs consist of 90 x 45 mm standard timber studs located at 550 mm spacings and secured to the URM wall using Ø12/230L mm mechanical screws, see **Figure 2**. This retrofit solution was investigated herein for application in both clay brick URM cavity- (see **Figure 3**) and solid-walls (see **Figure 2d,f,g**) with the aim of being a multi-purpose seismic mitigation system and as support to the inner wall lining as well as allowing space for the installation of electrical and plumbing systems.

Based on previous airbag testing of cavity-walls (Walsh et al. 2015), Ø12/230L mm mechanical screw were identified as the most effective retrofit solution in terms of increased out-of-plane cavity-wall capacity when compared with stainless steel helical rods and chemical ties. The screws had a hexagonal washer type head and a total threaded length of 160 mm as shown in **Figure 2e**, and were installed with a spanner in a pre-drilled Ø12 mm hole. The masonry was drilled using a low-impact drill making sure to limit vibrations in the walls, see **Figure 2a**. High torque is required during installation of Ø12 mm screw and from pull-out testing it was observed that in the case of weak bricks in lime-based mortar the screws had a tendency to split the bricks, resulting in a lower pull-out capacity of 18 kN (6 samples, COV 4%). In the cavity-walls the Ø12 mm mechanical screw also serves as a tie to secure the two wall leaves together (see **Figure 2b**) and hence the vertical timber studs were fixed using steel angle brackets mounted onto the wall at a spacing of 400 mm through the screws, see **Figure 2c** and **Figure 3**. In this way the screws reached at least half the depth of the bricks of the opposing masonry leaf (**Figure 3a**), thereby ensuring an adequate embedment length without modifying the external appearance of the building. In the solid-walls the screws were located at the centre of the timber studs with a vertical spacing of approximately 500 mm (see **Figure 4**) and using a washer countersunk 10 mm into the strong-back to provide a smooth surface for the wall lining, see **Figure 2d**. The base of the strong-backs was fixed to the floor-diaphragm (shake-table) using a 5 mm thick steel bracket and two Ø12 mm standard timber screws to allow the transfer of shear induced in

the strong-back, see **Figure 2f**. The top of the strong-back was fixed to the roof-diaphragm using steel brackets and 30 mm long $\text{Ø}5.5$ mm standard timber screws, see **Figure 2c-d**. Standard GIB plasterboard was fixed to the timber strong-backs to demonstrate the aesthetic finish achievable using the securing technique, as shown in **Figure 2g**.
