Out-of-plane adobe wall veneer performance from a novel quasi-static and dynamic tilt test

H.W. Morris & J.G. Brooking

2017 NZSEE
Conference

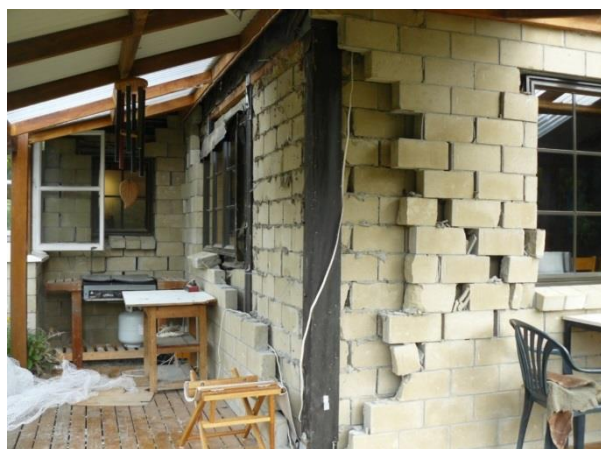
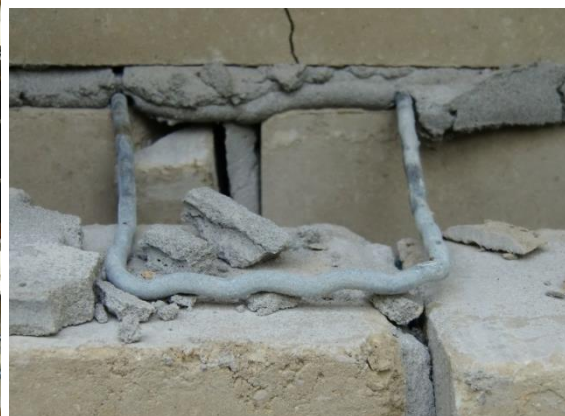
Figure 1. Double skin pressed earth brick walls illustrating worst case veneer problems Christchurch
Exterior burnt brick house veneers often performed poorly in the Christchurch earthquake sequence as was somewhat expected for those constructed prior to 1996 (Dizhur et al., 2013, Beattie & Thurston,

2010). External veneers of unreinforced cement stabilised pressed earth bricks were among the worst observed failures in modern earth buildings in the Christchurch events (see Figure 1) (Morris et al., 2010). A less serious reinforced veneer failure was also observed near Kaikoura in an area subjected to severe shaking in 2016 as shown in Figure 2.

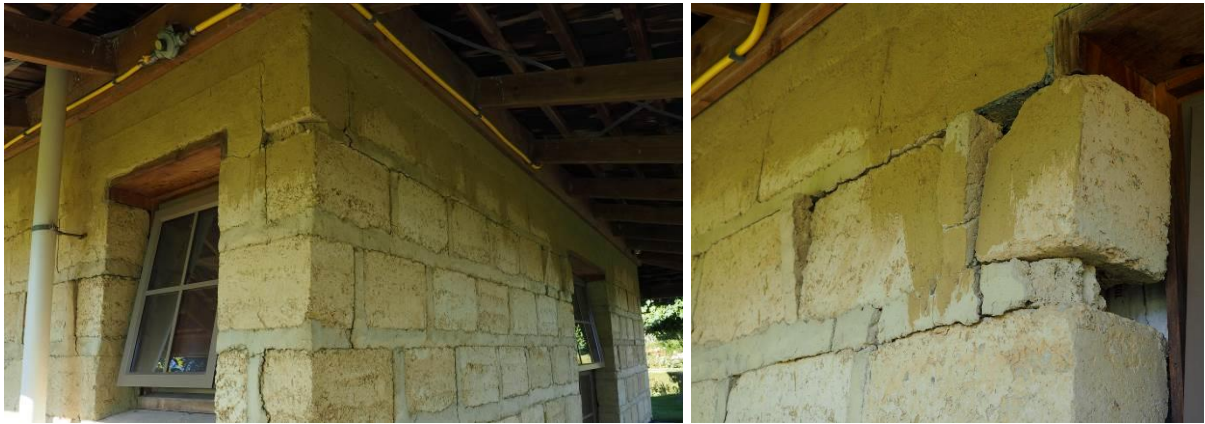
Figure 2. Damage to reinforced pressed earth brick veneer in zone of high accelerations near Kaikoura 2016 (Photo's G North)

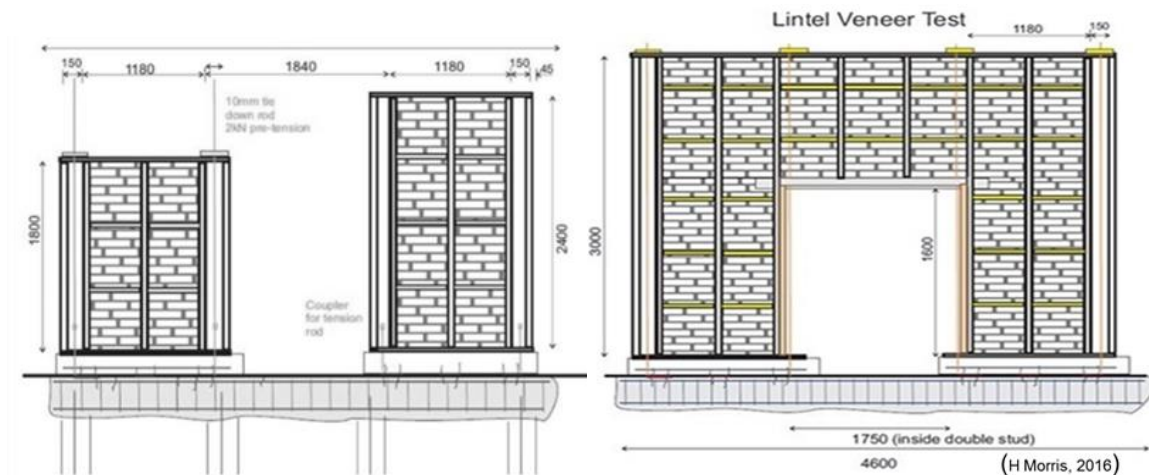
Figure 4. Front views of individual wall specimens on two separate hinged concrete bases and wall with opening and lintel - both bases connected. (Top of external load frame not shown.)

Wall specimen materials used are in accordance with the Half Brick Specification amendment outlined in the Materials and Workmanship standard NZS 4298. They are constructed under a further amendment under consideration for NZS 4299 (Standards New Zealand 1998). Specimen wall dimensions are shown in Figure 4. The veneer wall construction consisted of an adobe veneer made from adobe half bricks and earth mortar. The veneer was screw fixed using Lumberlok brick ties to a ply covered light timber frame.

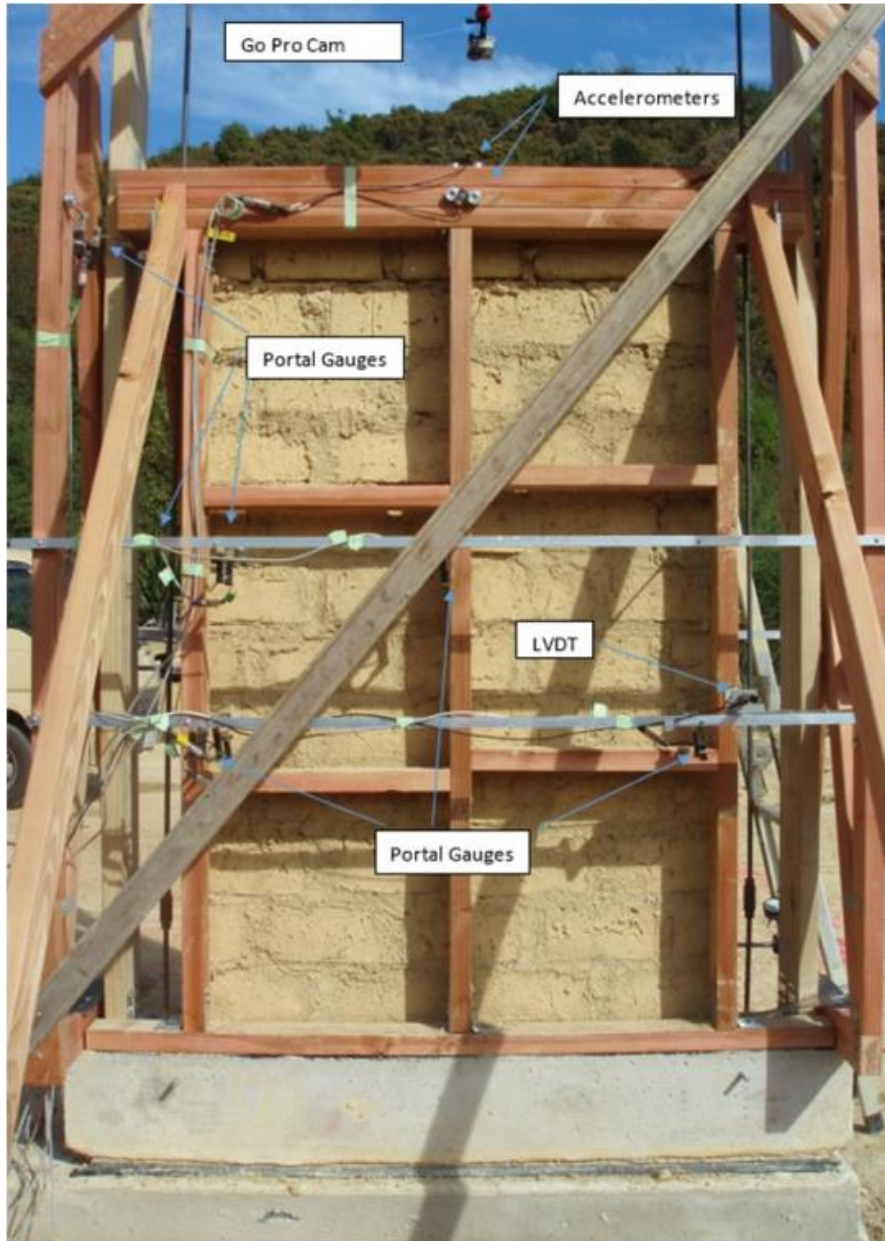
Figure 5. Camera, accelerometers and devices measuring deformations to the reference frame.

Key instruments used included: Portal Gauges measuring deformations, LVDT's (Linear Variable Differential Transducers) measuring deformations, Accelerometers measuring acceleration at the top of the wall, Data acquisition system, Motion and still cameras attached to the wall and external to the wall.

Figure 5 shows the instrument layout and independent reference frame for the 1.8m wall.

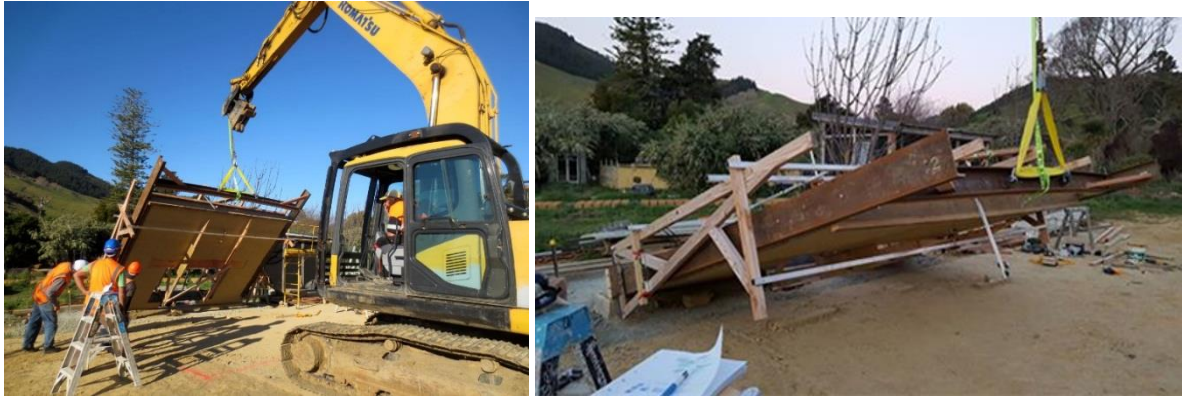
Figure 6. Both bases were connected for the static tilt test of the 3m high panel with lintel (Photo Idema)

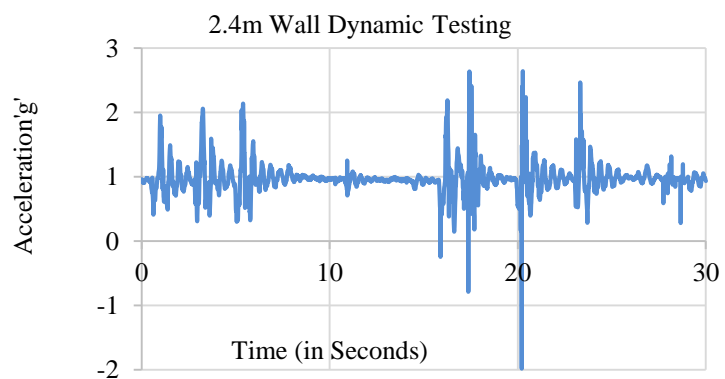
Figure 7. Tilt of 1.8m wall and dynamic accelerations up to 2.64g induced by shaking

Static and dynamic test results exceeded expectations and did not show any significant damage to the 1.8m or 2.4m walls. This proved it was feasible to go ahead with the building and testing of the 3.0m high lintel wall. The tests on the 1.8m and 2.4m walls showed that the walls were capable of withstanding significant dynamic loading as shown in Figure 6 where the 2.4m wall was subjected to an equivalent upper wall lateral acceleration of 2.64g without damage.

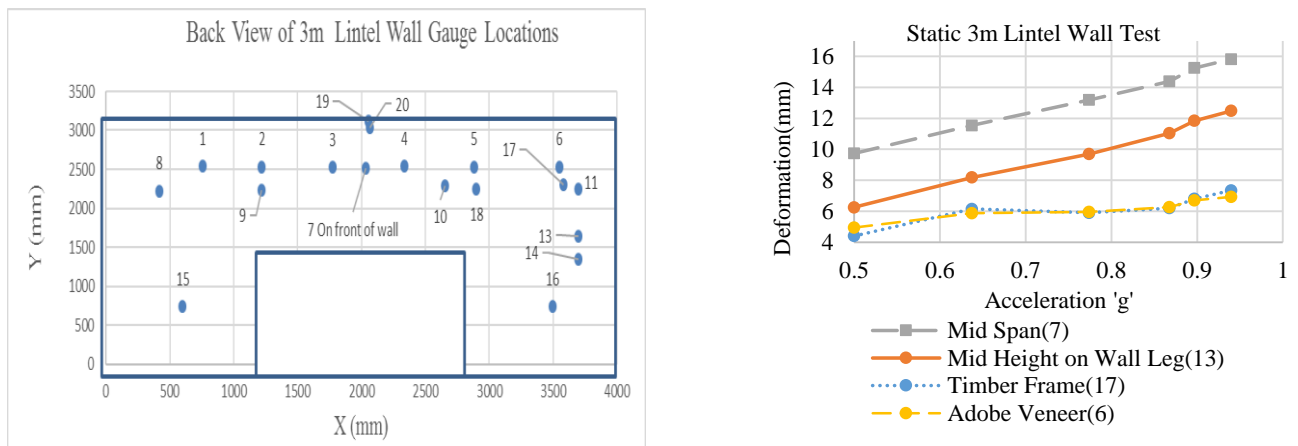
Figure 8. Static deformations as tilt induces out-of-plane loads

The numeral in the graph legend in Figure 8 refers to the instrument type and position as shown. The tilt angle was used to determine the effective out of plane acceleration as a proportion of gravity. The maximum 'g' on the graph of $0.94g = 70$ degrees of tilt.

Measurements also indicated that the timber frame deformed by the same amount as the adobe veneer with no slip on the ties, so components of the wall acted in unison (governed by the flexural strength of the timber frame). This is important as wall failure is often due to the bricks detaching and falling.

The deformation vs 'g' or tilt relationship can be considered linearly proportional. This shows that the wall's response is uniform to at least $0.94g$.

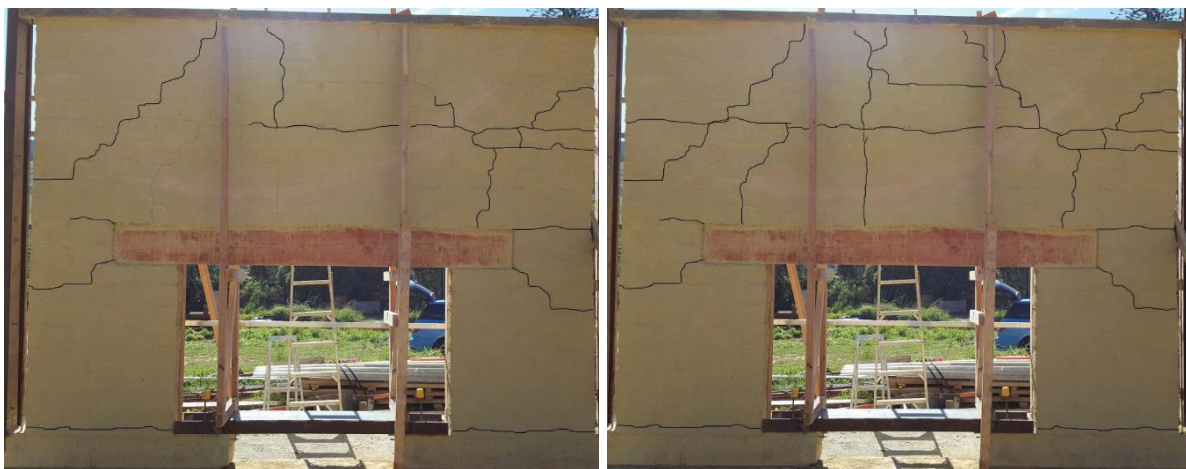
Figure 9. Cracking highlighted at the end of static testing ($0.86g$) and after dynamic testing

As shown in Figure 9, the cracking at the end of static load tests is drawn on the photo. Following the dynamic tests a complete horizontal crack midway between the lintel and top plate shows that strong

one-way bending has occurred here. Two-way bending effects were confirmed by vertical cracks and diagonal corner cracks relating to the support conditions and became nearer to symmetrical. Only mortar and mortar interface cracks were observed suggesting a stronger brick to mortar strength ratio.

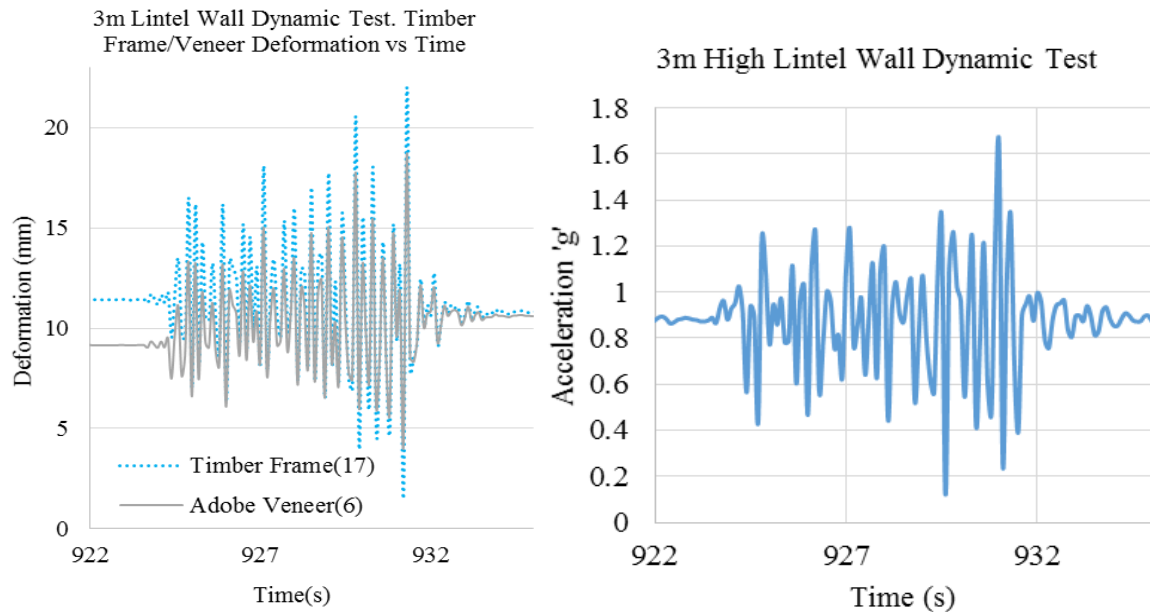
Figure 10a and 10b. Induced deformations and accelerations in the 3m high wall with lintel

Dynamic testing attained a maximum 1.64g as shown in Figure 10b. This is less than the 2.64g applied to the 2.4m wall, possibly due to the differing loading stop's ability to absorb shock. The 2.4m test also had a chain which came into play when the elastic stop used was over extended causing a jolt. Wall size and operator dexterity could also have contributed. This is still a good result to achieve this level of load and the wall remained intact.

Figure 10a shows that under dynamic loading there is no significant evidence of any brick tie slip marked by the similar in-phase veneer and timber deformations. This is consistent with the static tests.
