NEW ZEALAND SOCIETY FOR EARTHQUAKE ENGINEERING  
**2019 Pacific Conference on  
Earthquake Engineering**  
TURNING HAZARD AWARENESS INTO RISK MITIGATION  
4 – 6 April | SkyCity, Auckland | New Zealand

# ILEE-QuakeCoRE collaboration: Low-damage concrete wall building test

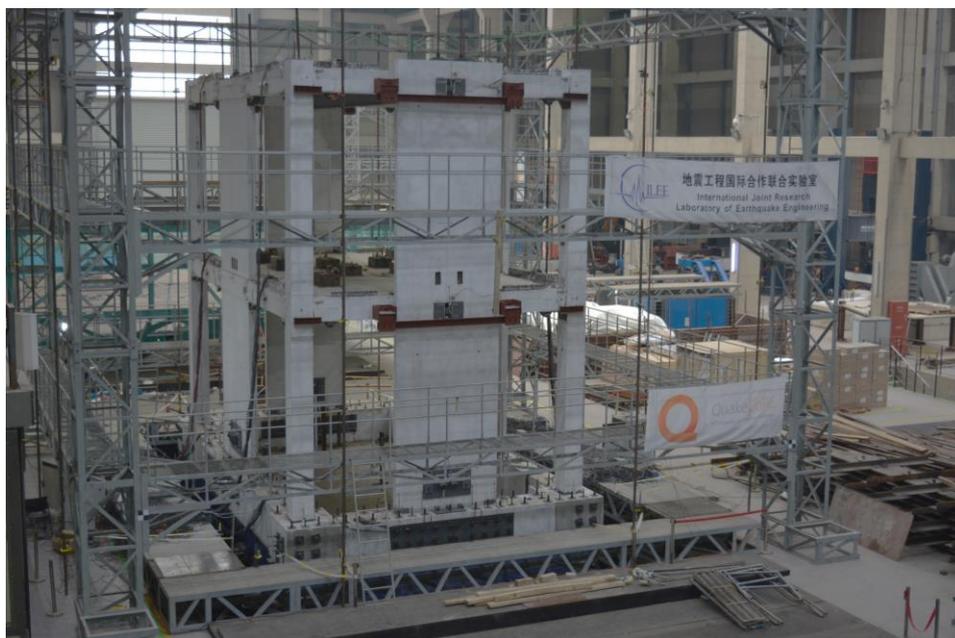
*Figure 1: The test building on the shake-table array at Tongji University's Jiading campus.*

The test building was assumed to be used for general office purpose and located in Wellington, New Zealand. The two-storey test building had plan dimensions of  $5.4 \times 8.95$  m. The total height of the building from foundation surface was 8 m with each storey 4 m high. The building structural system consisted of a perimeter frame and two exterior PT walls in both directions. The four PT walls are designed to primarily resist seismic loads in both directions. The perimeter frame was designed to primarily carry gravity loads and used a slotted beam detail (Muir et al, 2012; 2013). The Level 1 floor system consisted of a long-span precast concrete double tee and a steel tray composite floor was used in level 2 in a short span configuration. A secondary steel beam is aligned through the longitudinal center of the floor to reduce the span of composite floor. The building design is described in detail by Lu et al. (2018) and the constructed building is shown in Figure 1.

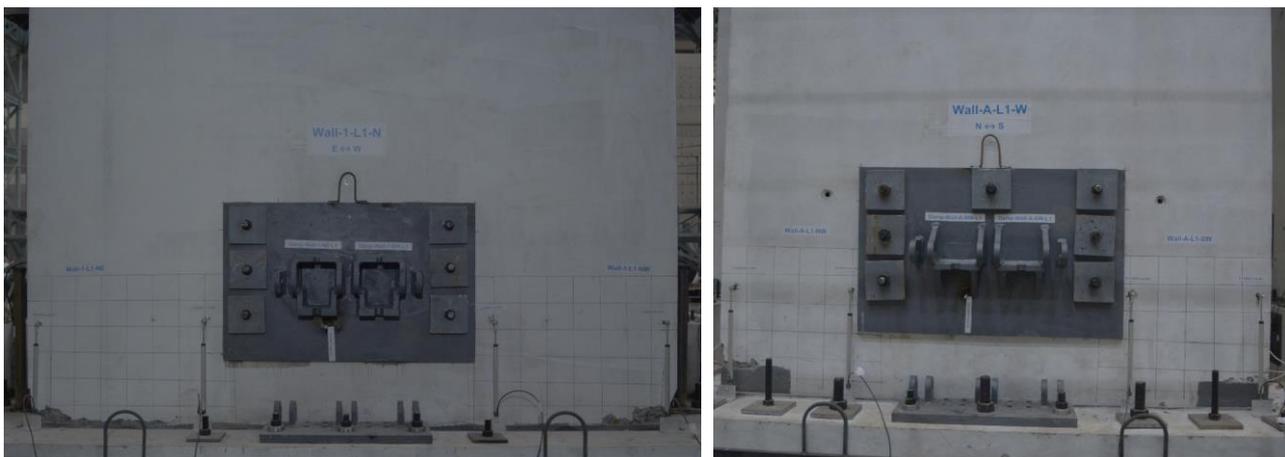
*a) A long-span wall utilising a grouted joint detail and a small steel angle for armouring*

*b) A short-span wall utilising a recessed steel pocket detail and armoured end toe region*

*Figure 2: Wall condition at the end of testing*

The building was subjected to approximately 40 separate ground motions, consisting of five structural design configurations with different energy dissipating devices and combinations of ground motions including an SLS record, far field and a near fault ULS records, and short and long duration MCE records. The structure was subjected to both long-span and short-span unidirectional shaking, as well as bi-directional horizontal shaking. The building sustained all of these tests with only minimal damage. Minor spalling occurred at the wall toes during larger intensity shaking, as shown in Figure 2. Both wall base details performed well, with no significant wall sliding or out-of-plane walking. The flexible wall-to-floor connections accommodated the wall deformations as intended, with some resulting cracking in the floors. The isolated wall-to-floor connection was successful at preventing any unintended demands on the floor with no cracking observed around these connections. The slotted-beam connections performed well, minimising beam-elongation (frame dilation) demands on the floors which resulted in only modest residual crack widths.
