Shaking table test of a reduced-scale reinforced concrete structure subjected to near-fault ground motion

W.C. Shen, F.P Hsiao, R.J. Tsai, P.W. Weng, Y.A. Li & S.J. Hwang

National Center for Research on Earthquake Engineering, Taiwan.

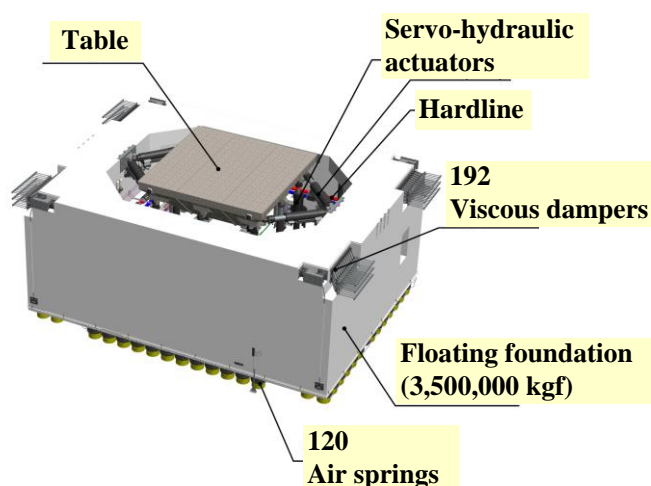
Figure 1: Shaking table at the NCREE Tainan laboratory

In the past decade, testing of non-ductile RC frame specimens using the shaking table at the NCREE Taipei laboratory have been carried out by researchers (Wu et al. 2005, Kuo et al. 2008 and Lin 2009). However, it is difficult to use the existing experimental facilities to simulate the near-fault ground motions. As a result, a high performance seismic simulation shaking table has established to reproduce near-fault ground motions as shown in Figure 1. It possesses six degrees of freedom to simulate earthquake motions in three axes. The size of the shaking table is 8×8m with a self-weight of 100 ton. Specimens with a maximum weight of 250 ton can be accommodated on the shaking table. The shaking table is driven by eight high performance servo-hydraulic actuators. Four of them are installed horizontally and the other four are mounted vertically. The maximum horizontal stroke and velocity capacities of the shaking table are ± 1.0 m and ± 2.0 m/s, respectively. The maximum horizontal and vertical accelerations for the bare table are ± 2.5 g and ± 3.0 g, correspondingly. The reaction mass is isolated from the fixed foundation by 120 air springs and 192 viscous dampers.

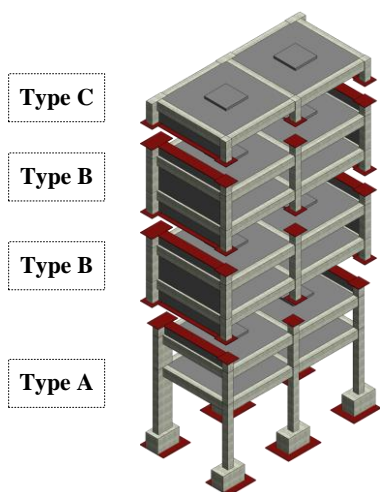
Figure 2: Modular design of specimen

Testing of a 1/4-scale twenty-story RC specimen has been carried out at the E-Defense shaking table. The reduced-scale specimen was separated into five blocks for shortening the construction period (Sugimoto et al. 2012). Considering the capacity of the overhead crane of the NCREE Tainan laboratory, the concept of modularity was utilized on the specimen design. The shaking table test specimen was fabricated separately in three different parts named Type A, Type B and Type C, and eventually assembled together. Type A can be freely connected with the other two types according to different test requirement. For example, in terms of the seven-story specimen, it is combination of one Type A, two Type B and one Type C. Figure 2 shows the modular design of specimen. On the other hand, the mega steel frame was also fabricated to protect the equipment and prevent the collapse of the specimen during the shaking table test. The seven-story specimen and the collapse prevention system were fixed to the shaking table using all-thread bolts as illustrated in Figure 3.

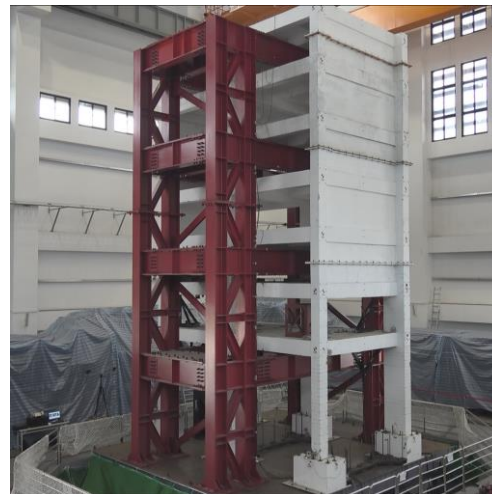
Figure 3: Overview of seven-story specimen and collapse prevention system

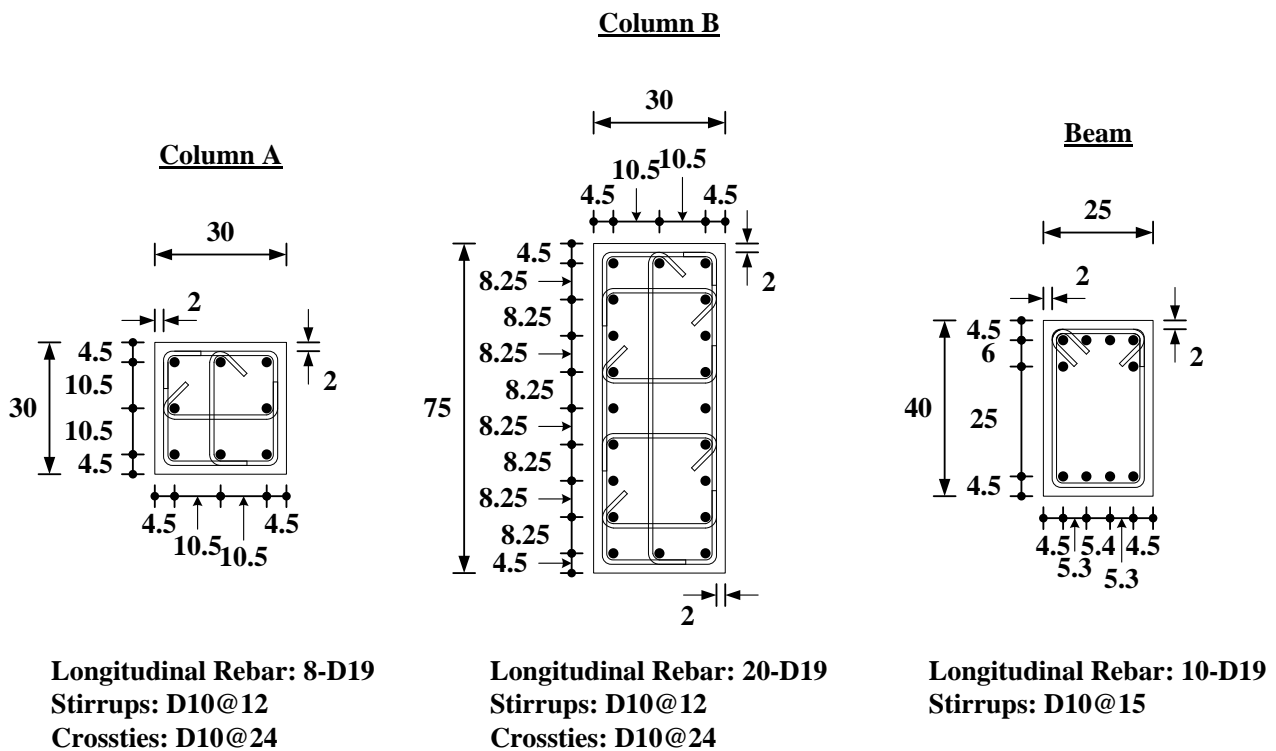
Figure 5: Cross sections of RC members (dimensions in cm)

The columns with longitudinal reinforcement ratio of 2.53% which had cross sections of 30×30 cm and 30×75 cm, respectively. The beam with longitudinal reinforcement ratio of 2.85% had cross section of 25×40 cm. As for column and beam elements, the D19 steel with design yielding strength of 4200 kgf/cm² (420 MPa) was used as the longitudinal rebar, and the D10 steel with design yielding strength of 2800 kgf/cm² (280 MPa) were used as the transverse reinforcement. The cross section information is shown in Figure 5. For stirrup hooks, 90-degree bend plus 6 bar diameters extension at the end bar was used. The use of crossies with a 90-degree turn at one end and 135-degree bend at the other end placed so that consecutive crossies had their 90-degree hooks on opposite sides of the columns. The spacing of stirrups and crossies in column elements were designed to be 12 cm and 24 cm, respectively. As for the beam elements, the spacing of stirrups were designed to be 15 cm. It is worth noting that the beam-column joints of the three-story specimen tend to be more vulnerable under high seismic loads because of insufficient transverse reinforcements in the joint region. The weak column-strong beam behavior and strong column-weak beam behavior are expected to appear during the shaking table test due of the two different column dimensions and only one beam dimension.

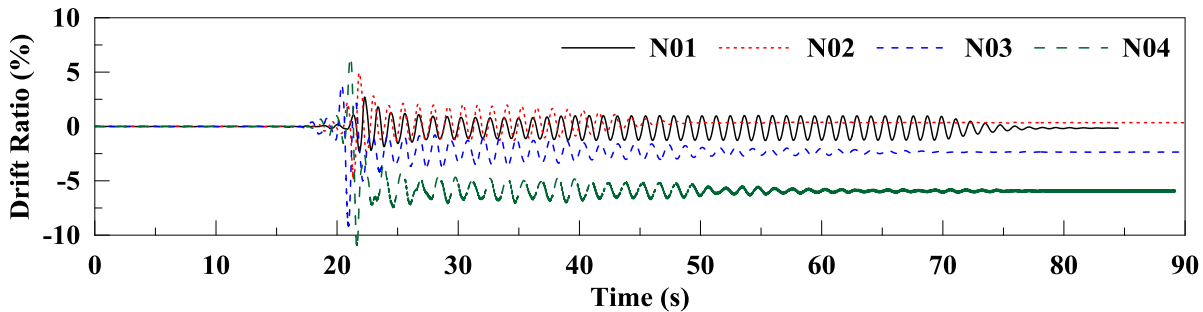
Figure 7: Comparison of inter-story drift ratio in the first story during near-fault ground motions

Figure 7 compares the inter-story drift ratio in the first story after the near-fault ground motion. A significant residual inter-story drift ratio is happened after each test excluding test N01. The response of the seven-story specimen during the 200% near-fault ground motion is demonstrated in terms of the histories of the inter-story drift ratio of first and second floors. The amplitude of the inter-story drift ratio in the first floor is about 11%, but remained close to 6% in the second floor as shown in Figure 8. The strong part of motion during test N04 started at approximately 18.5 seconds and resulted in the residual drift ratio about 6% in the first floor. Also, the residual drift ratio happened in the second floor. The maximum drift ratio recorded during each test are listed in Table 2.

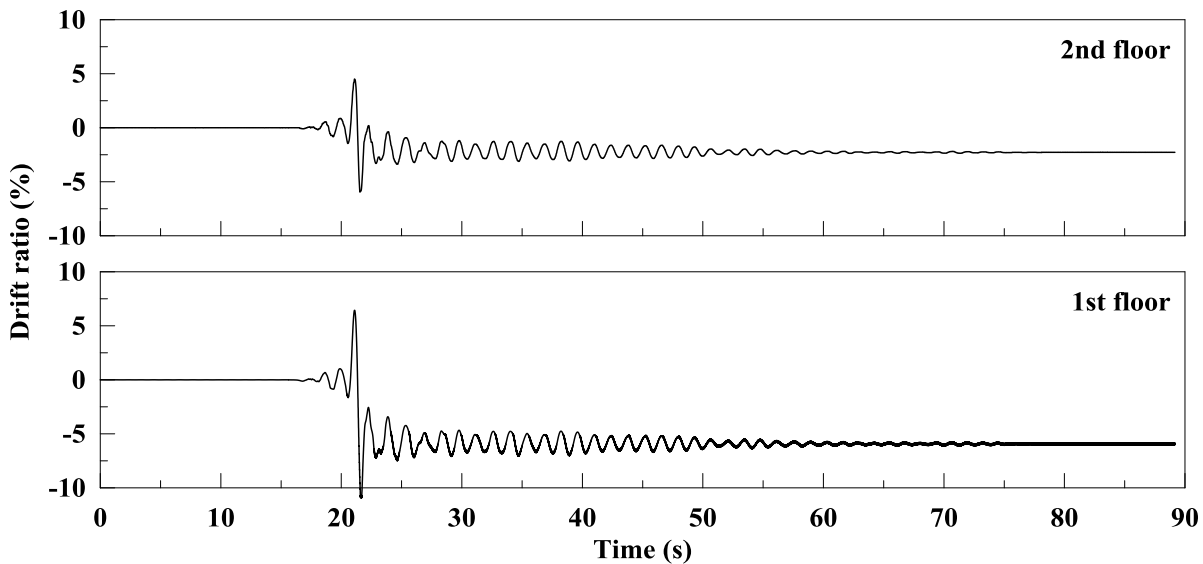
Figure 8: Inter-story drift ratio during 200% near-fault excitation (N04)

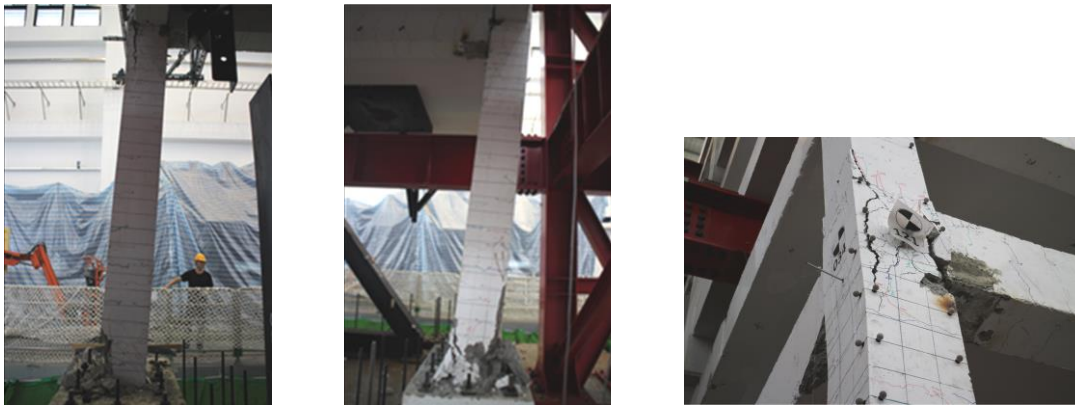
(a) Corner column

(b) Interior column

(c) Beam-column joint

Figure 8: Damage of specimen after test N04

No significant damage was observed in the seven-story specimen after the first two tests F01 and N01. After test N02, slight spalling of concrete occurred in bottom of the square corner column. More concrete was spalling or crushing after test N03. Figure 8 shows the damage of specimen after test N04. Concrete crushing

and reinforcement buckling were observed at each column end in the first story. Moreover, the significant cracks developed on the beam-column joint due to the poor detailing of reinforcement.
