NEW ZEALAND SOCIETY FOR EARTHQUAKE ENGINEERING
**2019 Pacific Conference on
Earthquake Engineering**
TURNING HAZARD AWARENESS INTO RISK MITIGATION
4 – 6 April | SkyCity, Auckland | New Zealand

An overview of post-earthquake damage and residual capacity evaluation for reinforced concrete buildings in Japan

M. Maeda

K. Matsukawa

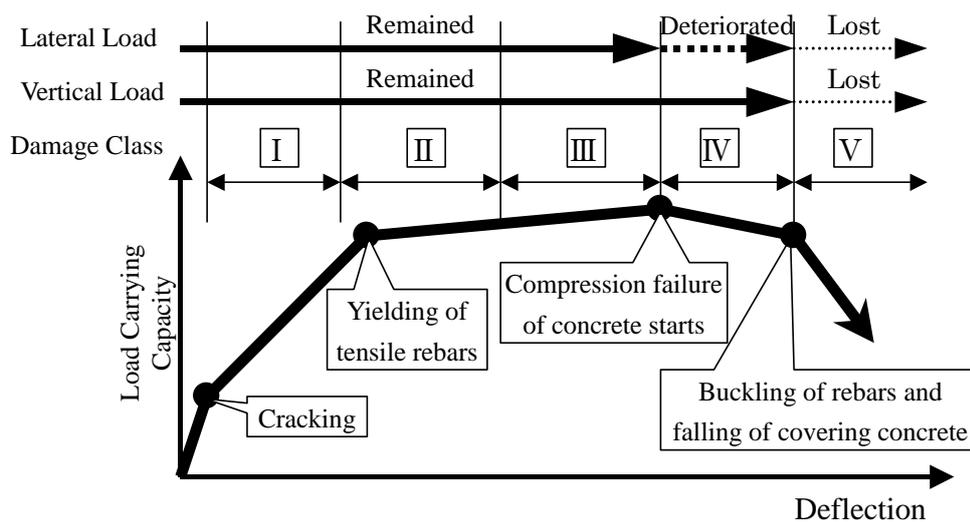
(a) Ductile member

Figure 1: Idealized lateral force-displacement relationships and damage class (JBDPA 2015)

Table 1 and the lateral force-displacement curve is approximated as shown in Figure 1a, b. Examples of damage class for columns and walls are shown in Photo 1.

In Figure 1a, a ductile member deforms up to a maximum lateral strength level after yielding. Furthermore, after reaching the maximum strength, the reduction of strength is relatively small. If the maximum deformation during an earthquake does not reach deformation at yielding point, extensive damage would not occur. This state corresponds to damage class I, between the cracking and yield points. If the maximum deformation does not exceed the maximum strength, damage to cover concrete is limited and most of the lateral and vertical strengths remains in the flexural member. This state corresponds to damage class II and

damage class III. If the maximum response exceeds the maximum lateral strength point, deterioration in lateral strengths with spalling of cover concrete would be observed. The vertical strength may remain if the buckling and/or fracture of reinforcing bars and crush of core concrete, etc., do not occur. This state corresponds to damage class IV. If buckling and/or fracture of reinforcing bars and crush of core concrete occur, both the lateral and vertical load carrying capacities will be lost (damage class V).

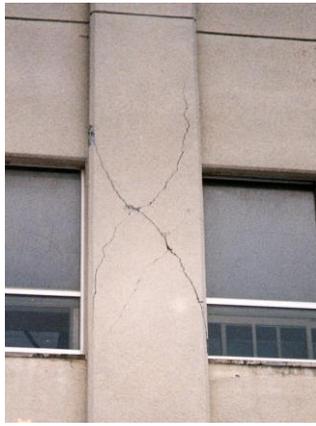
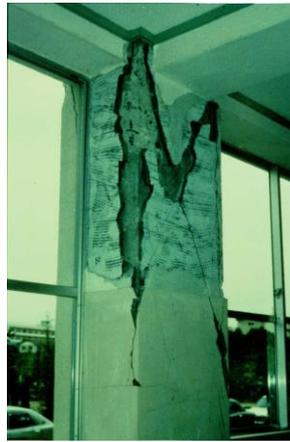
Damage class III: (left) Cracks with a width of about 2mm on structural concrete
(right) Spalling concrete cover and slightly exposed rebars

Photo 1: Damage class examples

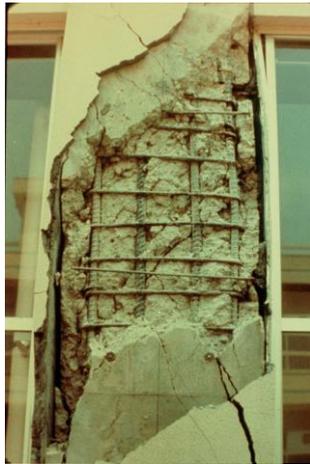
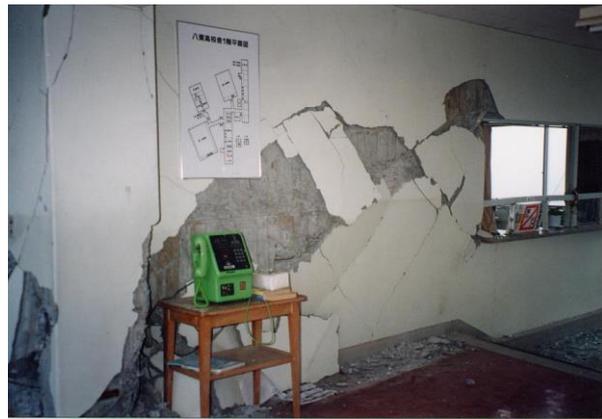
Damage class IV: Exposed rebars without buckling or fracture

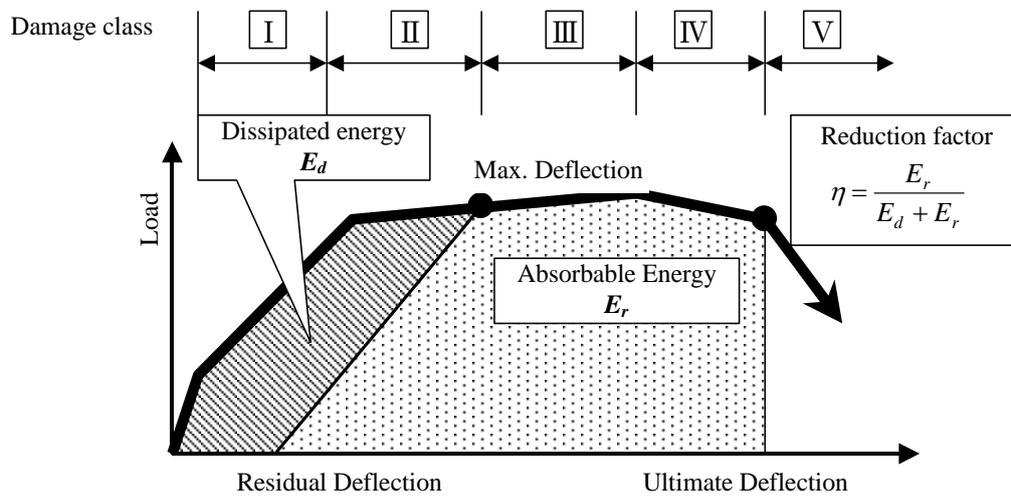
Figure 2: Seismic capacity reduction factor η

The seismic capacity reduction factors, *i.e.* η factors for structural members corresponding to the damage classes, are listed in Table 2. The values for η factors are determined from the residual crack width and the overall damage state of RC columns observed in the first author's experiments (Maeda 2004) and analytical studies (Maeda 2001 and Maeda 2009). The post-earthquake seismic capacity, DIs index, of the overall building after earthquake damage can be calculated based on the E_0 index reduced by the η factor corresponding to the observed damage class of each structural member.

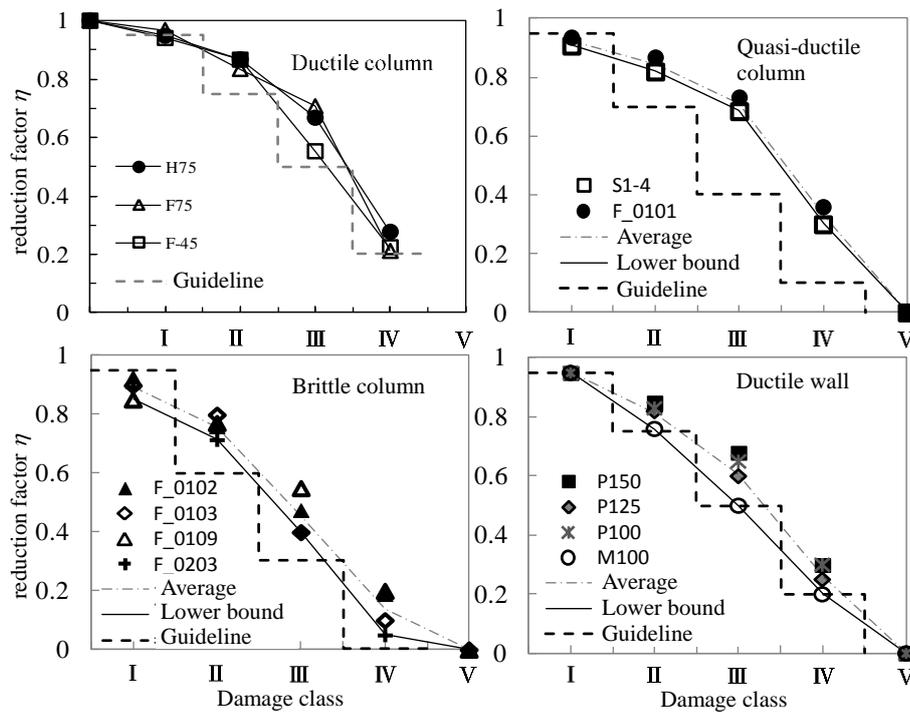
Figure 3: Experimental data of Seismic capacity reduction factor η

The values of η factors for brittle columns were applied to shear walls in the previous Guideline (JBDPA 2015), and no recommendation for beams as shown in Table 2, because experimental data focused on residual seismic capacity was quite limited at the 2001 revision. In the 2015 revision, the values of η factors were enhanced through examination of experimental data (Maeda2014 and Itoh 2015). A new category of "Quasi-ductile columns" was introduced in addition to ductile and brittle columns in the previous Guideline. The values of η factors were re-evaluated based on conservative estimation of experimental data are shown in Figure 3. Moreover, η factors for beams and walls were given independently as shown in Table 2.

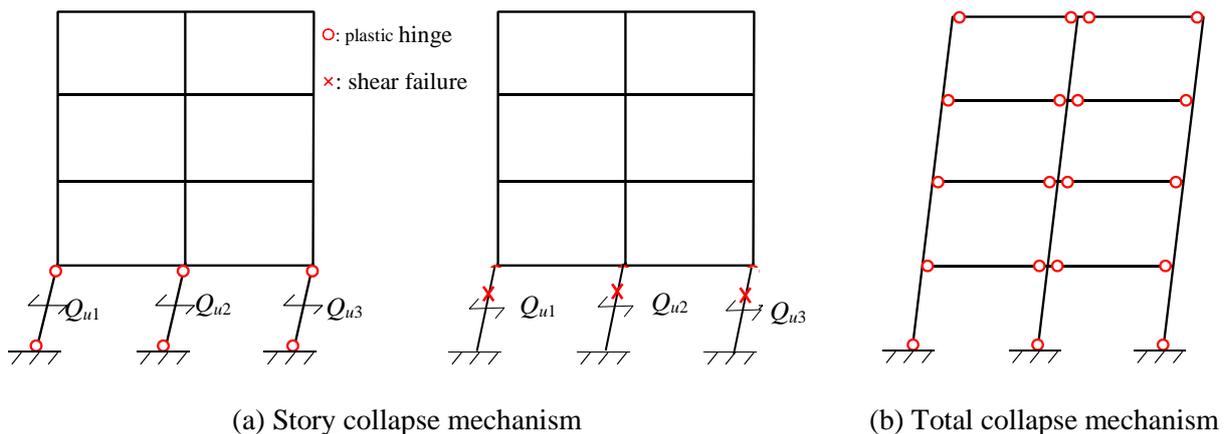
Figure 4: typical collapse mechanism of frame structures

Figure 4a ,b shows typical collapse mechanism of frame structures. As was revealed in past damaging earthquakes in Japan, typical life-threatening damage is generally found in vertical members, and story collapse mechanism, as shown in Figure 4a and Photo 2, is formed. Therefore, the current Guideline is essentially designed to identify and classify damage in columns and walls rather than in beams, and residual seismic capacity, R -index, can be evaluated based on story shear by Equation 3 assuming ductility index (F index) is uniform in all the vertical elements in the story. When damage is found in beams, the damage classification needs to be performed considering their deficiency in vertical load carrying capacity as well as lateral resisting of columns adjacent to damaged beams.

Although story collapse is the most popular failure mechanism, other relatively ductile failure patterns, total collapse mechanism, were observed in reinforced concrete buildings damage by recent earthquakes such as the 2011 East Japan Earthquake. Beam yielding total collapse mechanism (Fig. 4b), which is recommended in the current seismic code and guidelines, was found in some relatively new middle or high rise buildings designed according to current seismic codes. Therefore, the evaluation method for total collapse mechanism, proposed by the first author et al (Bao 2010) is introduced into the Guideline and the scope of application was widened. R -index for total collapse mechanism is evaluated by Equation 4. Equation 4 gives a ratio of internal work at all the plastic hinges in virtual work method before and after an earthquake.

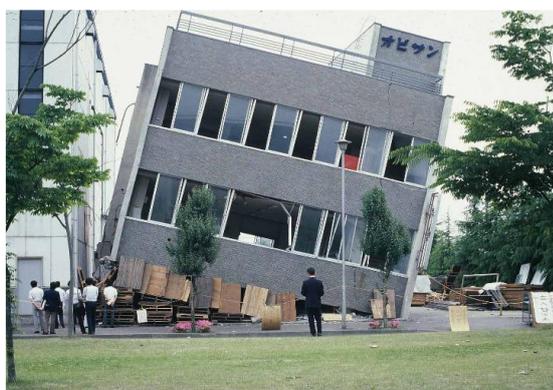
(a) 1978 Miyagi-ken-oki Earthquake

Photo 2: Story collapse of reinforced concrete buildings due to past earthquakes

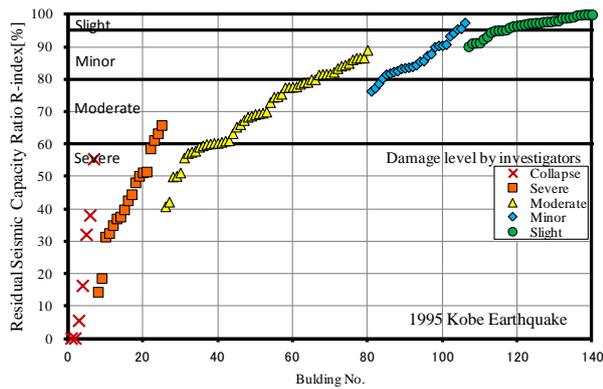
(a) 1995 Kobe Earthquake

Figure 5: Residual seismic capacity index R and observed damage levels due to the 1995 Kobe Earthquake and 2011 East Japan Earthquake

The proposed damage evaluation method was applied to reinforced concrete buildings damaged due to the 1995 Hyogo-Ken-Nambu (Kobe) Earthquake and the 2011 East Japan Earthquake. The residual seismic capacity ratio, R-index, of about 140 reinforced concrete buildings damaged due to the Kobe Earthquake and about 70 buildings due to the East Japan Earthquake are shown in Figure 5a, b together with the observed damage levels from field surveys by experts such as professors. The horizontal lines in Figure 5a, b are the boundaries between damage levels employed in the Damage Evaluation Guideline in 2001.

The boundary lines between damage levels were examined in the 2001 Guideline revision for the buildings in Figure 5a, of which failure mechanism is story collapse. The boundary line between slight and minor damage was set to $R = 95\%$ to harmonize “slight damage” to the serviceability limit state in which the building is functional without repair. Almost all severely damaged buildings and approximately 1/3 of moderately damaged buildings were demolished and rebuilt after the earthquake according to a report of the Hyogo Prefectural Government (1998). If the boundary between moderate and severe damage was set to $R = 60\%$, “moderate damage” may correspond to the repairability limit state.

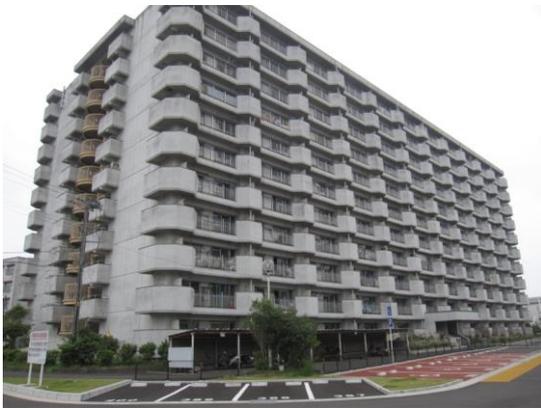
(a) Overall view

Photo 3: Damage to a residential building with total collapse mechanism of beam yielding type

As shown in Figure 5b, the damage levels based on the R-index generally agree with those classified by investigators for the buildings suffered from the 2011 East Japan Earthquake, which include buildings with total collapse mechanism. Photo 3d shows overall view and damages to a residential buildings suffered from the 2011 East Japan Earthquake. The building was a 11-storied steel reinforced concrete structure constructed in 1979. Structural drawing of an outside frame was shown in Figure 6 together with crack maps. Damage to non-structural walls are severe, in particular, in lower stories and shear failure was found as shown in photo 3b, c. On the other hand, damage to structural frame was limited. The frame formed total collapse mechanism with plastic hinges at beam ends by flexural yielding (Photo 3 d). Major damage class of beams were III for lower stories and I or II for middle and higher stories. Assuming story collapse mechanism, R-index is evaluated story by story ranging from 69% in the 2nd story to 95% in 8th story and as a result damage level is classified as “moderate”. However, calculation method for total collapse mechanism

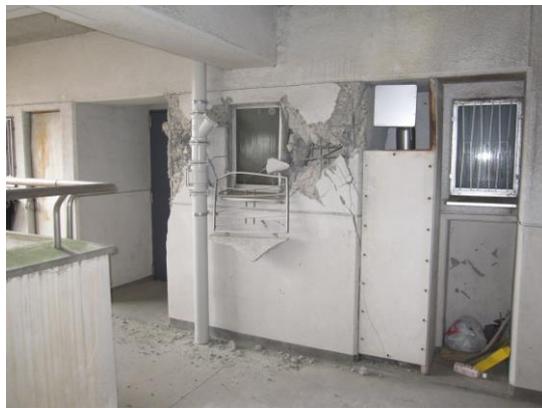
(b) Shear failure of non-structural wall

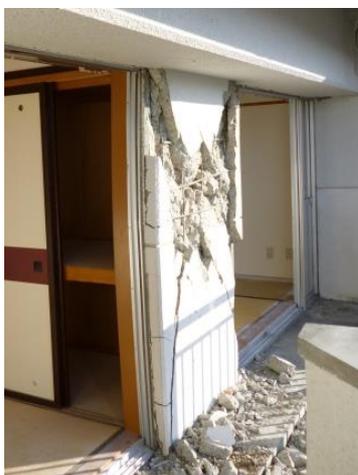
(c) Shear failure of non-structural wall

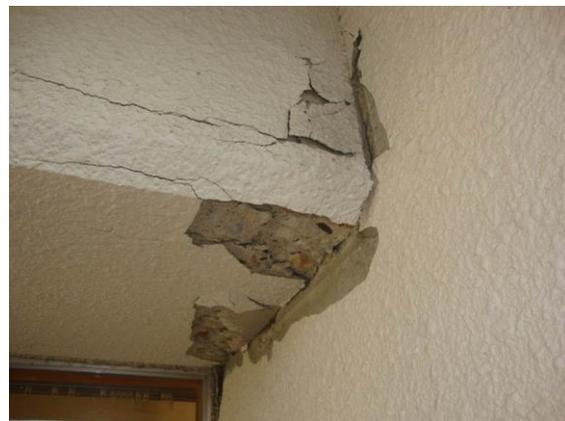
(d) Crush of concrete at plastic hinge region of a beam end

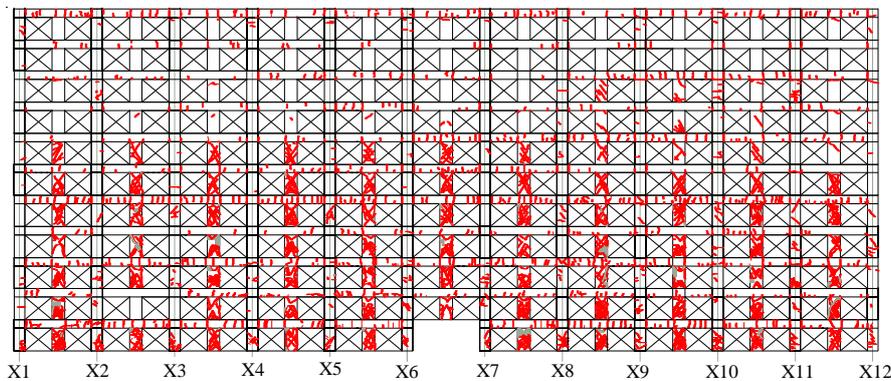
Figure 6: Elevation of a frame with crack map of a residential building damaged due to the 2011 East Japan Earthquake
